Service Bulletin

Bulletin No.: PI0488B

Subject: Diagnostic Information for Transmission No Forward, No Reverse, Slips, Cracked/Split Fluid Filter

Models: 2010-2012 Cadillac CTS-V, Escalade Models
2010-2012 Chevrolet Avalanche, Camaro, Corvette, Express, Silverado, Suburban, Tahoe
2010-2012 GMC Savana, Sierra, Yukon, Yukon XL
Equipped with 6L80 or 6L90 6-Speed Automatic Transmission (RPO MYC or MYD)

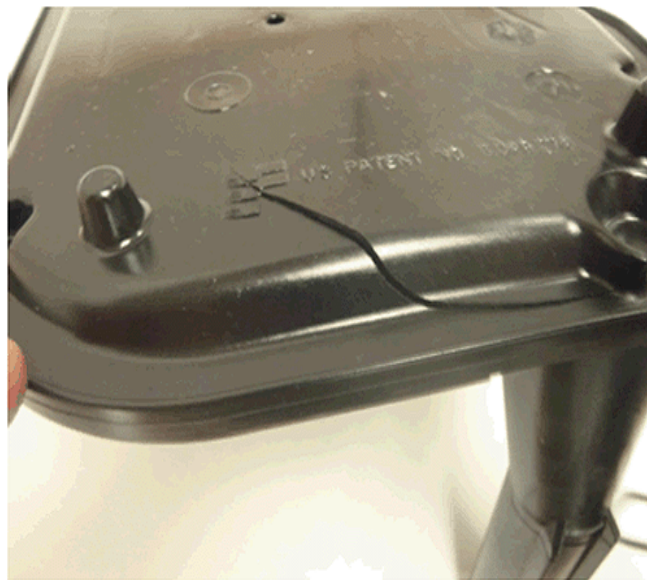
2665171

When diagnosing a confirmed condition of no forward or no reverse or slipping, be sure to thoroughly visually inspect the transmission fluid filter assembly. The filter may be cracked or split as shown in the photos below.

Testing and analysis of transmissions found to have split or damaged filters has shown that this condition may be caused by a damaged pump.

A damaged pump can send a high pressure fluid spike down the filter neck on a cold start, resulting in the filter body cracking or the filter seam splitting.

The filter is not defective and this is not a filter quality issue.

If a cracked or split filter is found, the fluid pump should be disassembled and inspected for possible damage.

Inspect for any of the following conditions:

- Scored pump rotor or pump vanes
- Scored pump cover or pump rotor pocket
- Cracked pump slide

The transmission should also be evaluated for any possible distress to the clutches.

Important: Do not replace the filter without inspecting the pump. Failure to inspect the pump and clutches could lead to a repeat condition.
