ITB11-041f

December 3, 2013

## VOLUNTARY SERVICE CAMPAIGN 1997-2003 QX4 IN NON SALT STATES LEFT FRONT STRUT HOUSING CORROSION

CAMPAIGN ID #: R1110  
NHTSA #: 11V-244  
APPLIED VEHICLES: 1997- 2003 QX4 (JR50)

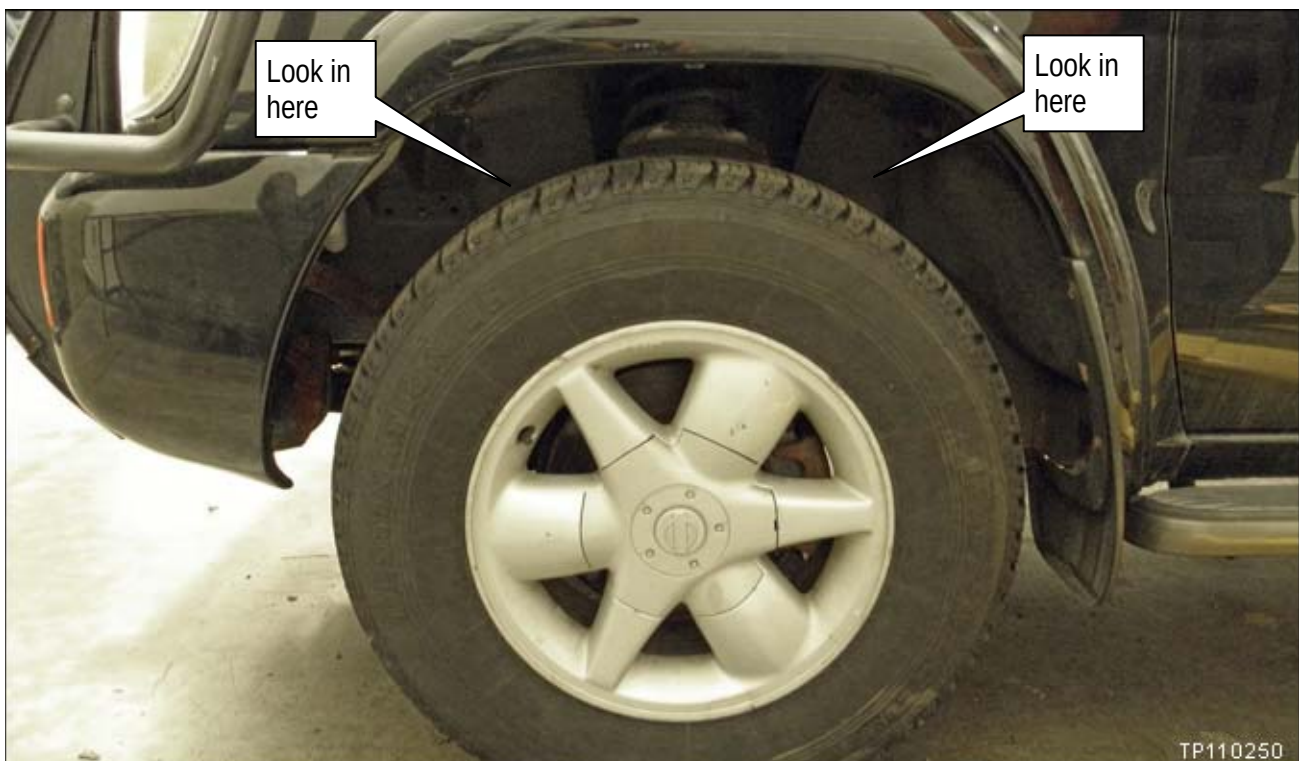
Figure A

4. Visually inspect for corrosion and rust on the wheel housing panels and the strut housing panels.

- Inspect for corrosion and rust on the panels only.

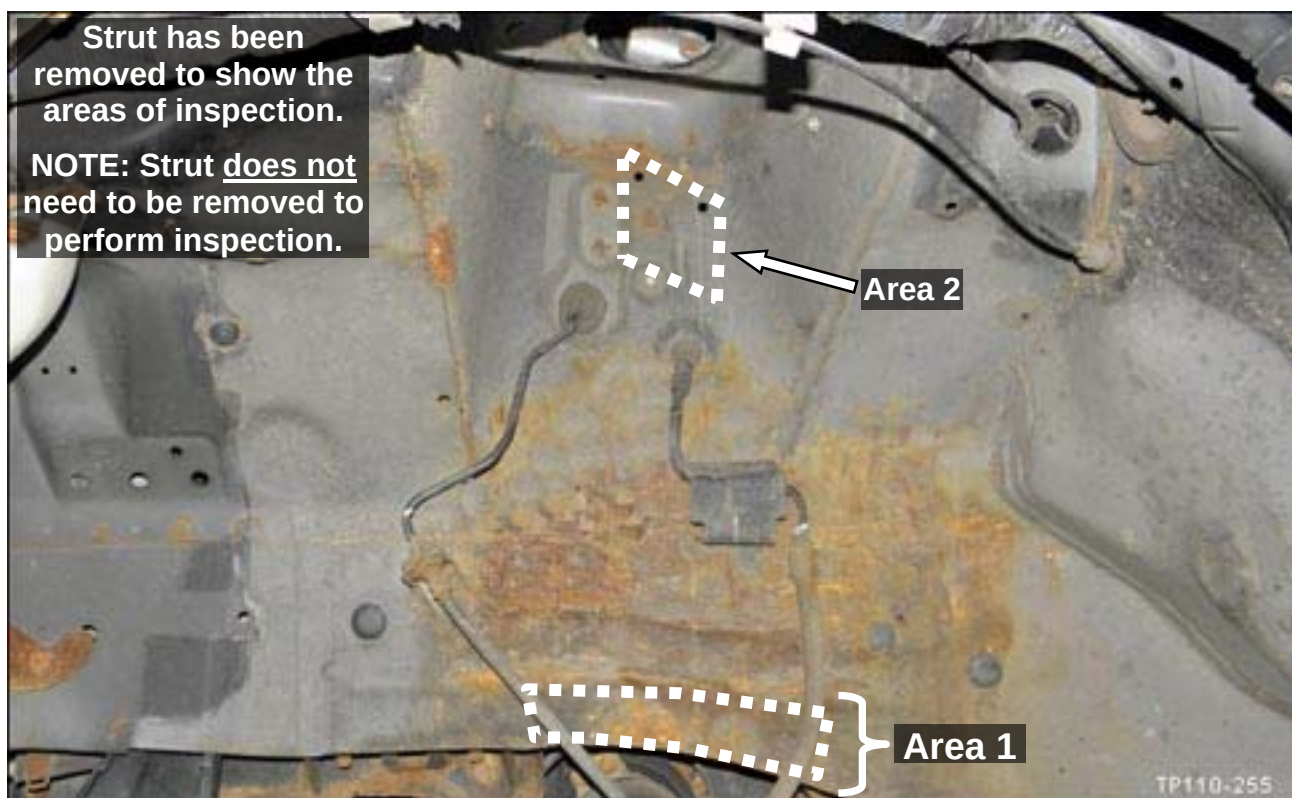
Figure 2

This example photo shows the inspection areas in relation to the repair bracket installation.

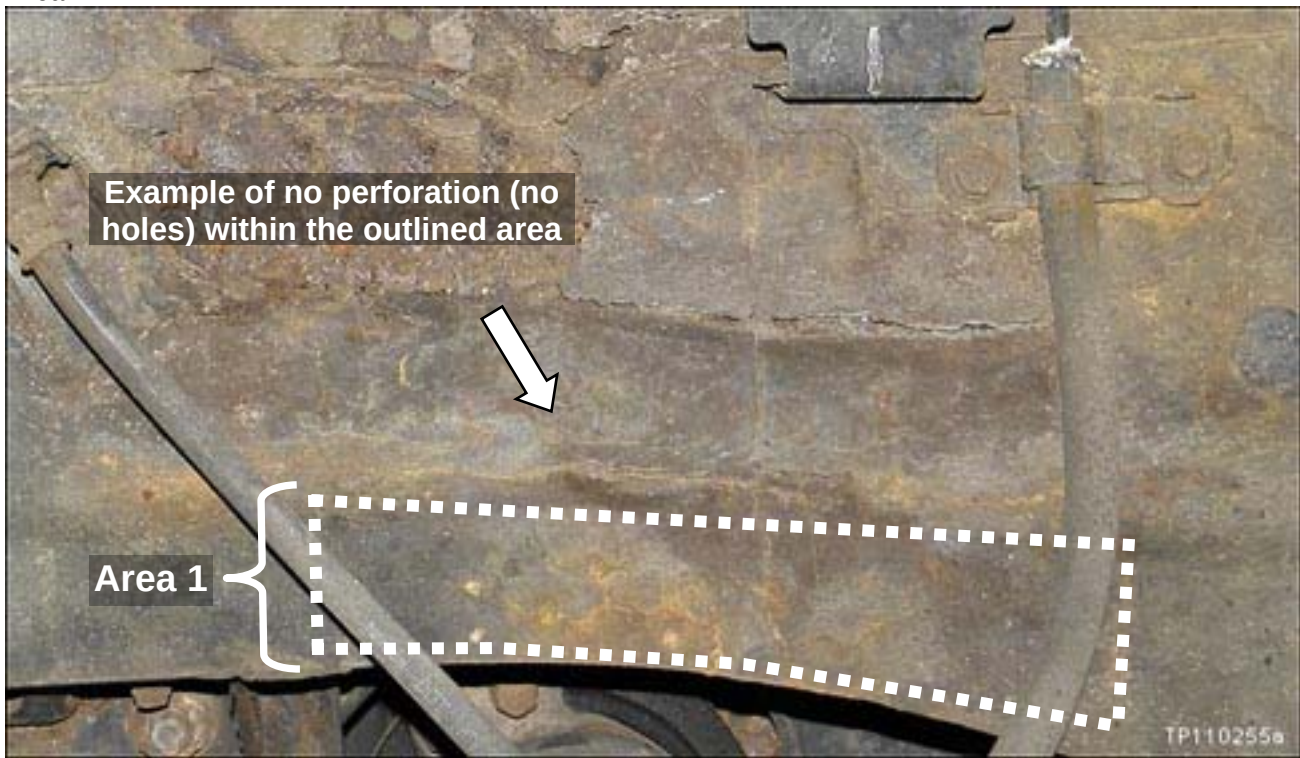
Figure 4

Area 1: Look for perforation (holes) in the metal only in the area outlined above.

- a. Retain the vehicle at the dealer. (The vehicle is not repairable.)
- b. Supply the customer with a rental car.
- c. Fax a completed Non-Repairable Report to Morley (see page 56).

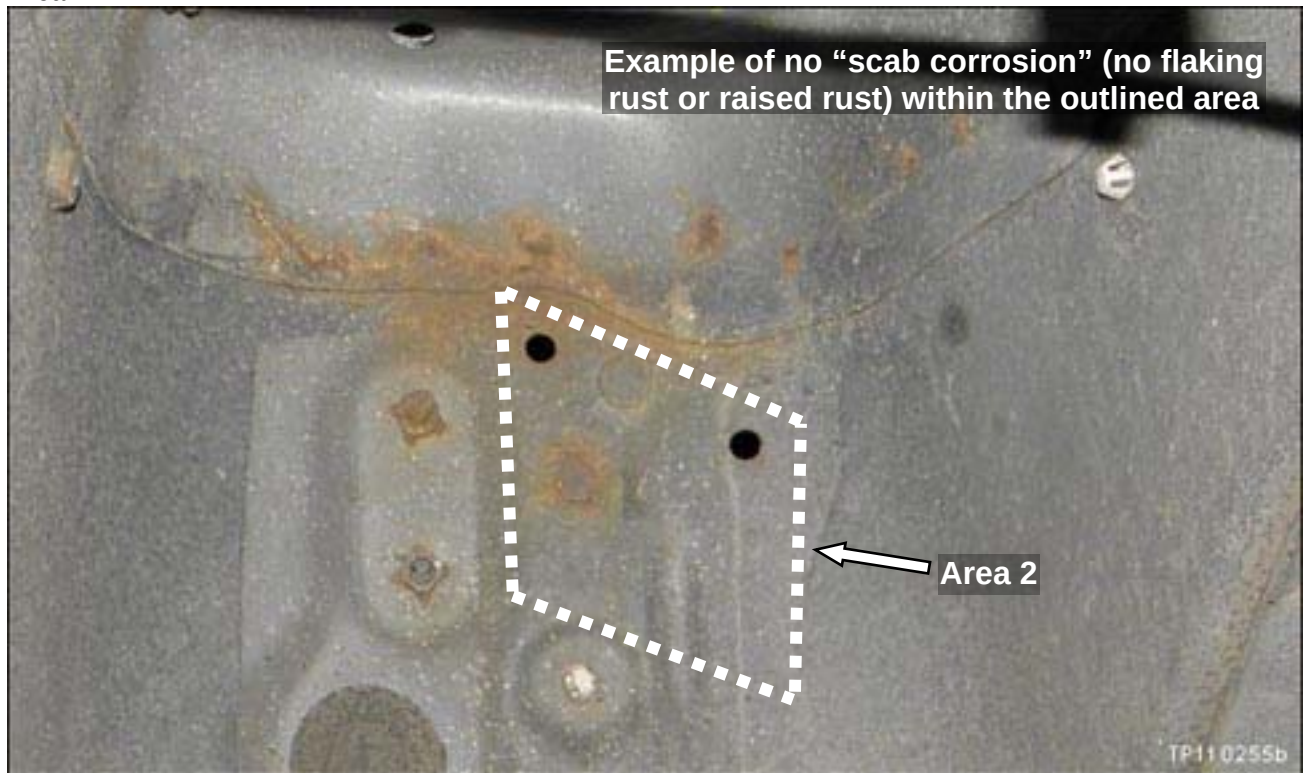
Figure 5

Area 2: Look for “scab corrosion” (flaking rust or raised rust) only in the area outlined above.

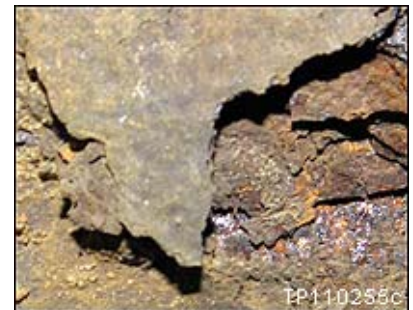
Figure 6 is an example of “scab corrosion” (flaking and raised rust).

If there is scab corrosion (flaking or raised rust) in Area 2 on the driver side OR passenger side:

- a. Retain the vehicle at the dealer. (The vehicle is not repairable.)
- b. Supply the customer with a rental car.
- c. Fax a completed Non-Repairable Report to Morley (see page 56).

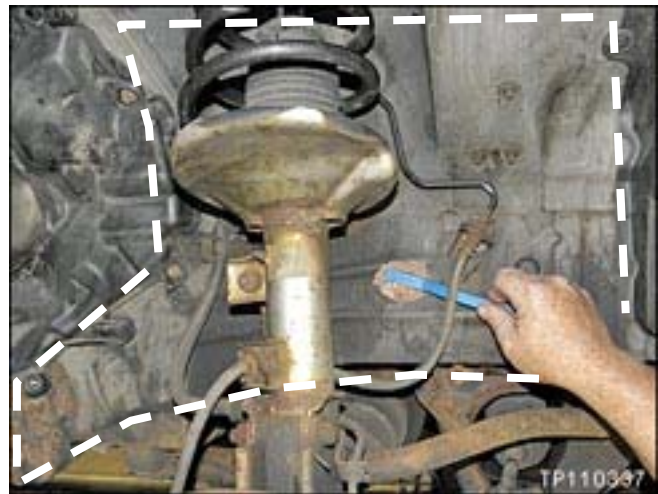
Figure 7

1. Use a wire brush to remove loose rust in the area shown with dashed line.

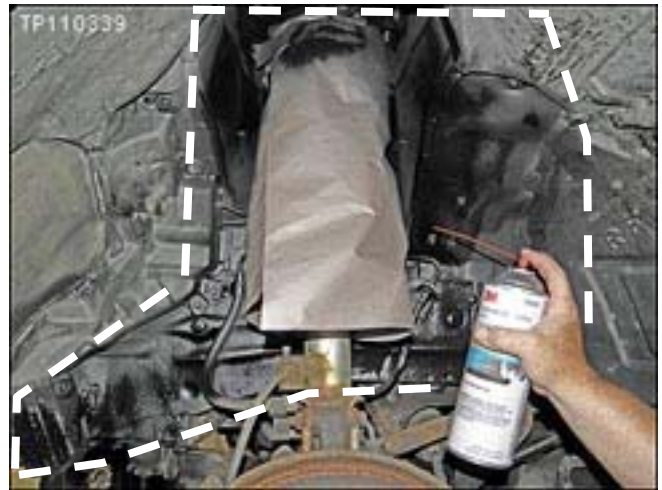
Figure 9

6. Let the undercoat dry for about 1 hour before removing the strut cover.

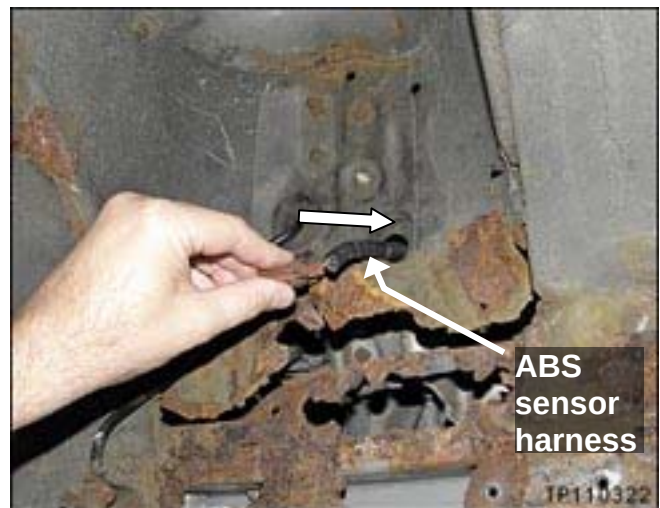
Figure RB1

1. Inspect the ABS sensor harness for damage. If damaged, repair as necessary.
2. Push the ABS harness and connector through the panel.
  - The harness/connector will now be out of the working area.

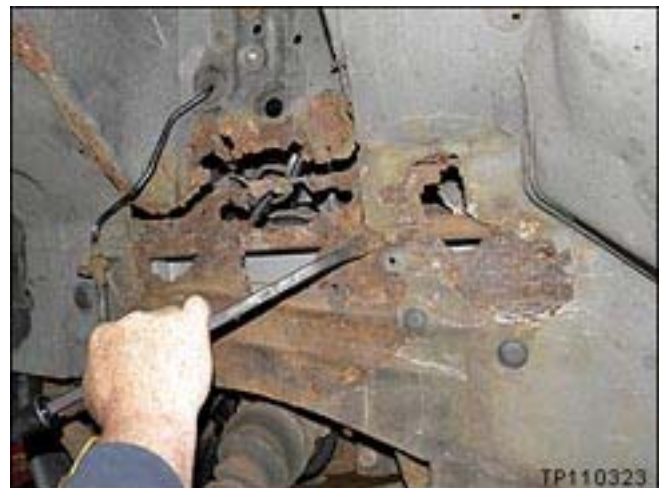
Figure RB2

3. Use a scraper bar to scrape off loose flaking rust and corrosion.

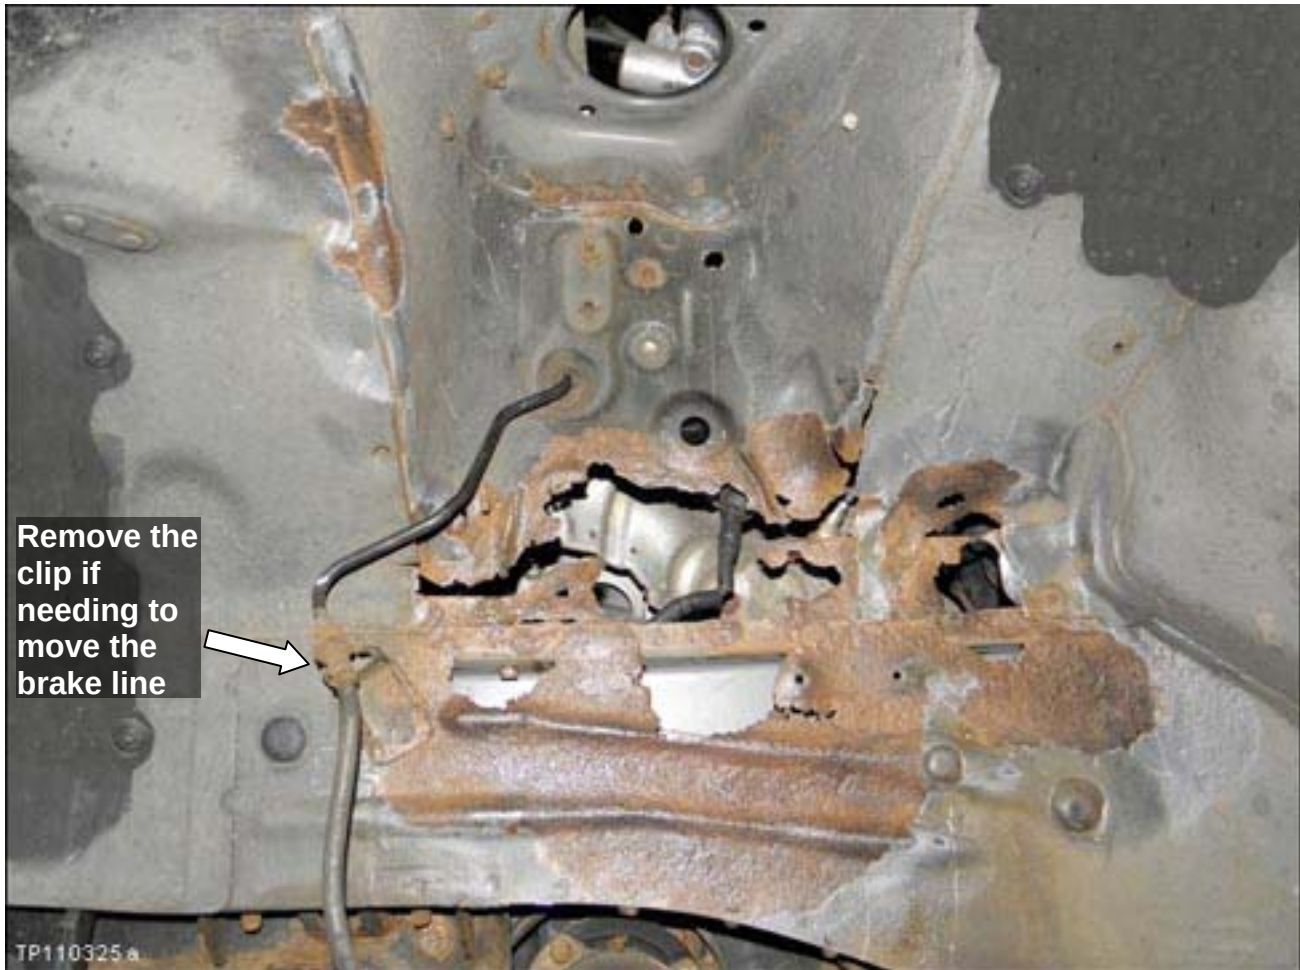
Figure RB3

4. Clean all the loose rust from the strut housing and wheel house areas (see Figure RB3).

**NOTE:** If the brake line is in the way of an area that needs cleaning, move it out of the way by first removing the clip from the mount.

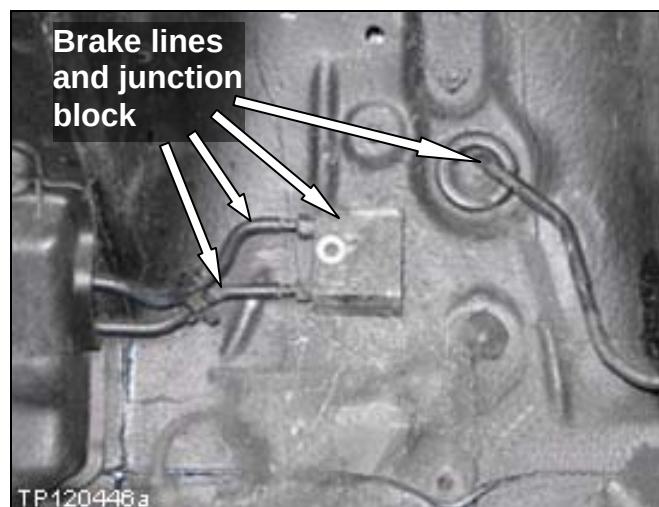
Figure RB4

4a. Passenger side: work around the 2 brake lines and junction block best as possible (see Figure RB4).

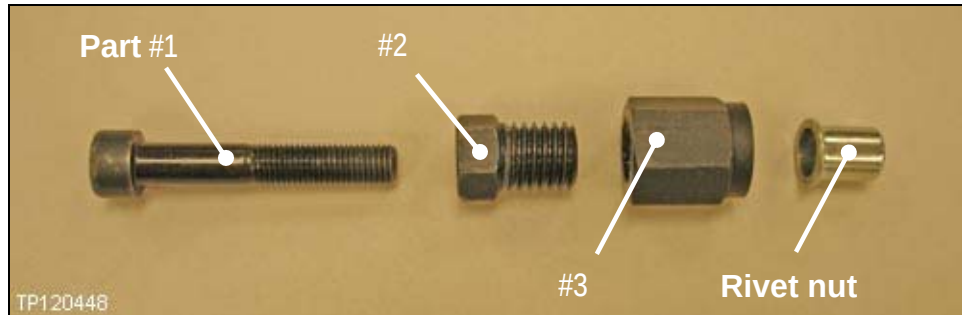
RB13 – Rivet Tool

**NOTE:** Rivet Tool J-50835 comes with extreme pressure lubricant. Apply to the threads and contact points of part #2 and part #3 for approximately every 60 rivet nuts installed (enough for 15 brackets).

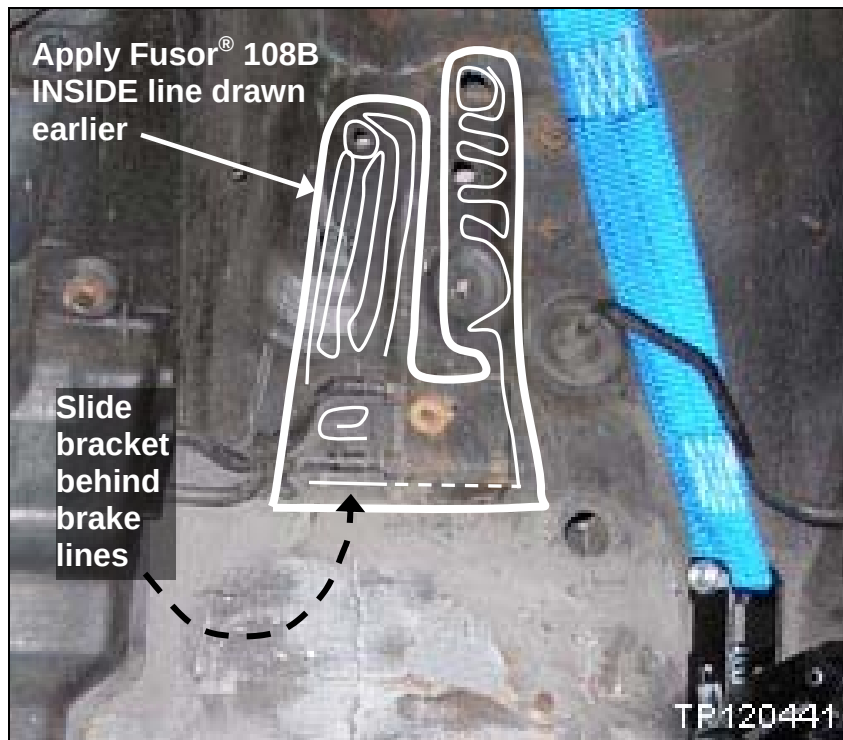
RB24 – Passenger side

27. Passenger side: Liberally apply Fusor® 108B on the strut housing area within the white line drawn earlier (see page 25, step 20, and Figure RB24 below).

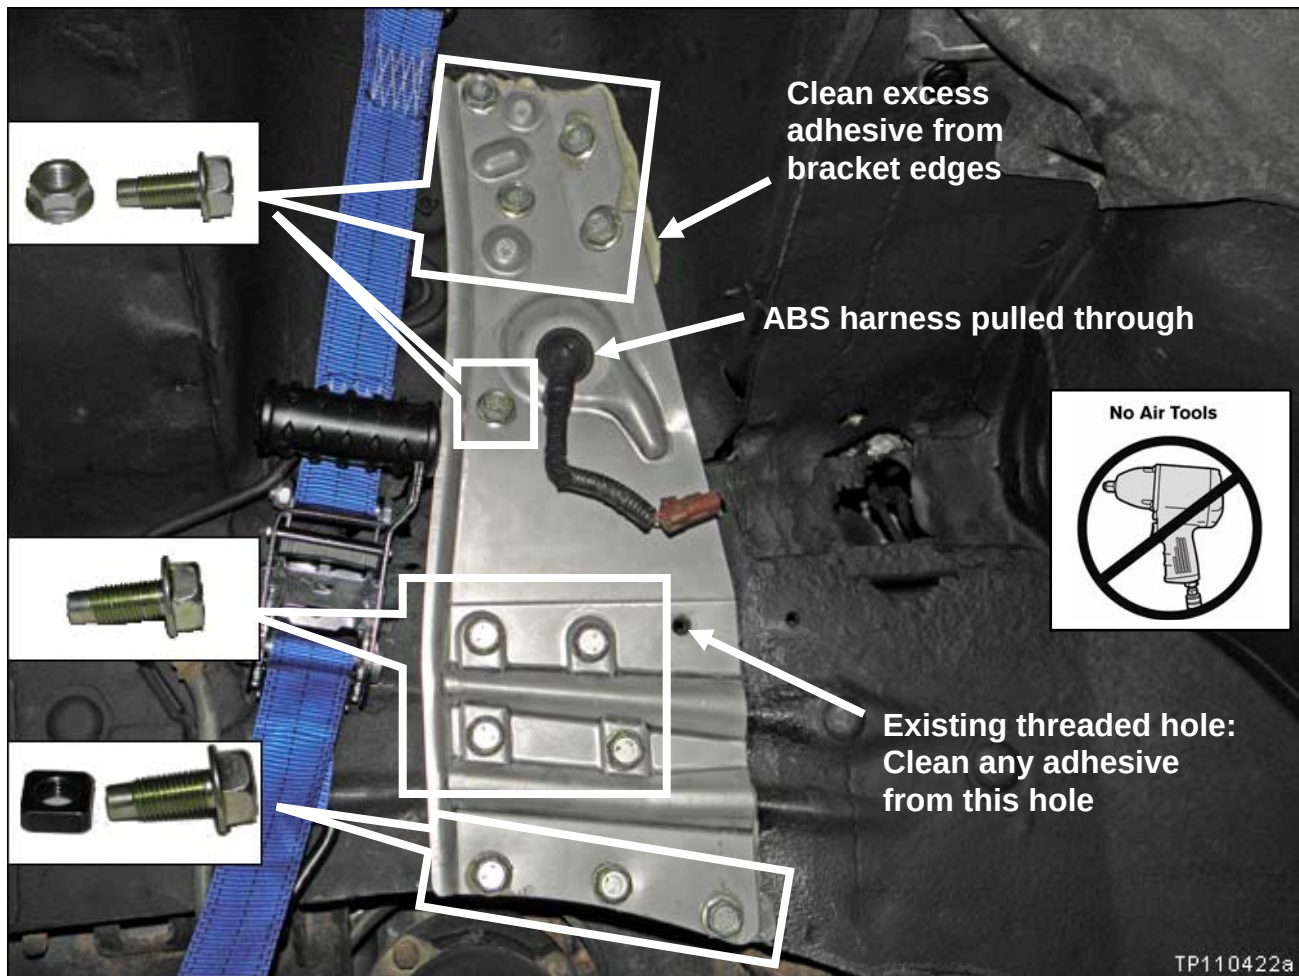
Figure RB25 – Driver side

- Driver side: make sure the ABS harness is pulled through its hole in the repair bracket.
- Use the correct nuts (see Figure RB25, or RB26 on next page, as it applies).
- Do not use air tools to tighten the bolts.
- Torque all new bolts/nuts to 50 N•m (5.1 kg-m, 37 ft-lb).
- Secure all existing bolts.

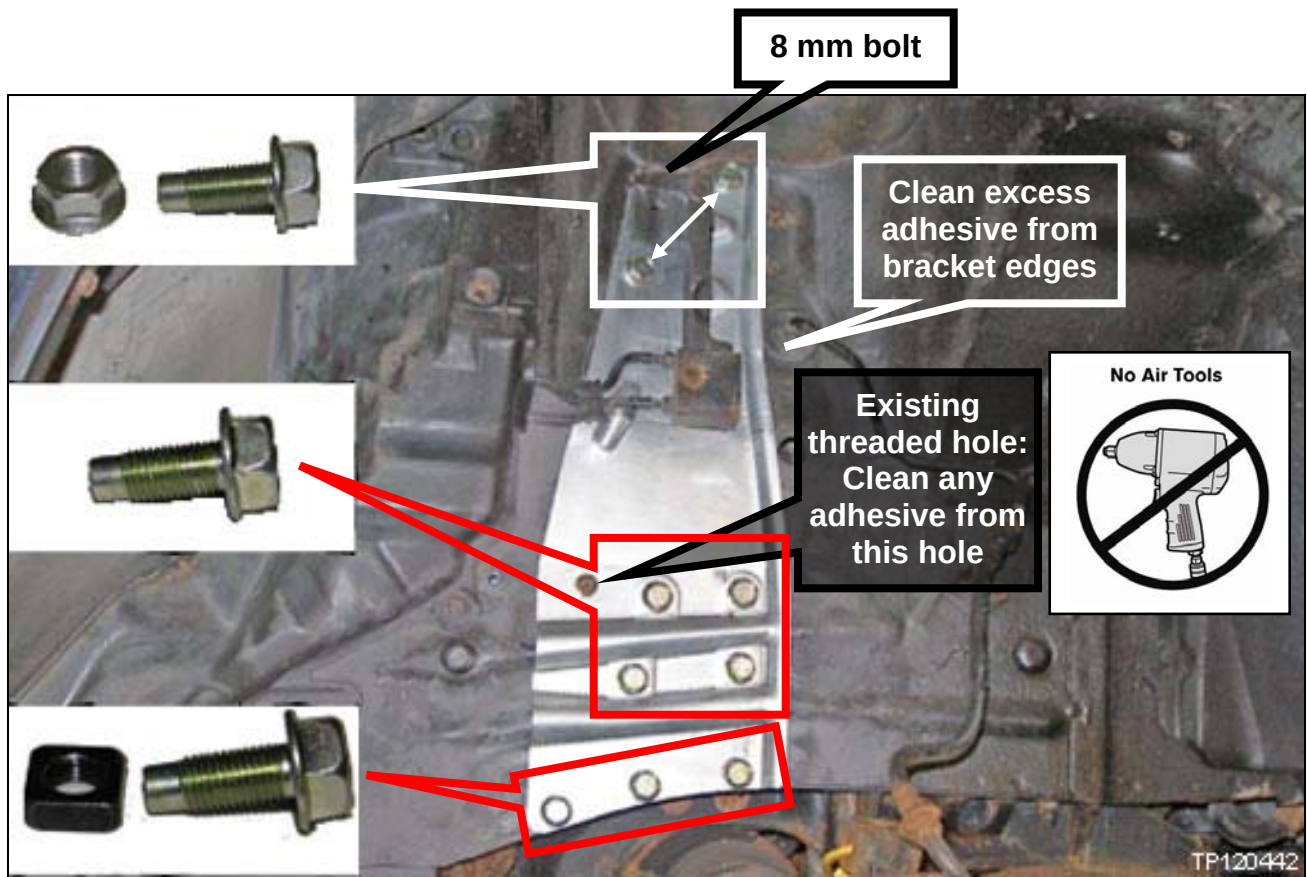
Figure RB26 – Passenger side

- If these bolts do not have enough metal to support them (make them tight), use Lord Fusor® 108B to glue the bolts in the holes. Do not leave open holes. These bolts are preferred for bracket support, but not required.
