# SERVICE CAMPAIGN BULLETIN

NTB11-066g

## VOLUNTARY SERVICE CAMPAIGN 1996-2004 PATHFINDER IN NON SALT STATES FRONT STRUT HOUSING CORROSION

**CAMPAIGN ID #:** R1108  
**NHTSA #:** 11V-244  
**APPLIED VEHICLES:** 1996 – 2004 Pathfinder (R50)

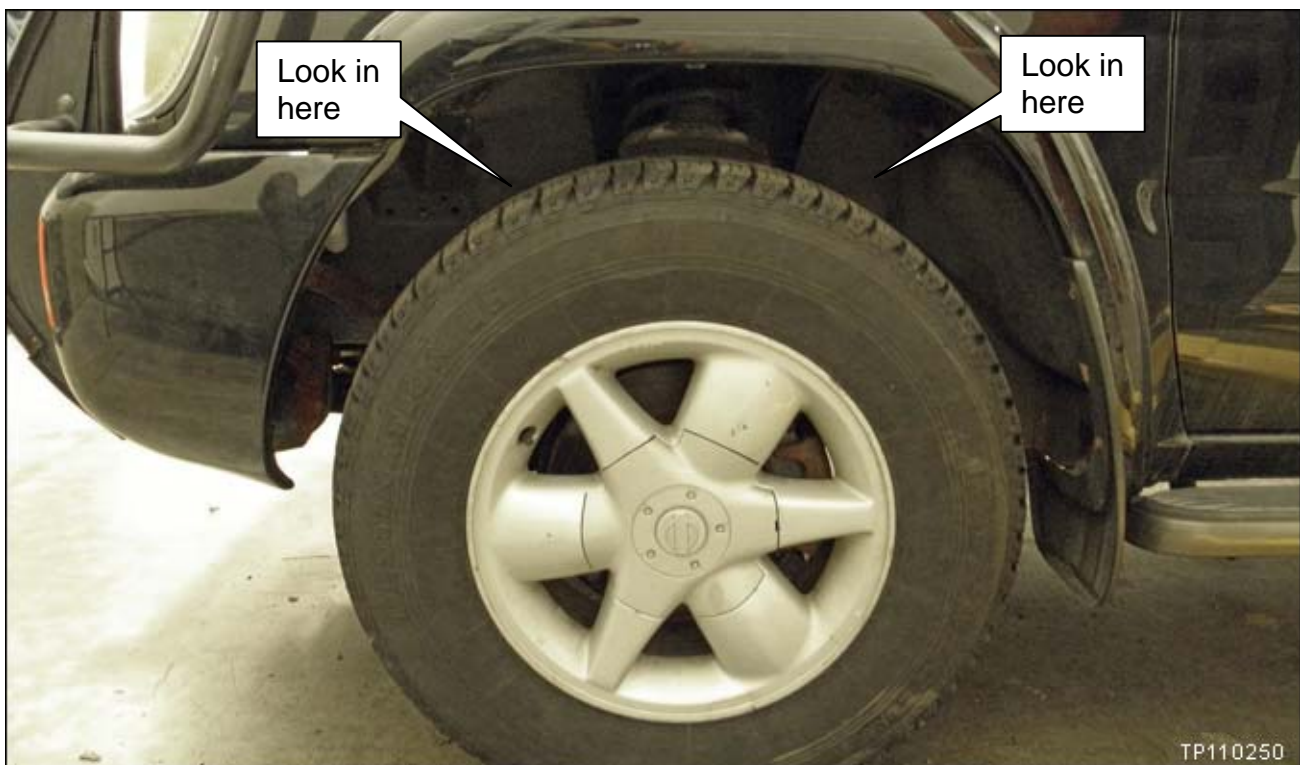
Figure A

**NOTE:** Turning the tires left and then right will allow a better view.

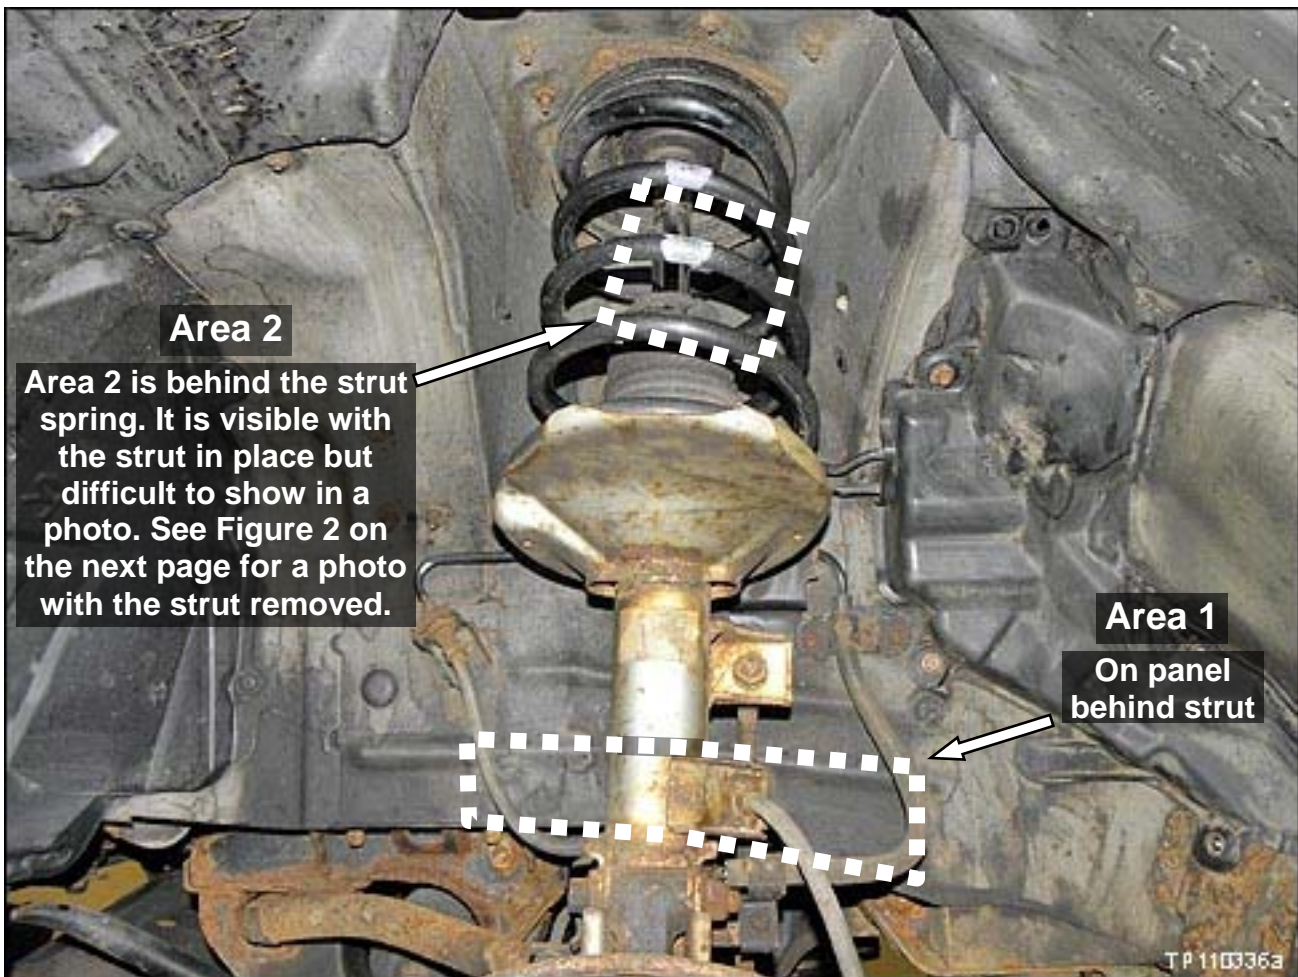
Figure 1

1. Lift the vehicle on a hoist.
2. Remove both front wheels.
3. Inspect for corrosion ON BOTH SIDES in the strut housing **Area 1** and wheel house **Area 2** (see Figures 1 through 6).

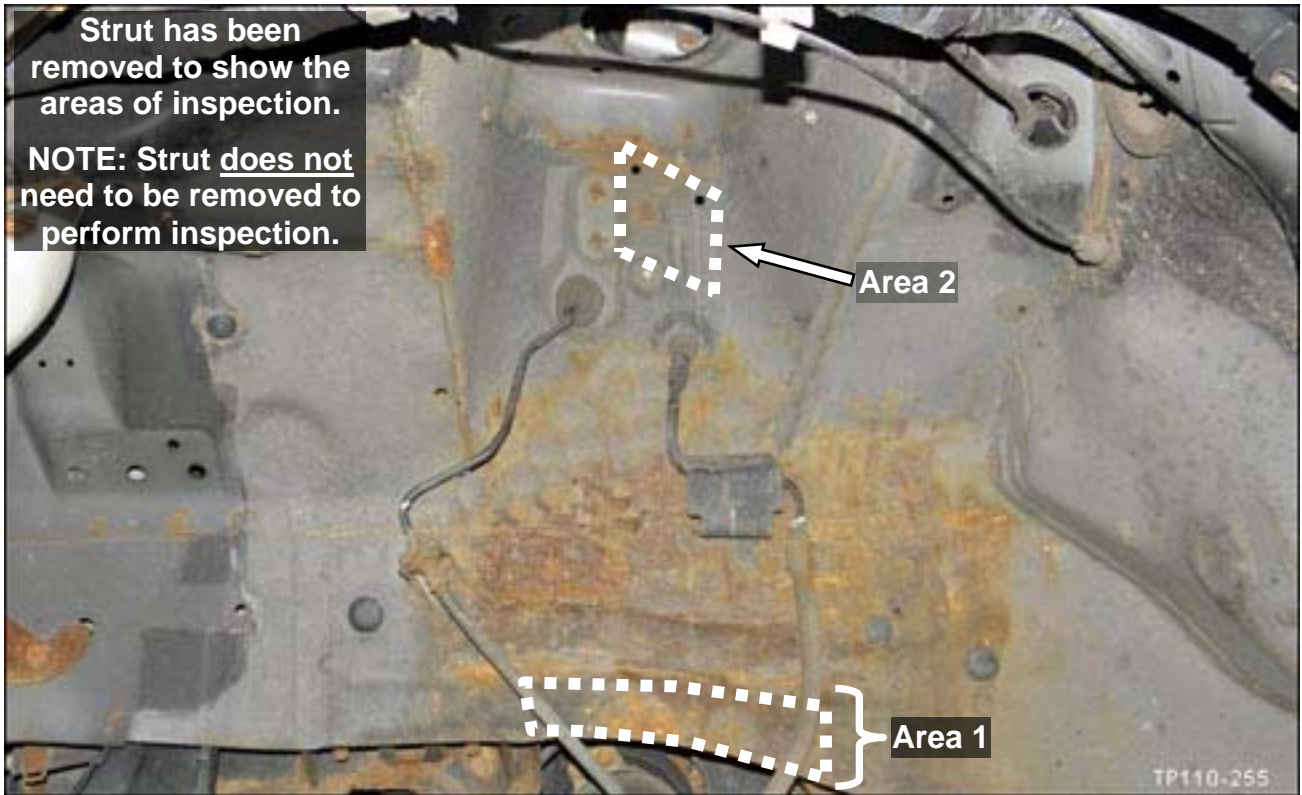
Figure 2

This example photo shows the inspection areas in relation to the repair bracket installation.

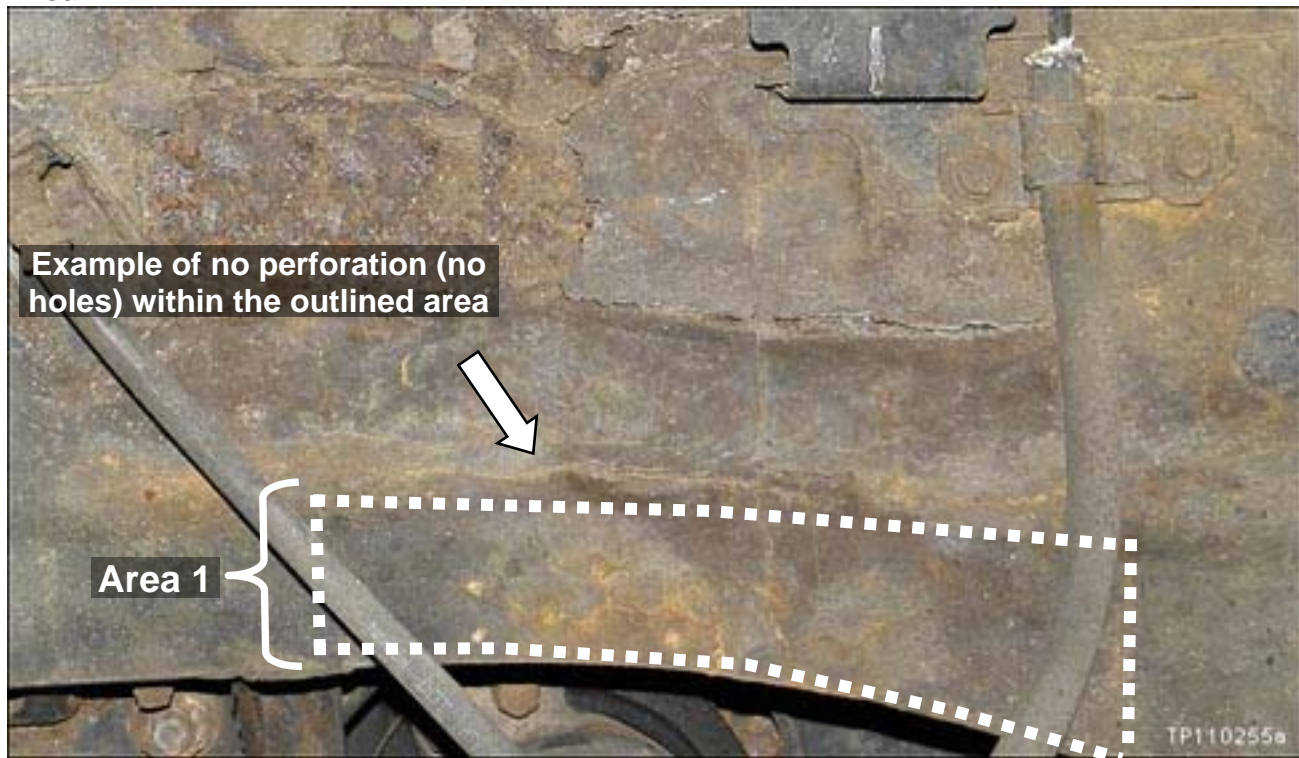
Figure 4

**Area 1:** Look for perforation (holes) in the metal only in the area outlined above.

- a. Retain the vehicle at the dealer. (The vehicle is not repairable.)
- b. Supply the customer with a rental car.
- c. Fax a completed Non-Repairable Report to Morley (see page 56).

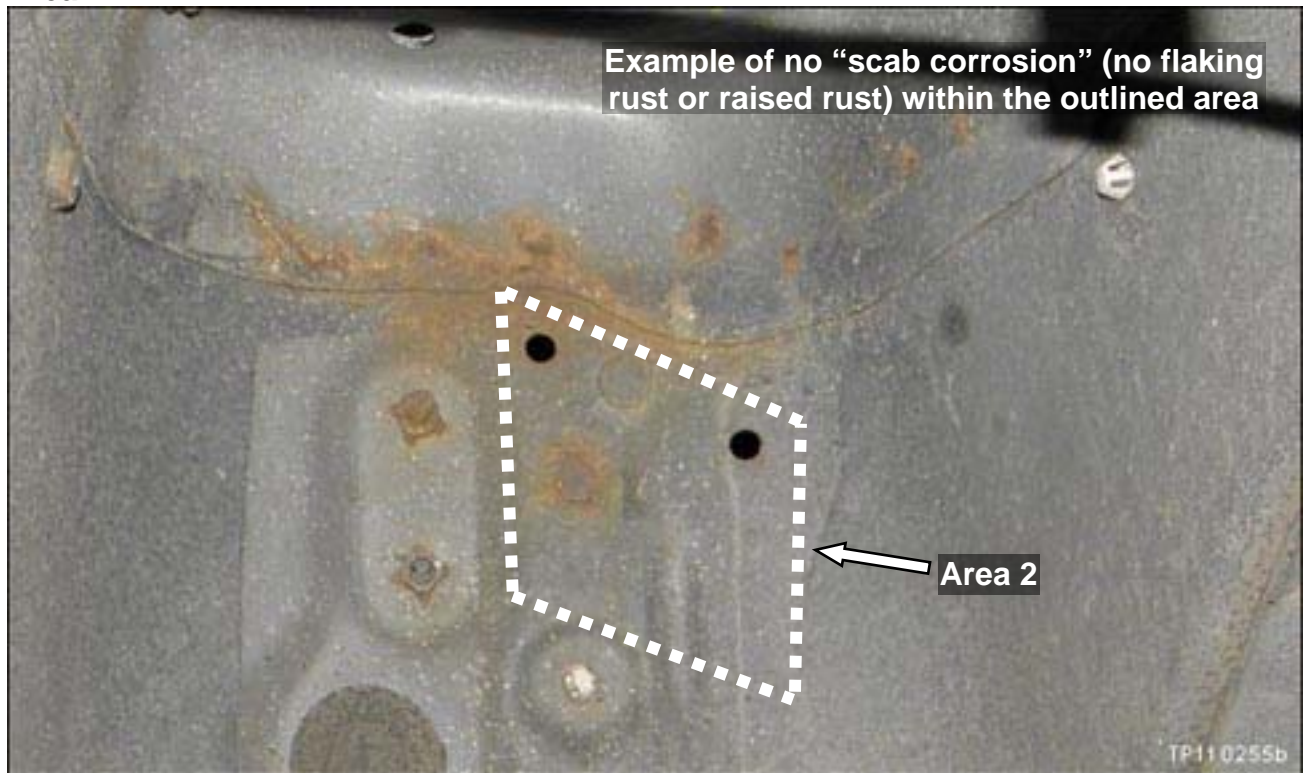
**Area 2:** Look for “scab corrosion” (flaking rust or raised rust) only in the area outlined above.

Figure 5 is an example of “scab corrosion” (flaking and raised rust).

- a. Retain the vehicle at the dealer. (The vehicle is not repairable.)
- b. Supply the customer with a rental car.
- c. Fax a completed Non-Repairable Report to Morley (see page 56).

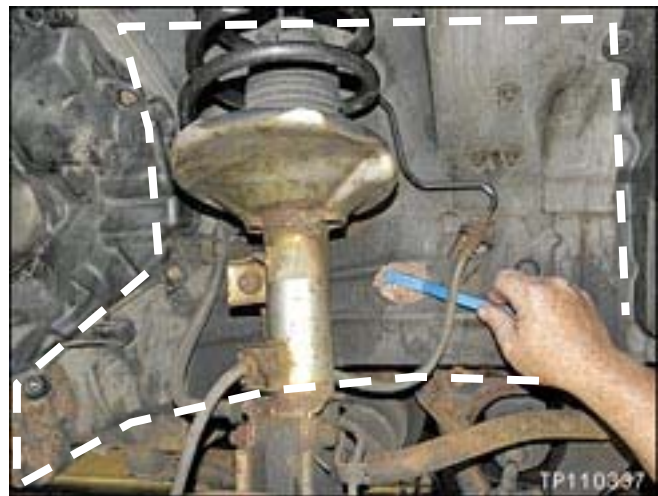
Figure 7

1. Use a wire brush to remove loose rust in the area shown with dashed line.

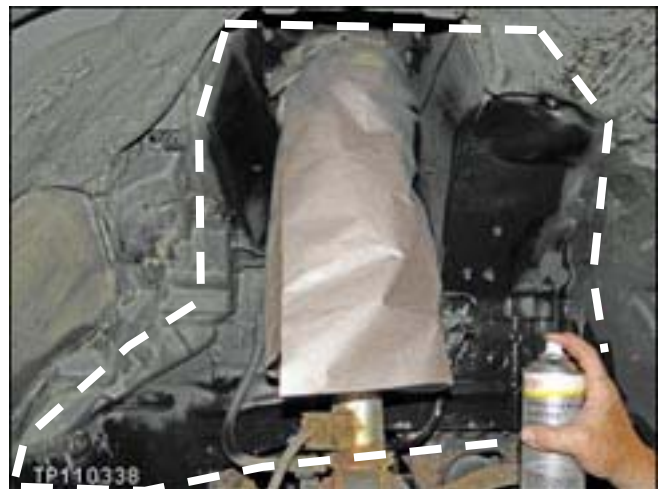
Figure 8

- Use DuPont Etch Primer (P/N A-4119S™) or equivalent.
- Follow all product instructions.
- Coat all of the exposed metal areas on the strut housing and wheel house panels.

- A second coat may be needed for heavy rust spots.
- Let each coat dry for 5 minutes.

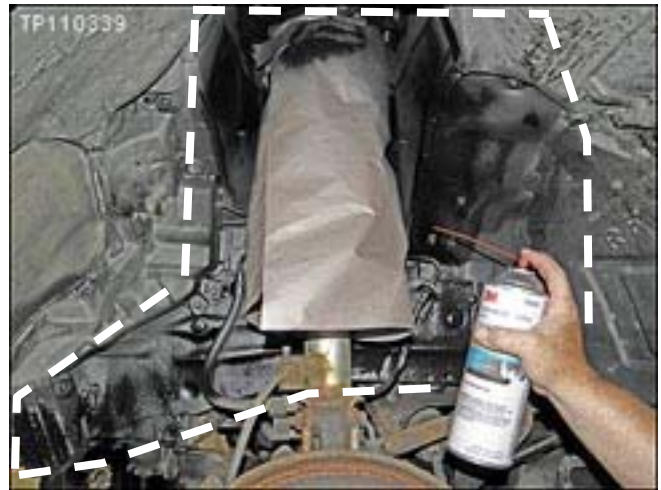
Figure 9

- Use 3M™ Rubberized Undercoating (P/N 051135 – 08883) or equivalent.
- Follow all product instructions.
- Coat all of the exposed metal areas on the strut housing and wheel house panels.
- Use a spray nozzle to spray the areas behind the strut and other hard to reach areas.

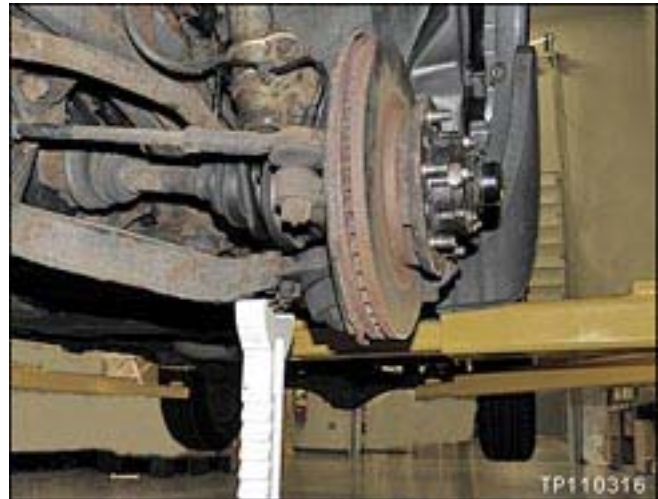
Figure SR1

1. Support the transverse link (lower control arm) with a jack stand as shown.
  - a. Position the jack stand under the lower control arm.
  - b. Lower the vehicle until the lower control arm touches the jack stand.

**NOTE:** Do not lower the vehicle beyond just touching the jack stand. Do not put tension on the coil spring.

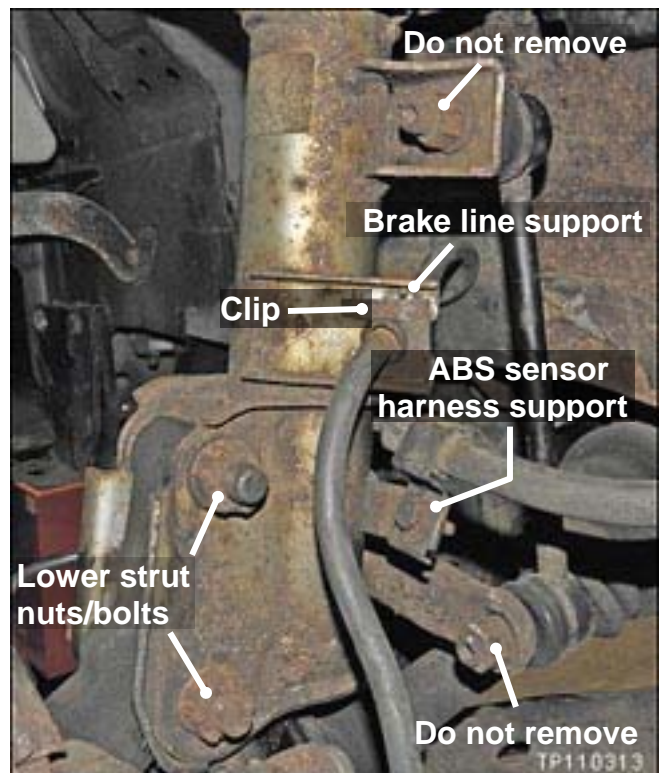
Figure SR2

2. Disconnect the following items:
  - Remove the clip and take the brake hydraulic line loose from its support.
    - Discard the clip, use a new clip for reassembly.
  - Remove the bolt for the ABS sensor harness support.
  - Take the ABS sensor harness loose from the support on the other side of strut (not shown).
  - Remove the lower strut bolts.
    - Discard the nuts, use new ones for reassembly.

**NOTE:** **Do not** remove the nuts from the stabilizer connecting rod.

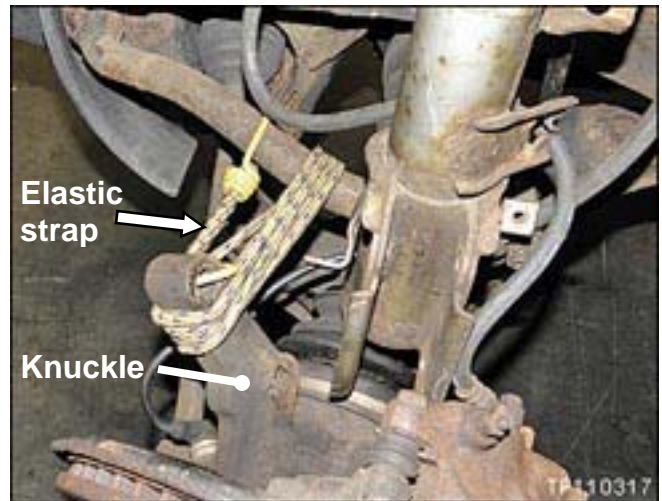
Figure SR3

4. Use an elastic strap or other suitable tool to secure the knuckle to the stabilizer bar as shown.

**NOTE:** Make sure the knuckle assembly is secure. Its weight must be supported during the entire repair process.

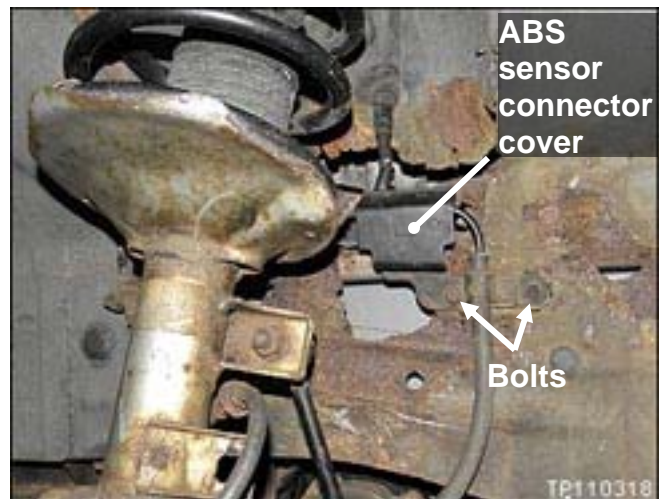
Figure SR4

5. Remove the 2 bolts for the ABS sensor connector cover.

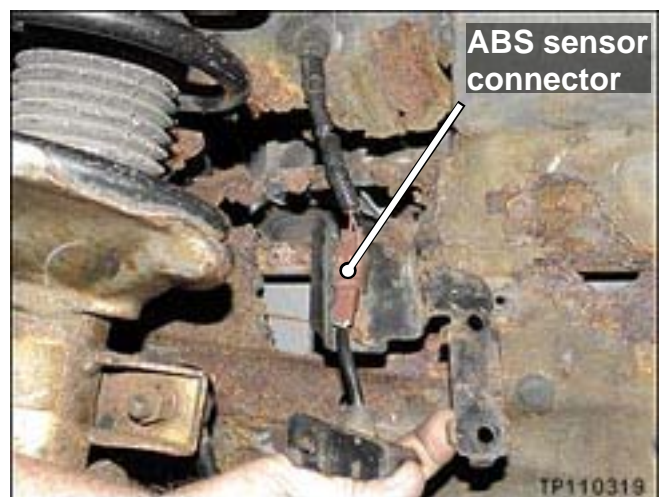
Figure SR5

6. Disconnect the ABS sensor connector.

- The ABS sensor connector is on the back side of the cover.

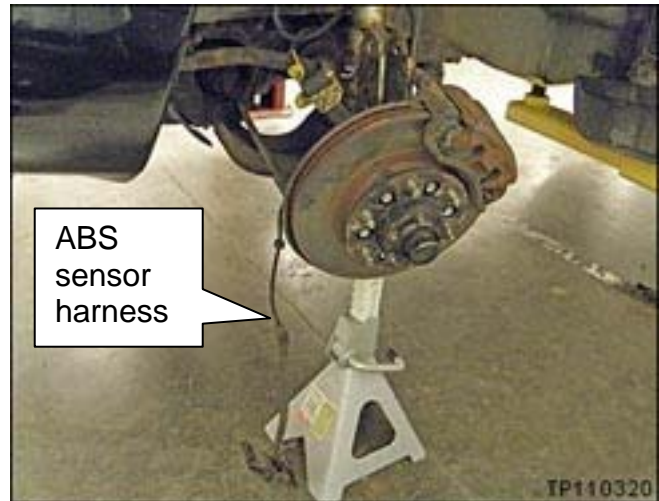
Figure SR6

7. Pull the ABS sensor harness from behind the strut.

8. Let the ABS sensor harness hang out of the way as shown.

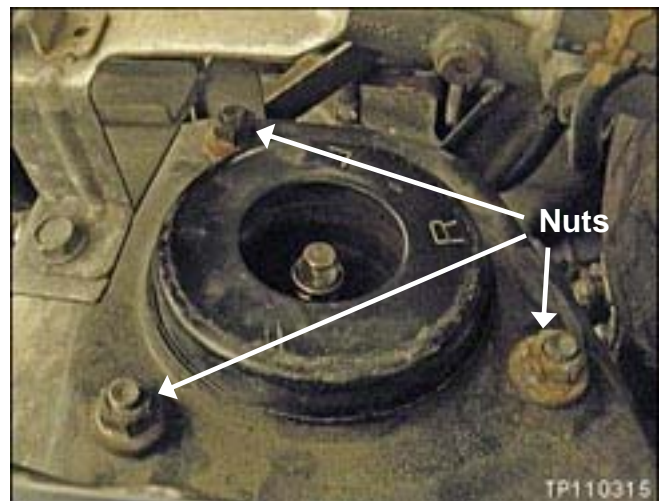
Figure SR7

10. Remove the 3 upper strut mounting nuts.

- Discard the nuts, use new ones for reassembly.

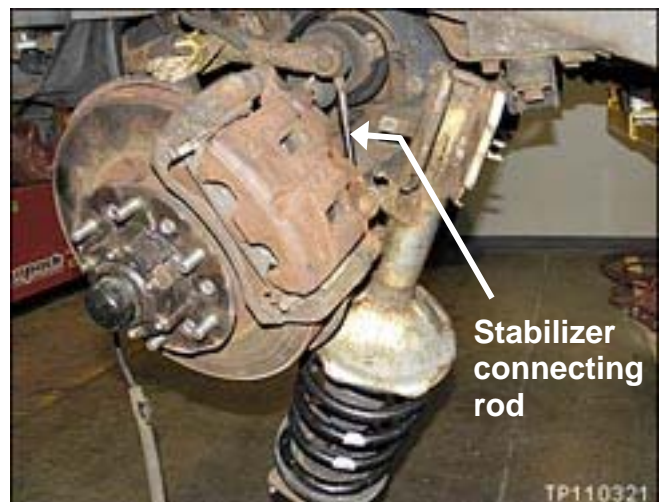
Figure SR8

11. Maneuver the strut so it is hanging upside down as shown.

**NOTE:** The weight of strut is supported by the stabilizer connecting rod.

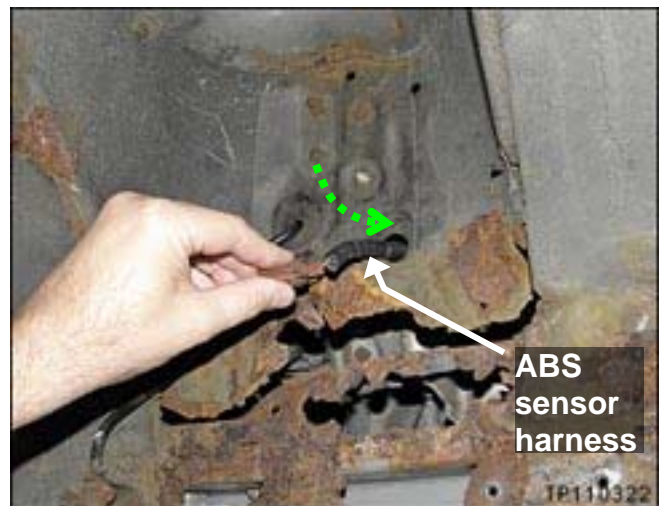
Figure RB1

1. Inspect the ABS sensor harness for damage. If damaged, repair as necessary.
2. Push the ABS harness and connector through the panel.
  - The harness/connector will now be out of the working area.

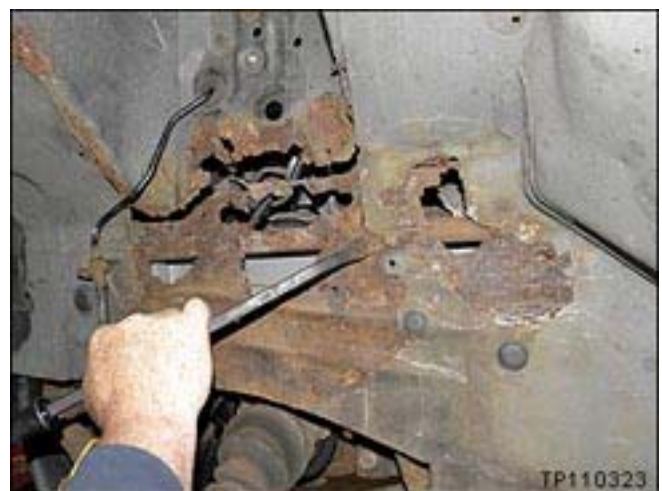
Figure RB2

3. Use a scraper bar to scrape off loose flaking rust and corrosion.

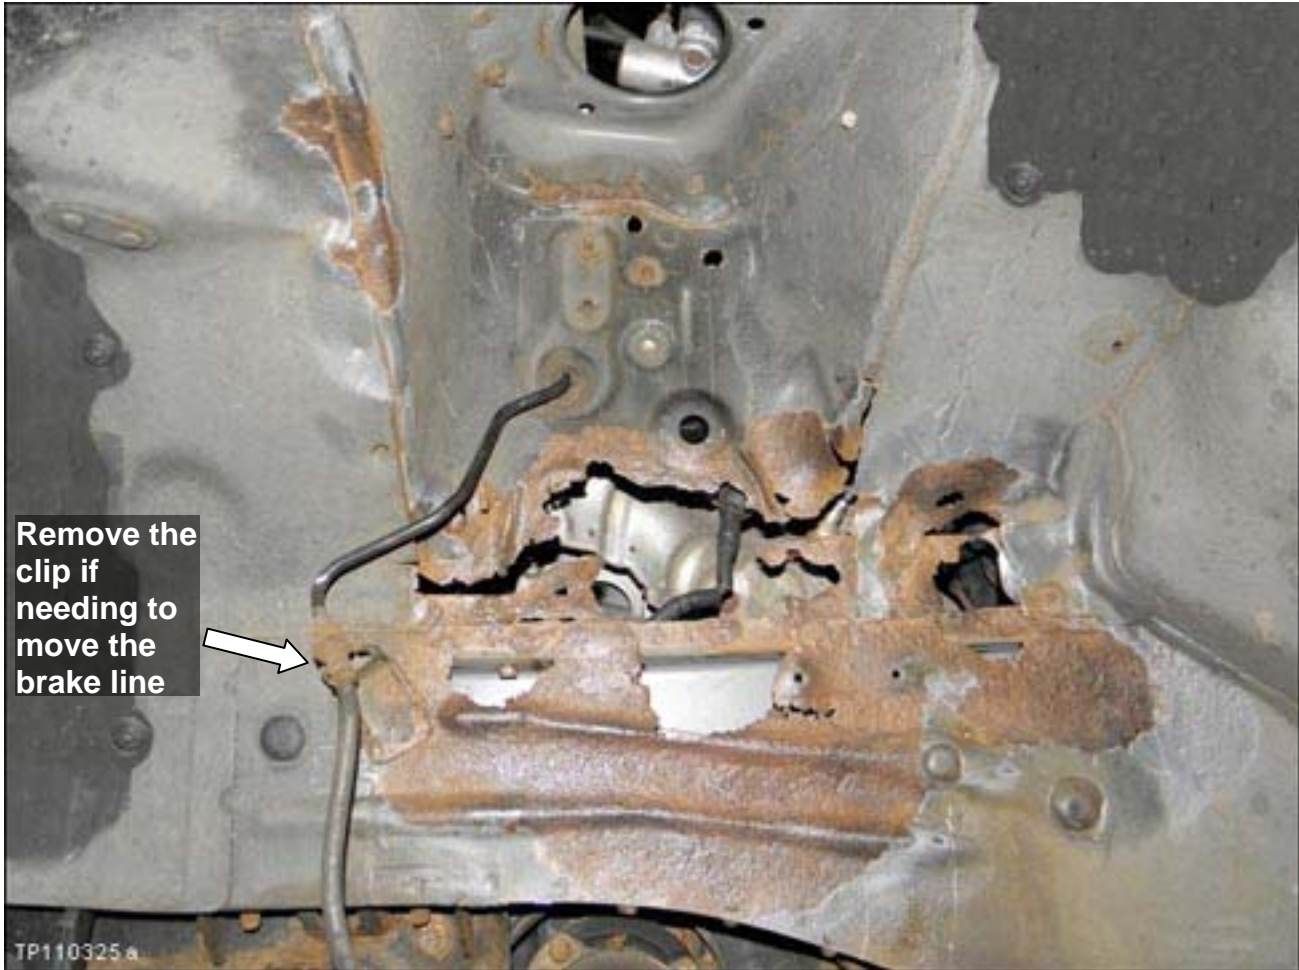
Figure RB3

4. Clean all the loose rust from the strut housing and wheel house areas (see Figure RB3).

**NOTE:** If the brake line is in the way of an area that needs cleaning, move it out of the way by first removing the clip from the mount.

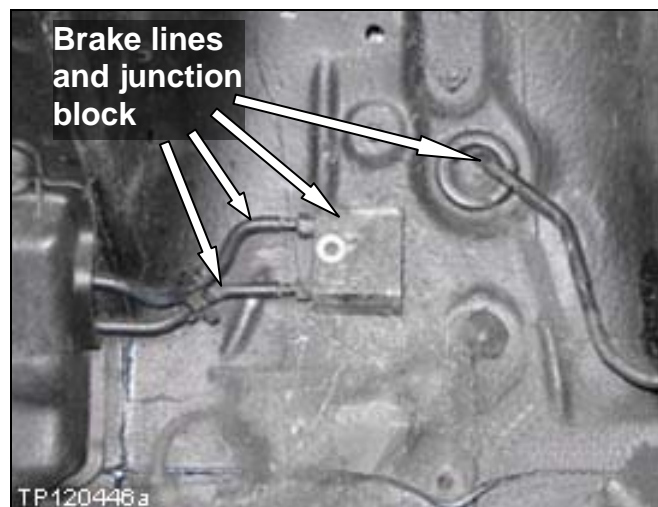
Figure RB4

4a. Passenger side: work around the 2 brake lines and junction block best as possible (see Figure RB4).

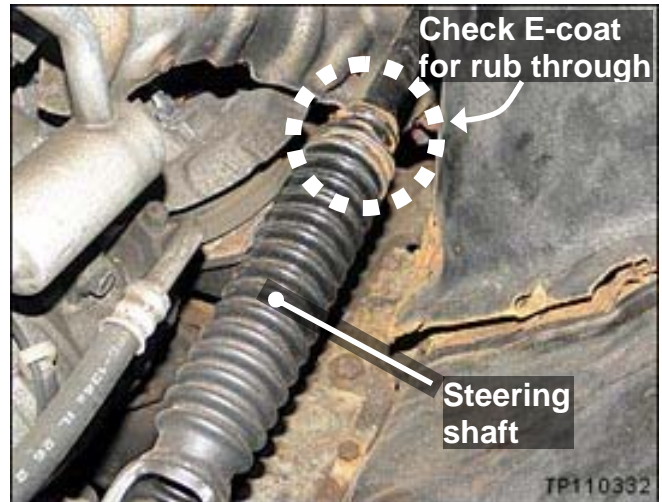
Figure RB5

Contact may have occurred if the strut housing separated from the wheel house.

- **ONLY if the E-coat has been rubbed through to bare metal**, the steering shaft will need to be replaced.
- If the steering shaft needs replacement, you will be instructed to replace it later in this procedure.

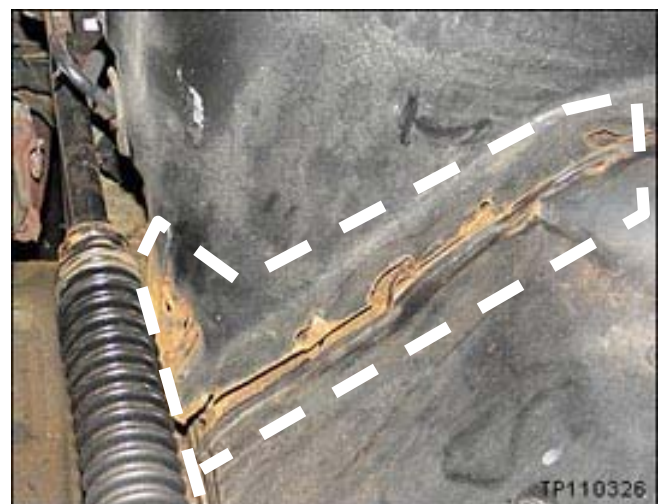
Figure RB6

- 7a. Only if the strut housing panel is separated as shown in Figure RB6:

Use a wire brush to clean any loose rust, paint, or other debris from the area shown with dashed line.

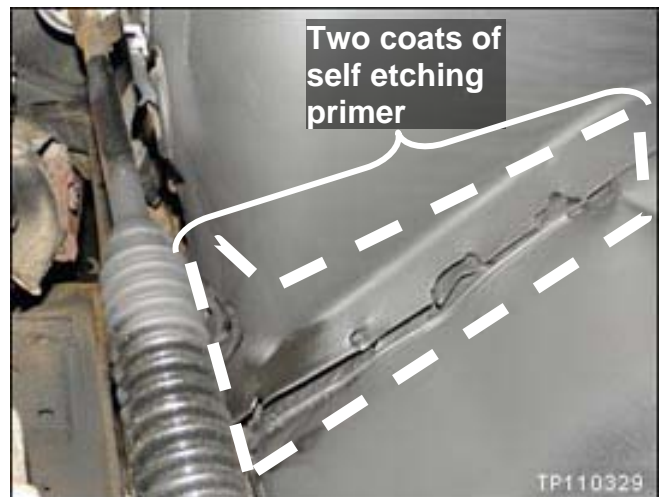
Figure RB7

- Use DuPont Etch Primer (P/N A-4119S™) or equivalent.
- Follow all product instructions.
- A second coat may be needed for heavy rust spots.
- Let each coat dry for 5 minutes.

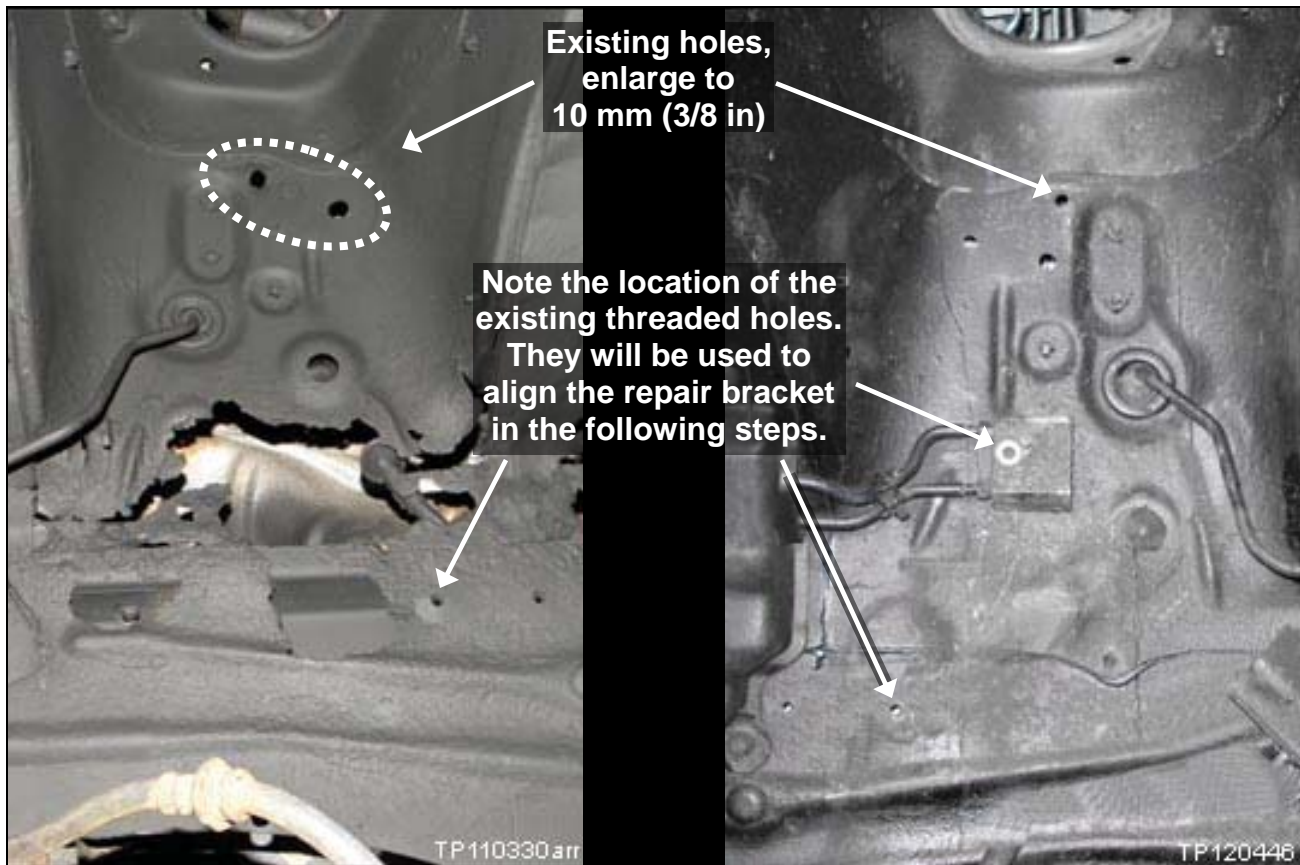
Figure RB8a

12. Driver side: Locate the 2 existing holes at the upper area of the strut housing panel (see Figure RB8a).

- With a drill bit, enlarge the one existing hole to 10 mm (3/8 in).

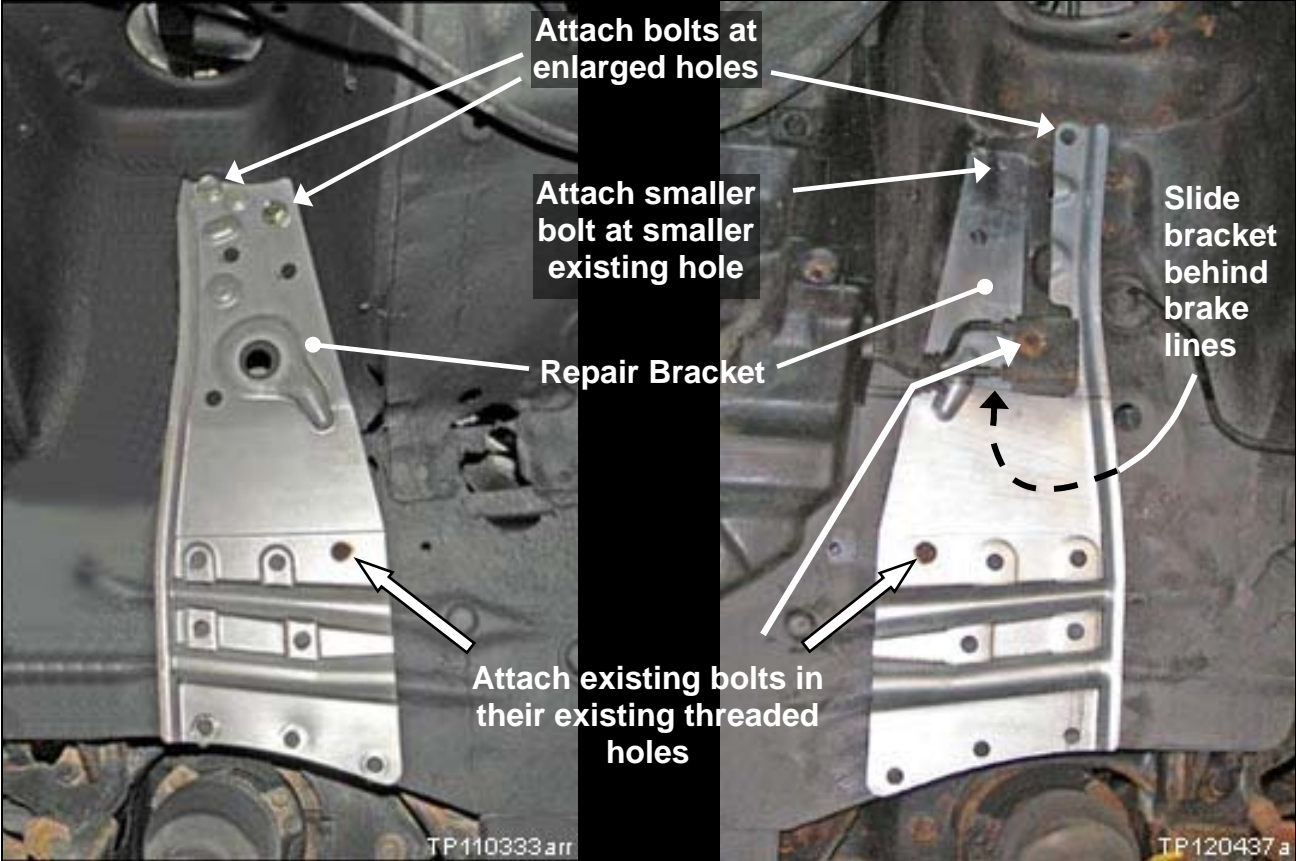
Figure RB9

14. Attach the repair bracket using the existing holes that you enlarged (see RB9).

- The repair bracket is part of the Repair Kit listed in the Parts Information.
- Use bolts and hex nuts from the Repair Kit.
- Also use the existing bolt(s) where shown in RB9.
- Tighten the bolts/nuts finger tight.

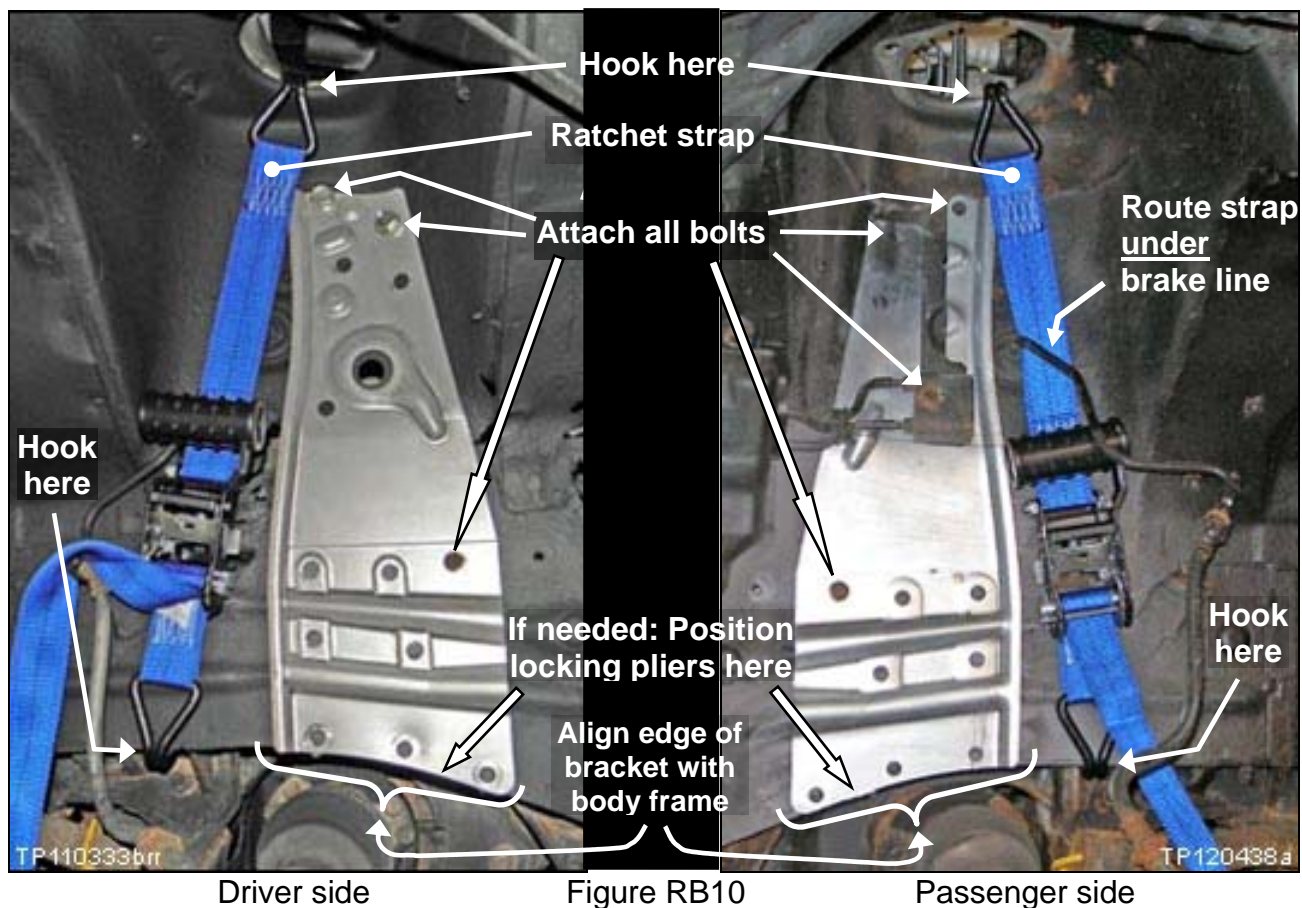
- a. Attach the ratchet strap as shown in Figure RB10.
- b. Use the ratchet strap to pull the strut housing panel down until the existing threaded hole(s) is aligned with the matching hole in the repair bracket (see Figure RB10).

18. Once the bottom edge is aligned, securely tighten all bolts (see Figure RB10).

- At this time, a pair of locking pliers or equivalent tool may be used to further support the repair bracket (see Figure RB10).
- Bolts need to be tight enough to hold the bracket in place while center punching and drilling holes in the next step.

**NOTE:** Photos for installation of the repair bracket show the ratchet strap being used. In most cases, the strut housing panel will not be separated and the ratchet strap will not be needed.

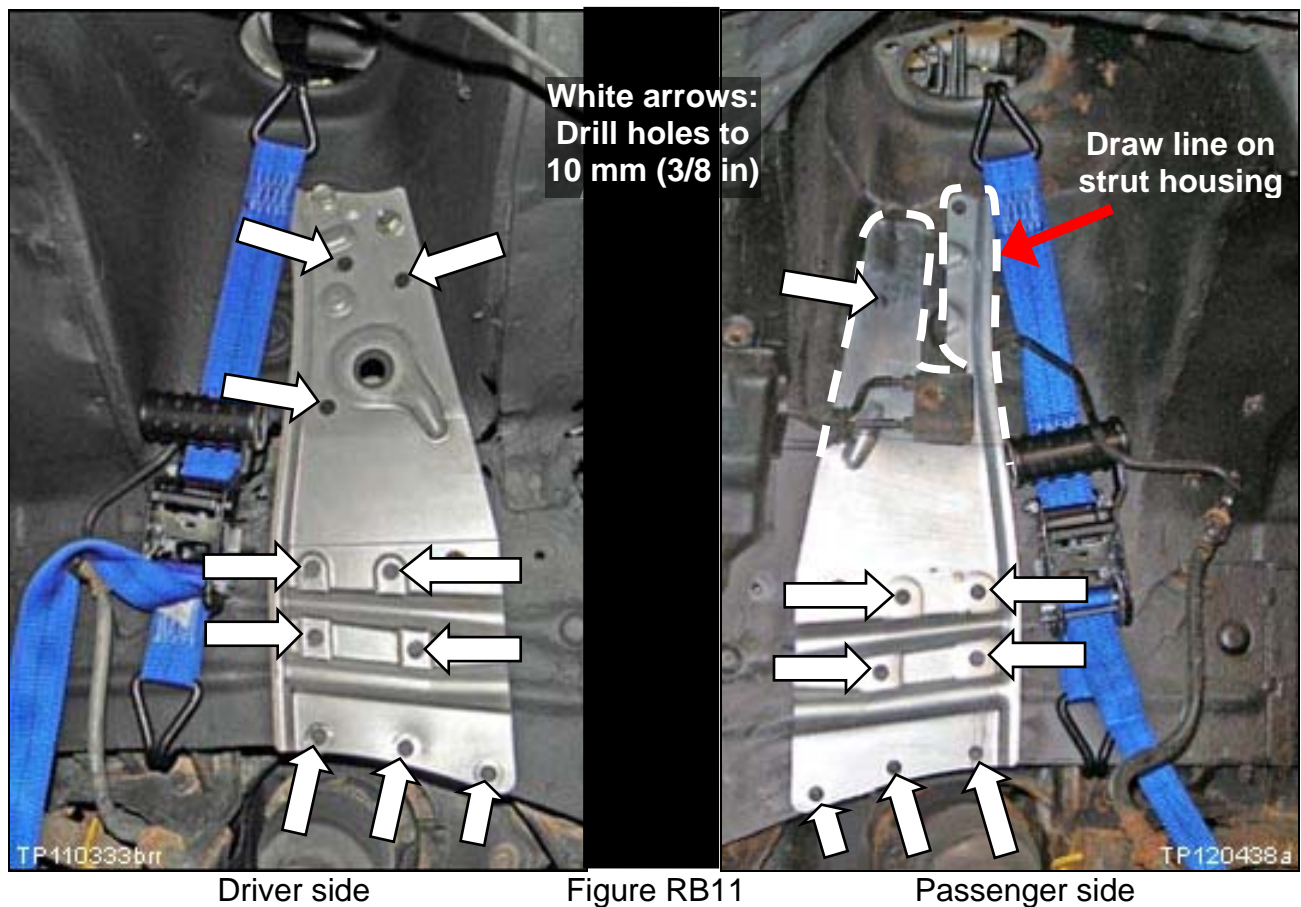
19. Drill the holes shown by white arrows in Figure RB11 to **10 mm (3/8 in)**:

- a. Center punch the holes.
- b. Pilot drill with a 1/8 drill bit.
- c. Drill holes to **10 mm (3/8 in)**.

20. Passenger side: Draw a white line as shown in RB11.

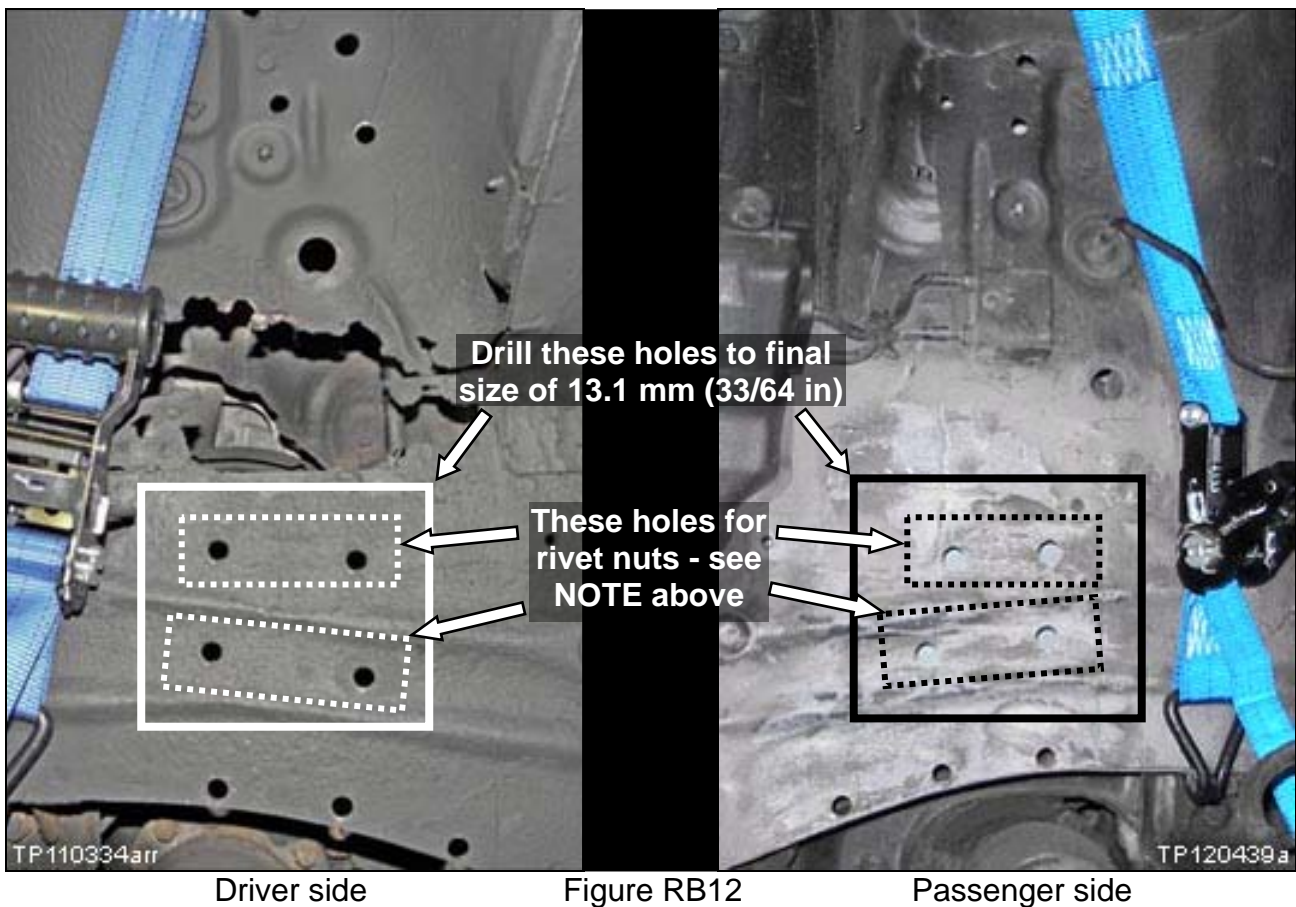
22. For the 4 holes that will have Rivet Nuts installed, drill final hole size to **13.1 mm (33/64 in)**. See Figure RB12.

**NOTE:** All holes where pointed out in Figure RB12 are not required: If the metal in the area of these holes will not support rivet nuts, continue with the repair. Rivet nuts are preferred but not required in these holes.

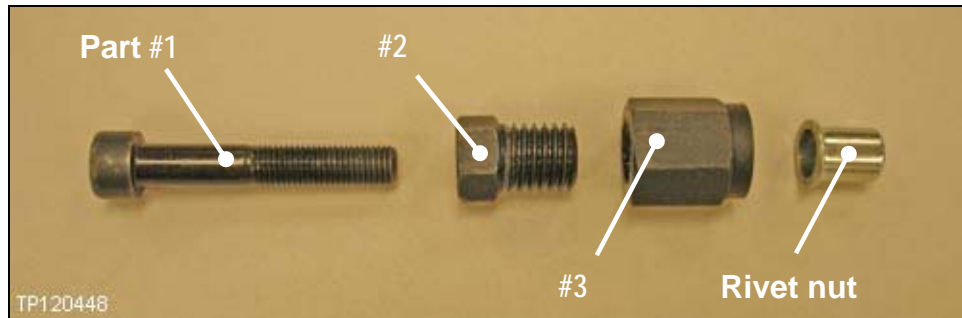
RB13 – Rivet Tool

**NOTE:** Rivet Tool J-50835 comes with extreme pressure lubricant. Apply to the threads and contact points of part #2 and part #3 for approximately every 60 rivet nuts installed (enough for 15 brackets).

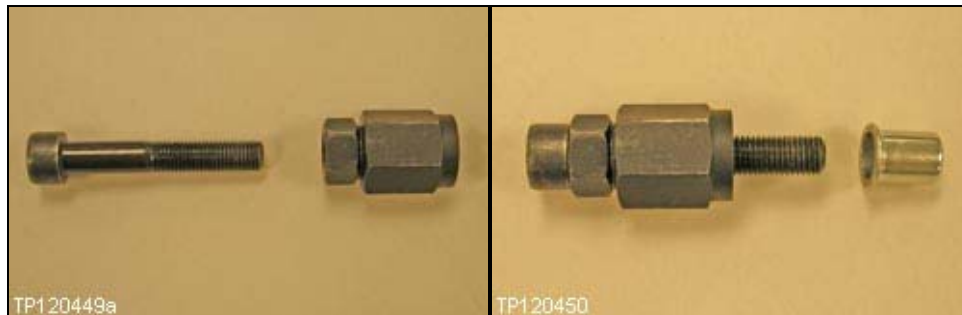
Figure RB14

1. Thread no more than finger tight part #2 into part #3 until it bottoms out (see Figure RB14).
  - This is a left handed thread.
2. Insert part #1 through part #2 and part #3 (see Figure RB15).

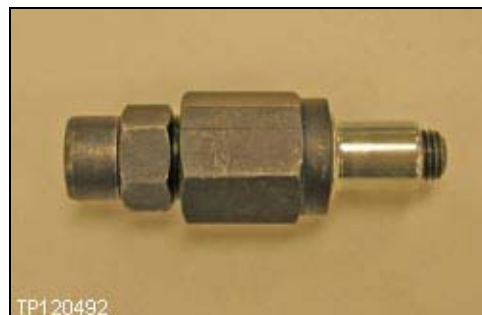
Figure RB16

3. Thread a rivet nut onto part #1 until it bottoms out no more than finger tight (see Figure RB16).

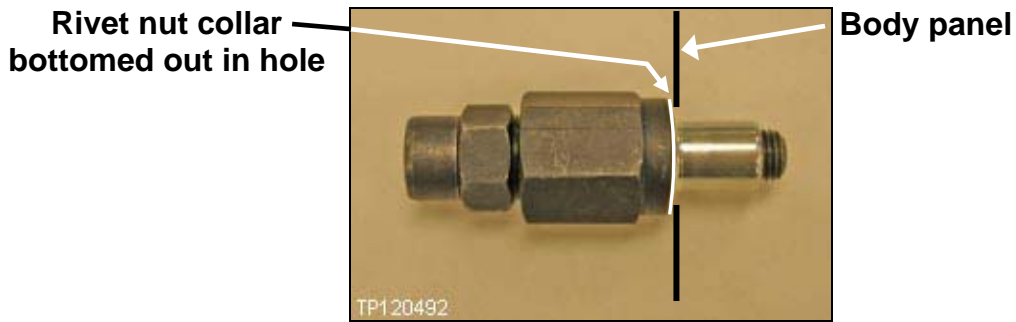
Figure RB17

4. Insert the rivet nut into the 13.1 mm (33/64 in) hole until it bottoms out on its collar.

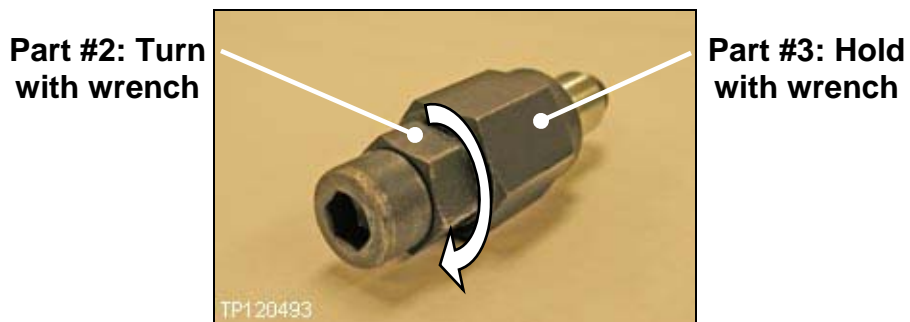
Figure RB18

- a. Hold the rivet nut and tool against the body panel with moderate pressure.
- b. Hold stationary part #3 while turning part #2 clockwise.
- c. Turn part #2 approximately 2 turns or until turning resistance increases.
  - At this point, the rivet nut is installed.

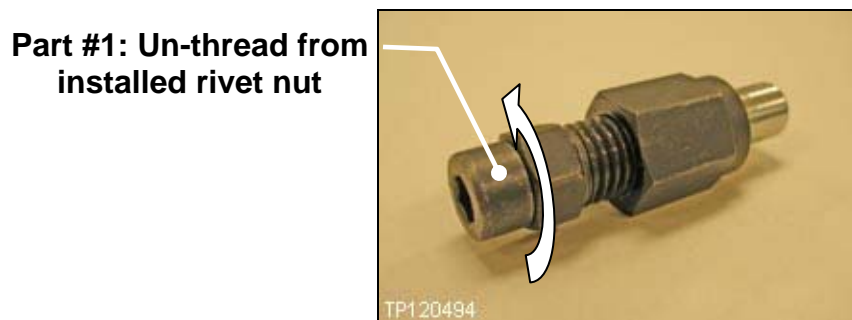
Figure RB19

d. Un-thread part #1 from the rivet nut.

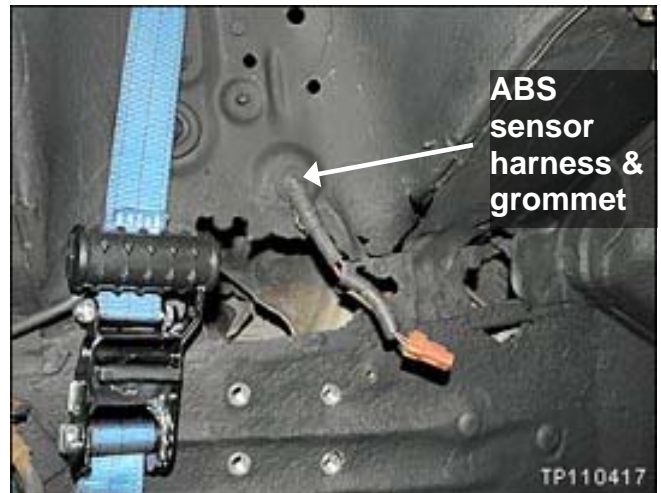
Figure RB20

24. Reinstall the ABS sensor harness in its hole.

- Make sure the rubber grommet is in place.

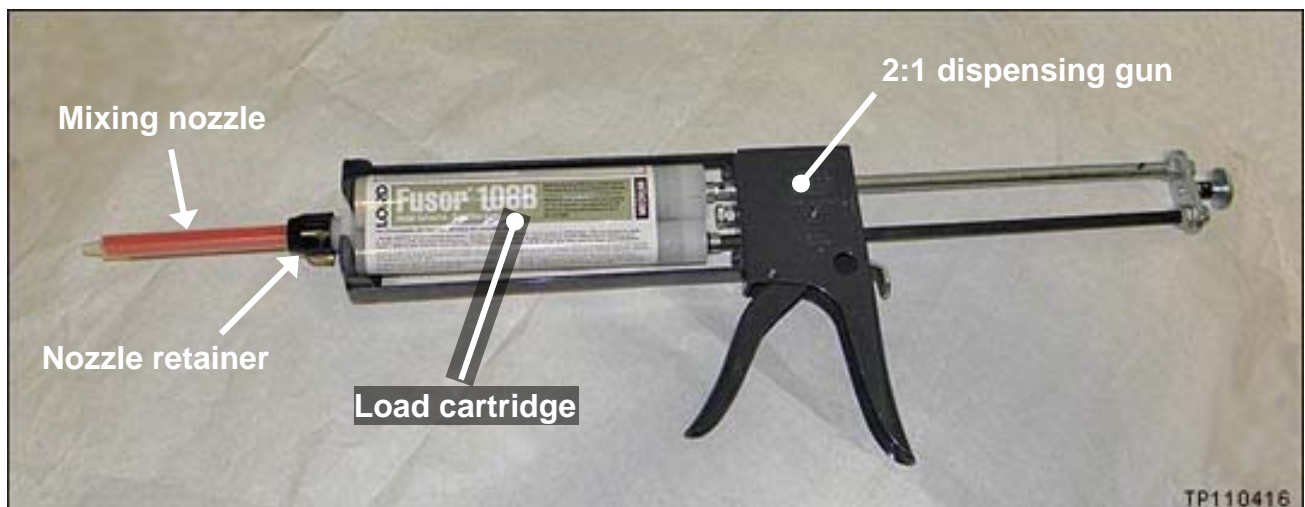
25. Prepare for application of LORD Fusor<sup>®</sup> 108B structural adhesive (see Figure RB21 and RB22).

- Mixing nozzles are one-time use only. Do not reuse mixing nozzles.
- Two mixing nozzles are included with each cartridge of Fusor<sup>®</sup> 108B.
- Refer to the Parts Information for additional product details.
- For cleanliness, using rubber gloves is recommended.
