# SERVICE CAMPAIGN BULLETIN

NTB11-066g

## VOLUNTARY SERVICE CAMPAIGN 1996-2004 PATHFINDER IN NON SALT STATES FRONT STRUT HOUSING CORROSION

**CAMPAIGN ID #:** R1108  
**NHTSA #:** 11V-244  
**APPLIED VEHICLES:** 1996 – 2004 Pathfinder (R50)

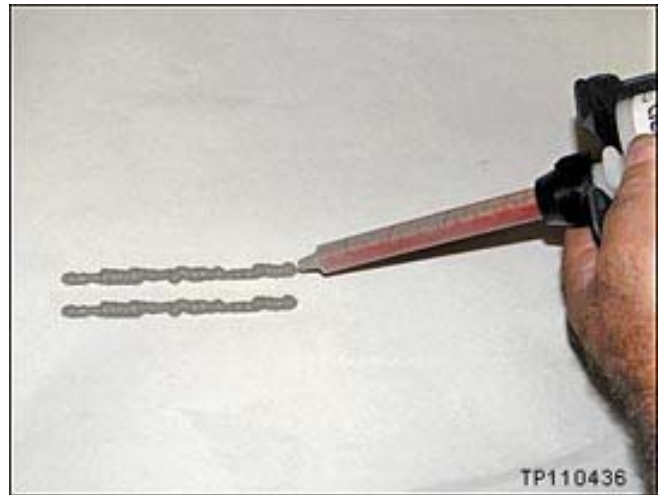
Figure RB22

e. Dispense 2 beads of Fusor<sup>®</sup> 108B onto a paper that will be discarded.

- Each bead should be about ¼ inch diameter and about 6 inches long (length of the nozzle).

**NOTE:** Performing this action will ensure the dispenser plungers have leveled, air bubbles have been expelled, and adhesive is mixed correctly.

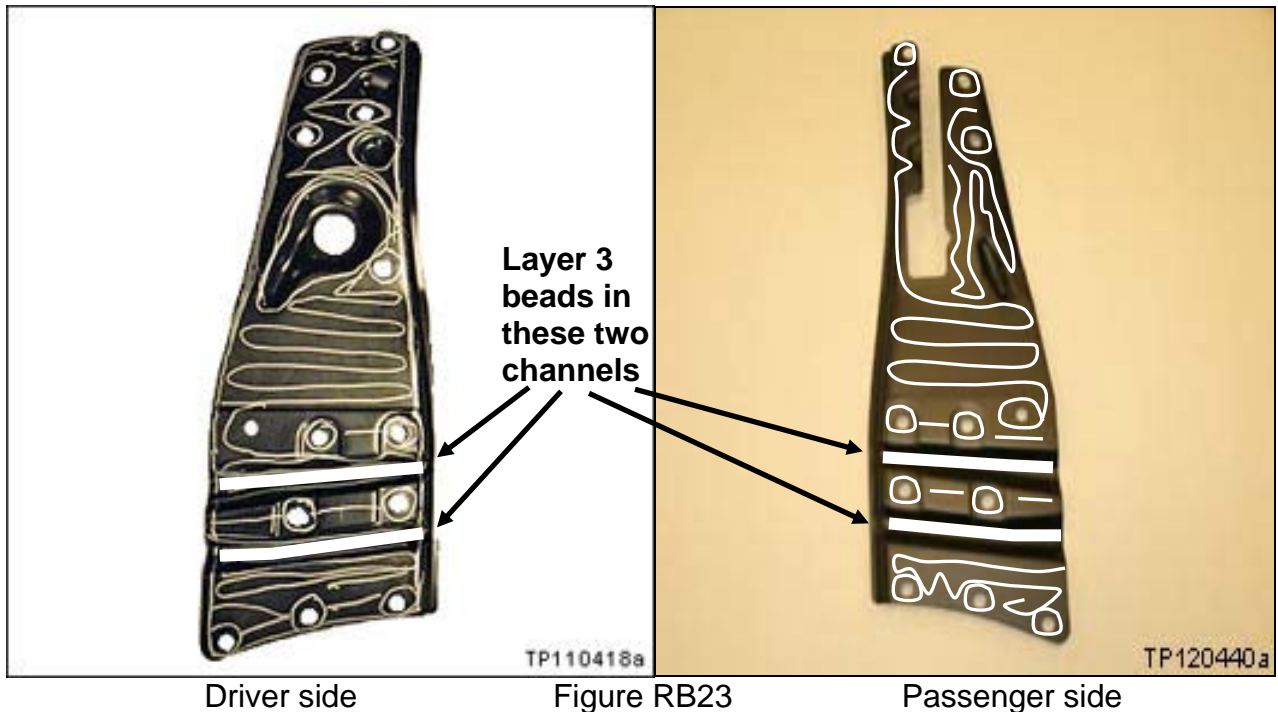
26. Liberally apply Fusor<sup>®</sup> 108B to the back side of the repair bracket as shown.

**NOTE:** Filling the two channels with 3 beads will ensure good adhesion in the channel area.

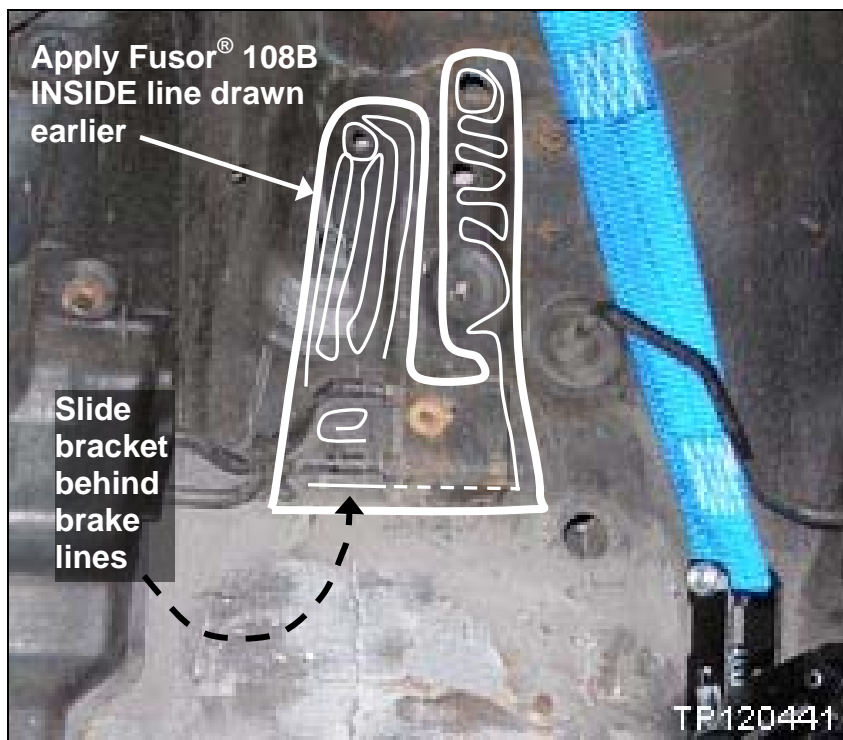
RB24 – Passenger side

27. Passenger side: Liberally apply Fusor® 108B on the strut housing area within the white line drawn earlier (see page 25, step 20, and Figure RB24 below).

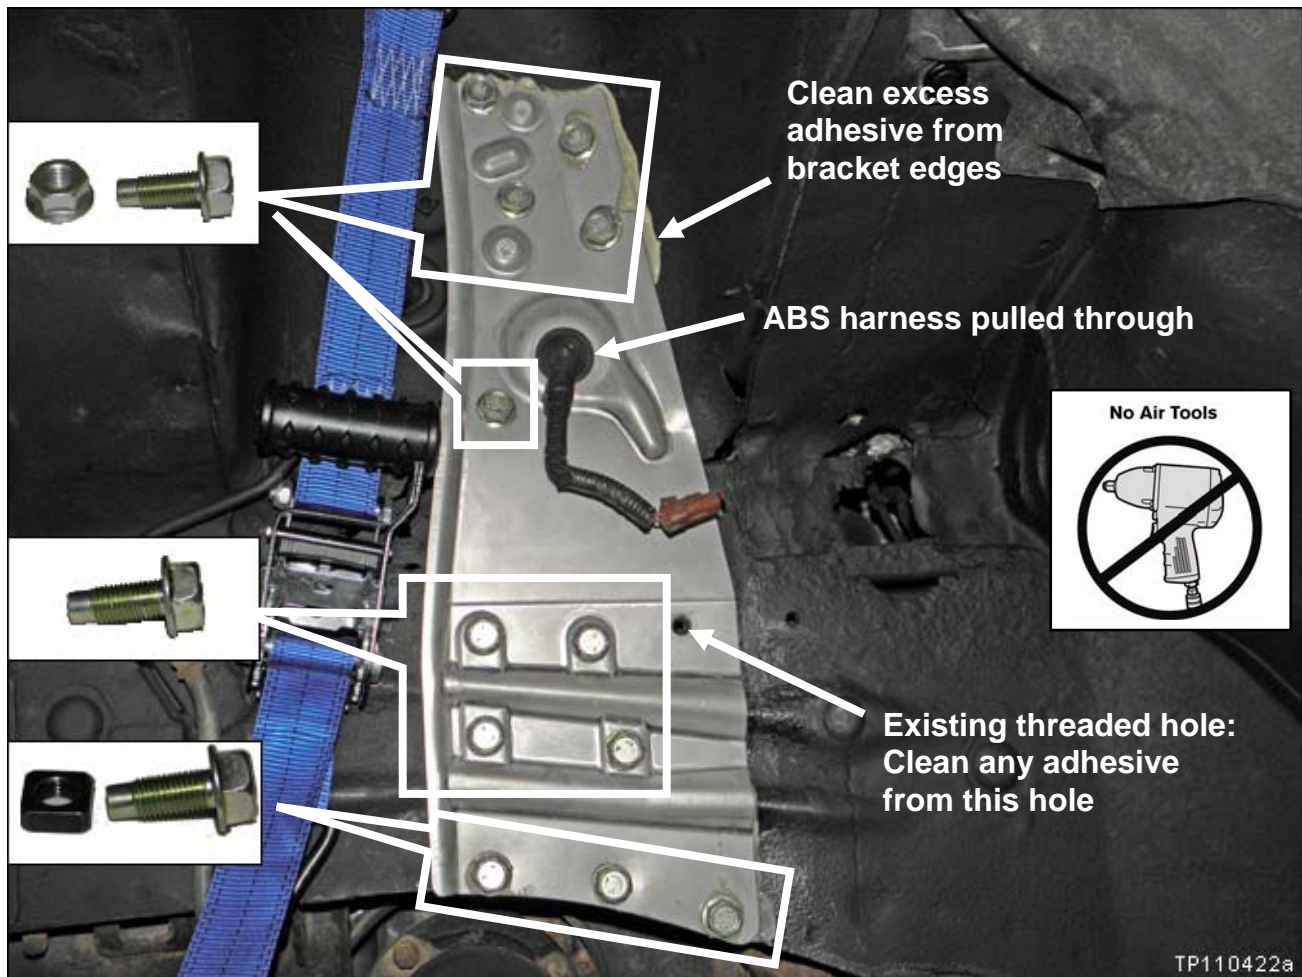
Figure RB25 – Driver side

28. Bolt the repair bracket into place.

- Driver side: make sure the ABS harness is pulled through its hole in the repair bracket.
- Use the correct nuts (see Figure RB25, or RB26 on next page, as it applies).
- **Do not use air tools to tighten the bolts.**
- Torque all new bolts/nuts to 50 N•m (5.1 kg-m, **37 ft-lb**).
- Secure all existing bolts.

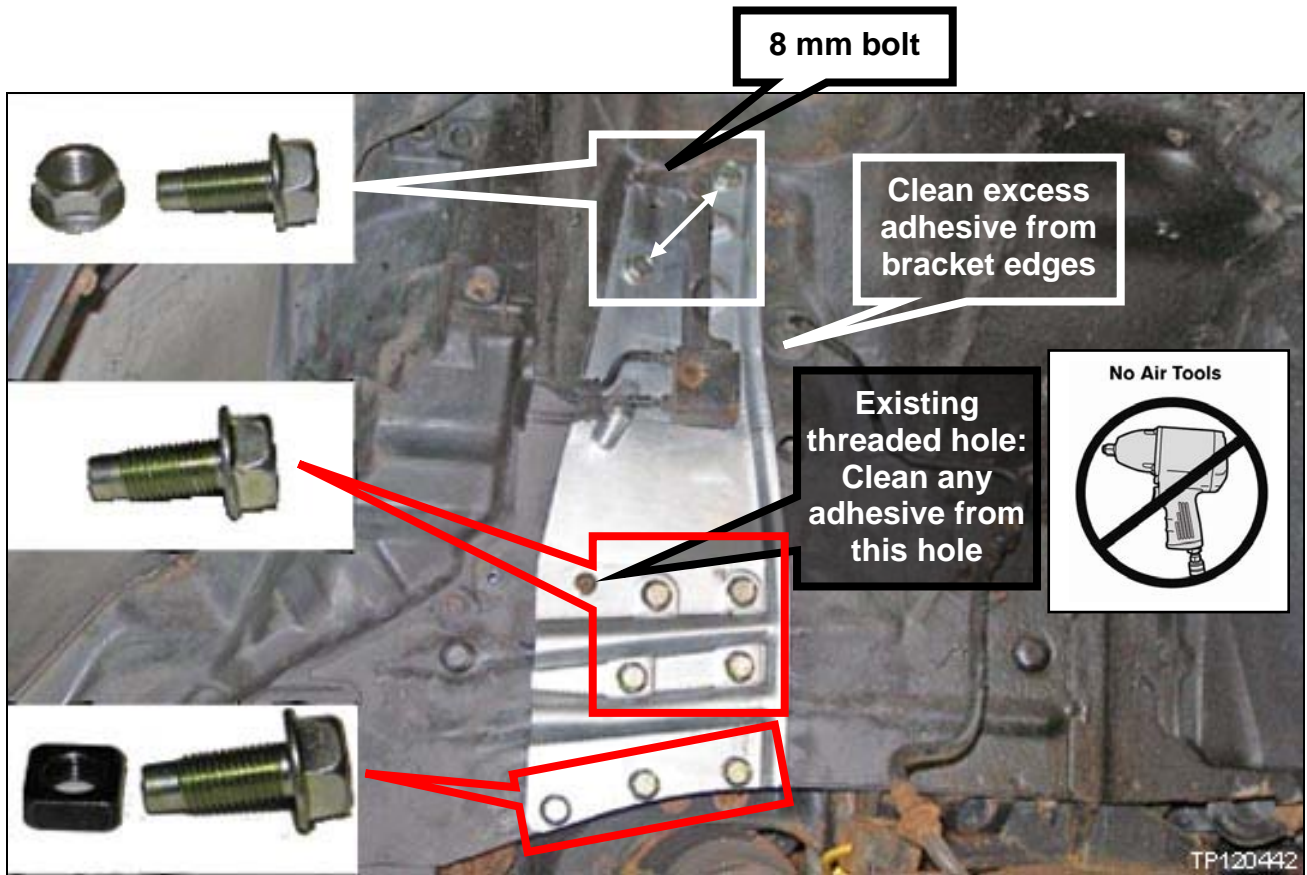
Figure RB26 – Passenger side

- If these bolts do not have enough metal to support them (make them tight), use Lord Fusor<sup>®</sup> 108B to glue the bolts in the holes. **Do not leave open holes.** These bolts are preferred for bracket support, but not required.

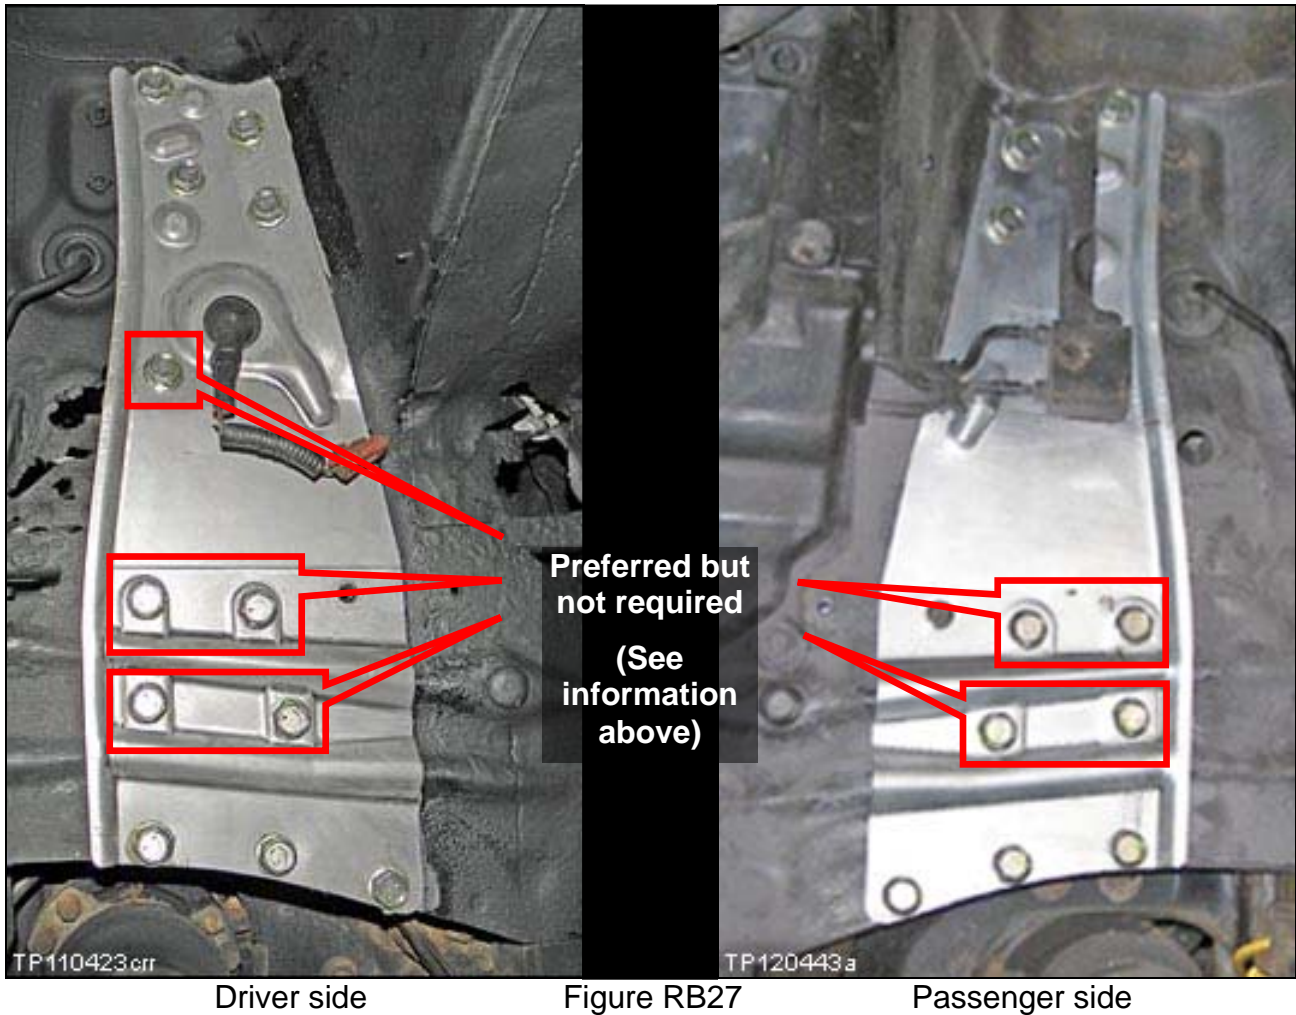
### Bolts that are preferred but not required (see Figure RB27):

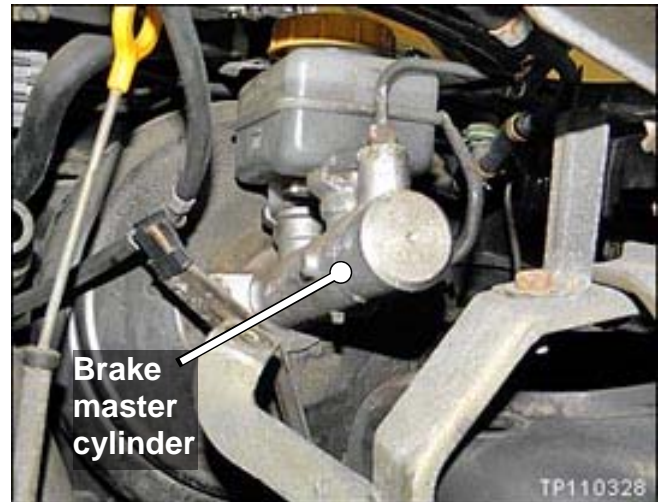
Figure RB28

32. Driver side: Inspect the brake master cylinder for damage due to contact with the separated strut housing.

Contact with the strut housing may have occurred if the strut housing separated from the wheel house.

- If there is damage, replace the master cylinder.
- Refer to the appropriate Service Manual for brake master cylinder replacement information.

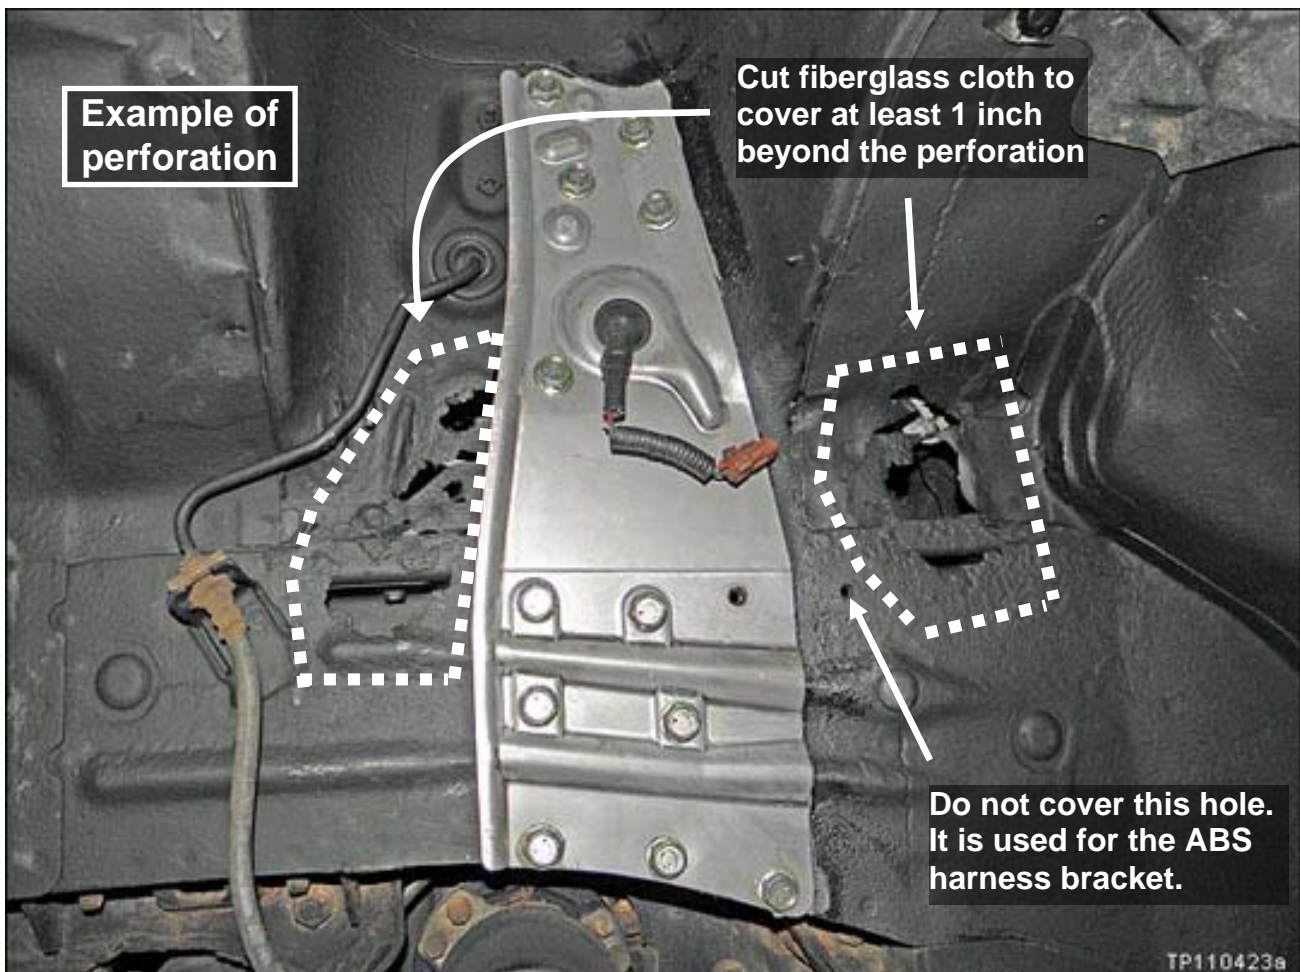
Figure RB29

33. Cut fiberglass cloth to cover perforated areas (see example in Figure RB29).

- Cut cloth to cover at least 1 inch beyond the perforation on all sides, except when the perforation is next to the repair bracket.
- Where perforation is next to the repair bracket, cut cloth to fit along the edge of the repair bracket.
- If there is more than one perforation, cut fiberglass cloth for each perforated area.
- Use 3M™ Bondo Fiberglass Repair Kit (P/N 422) or equivalent.
- Use protective gloves (such as rubber gloves or disposable gloves) while working with fiberglass and resin.
- Do not install fiberglass patch on or over the repair bracket.

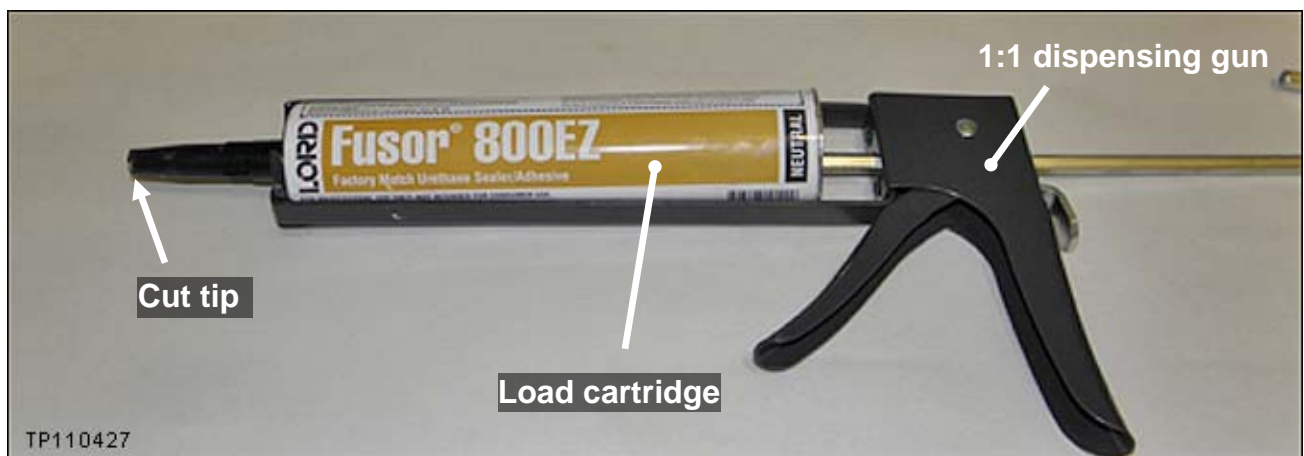
Figure RB30

- a. Load the cartridge into a 1:1 dispensing gun (see Figure RB30).
- b. Cut the tip at about ¼ inch diameter opening.

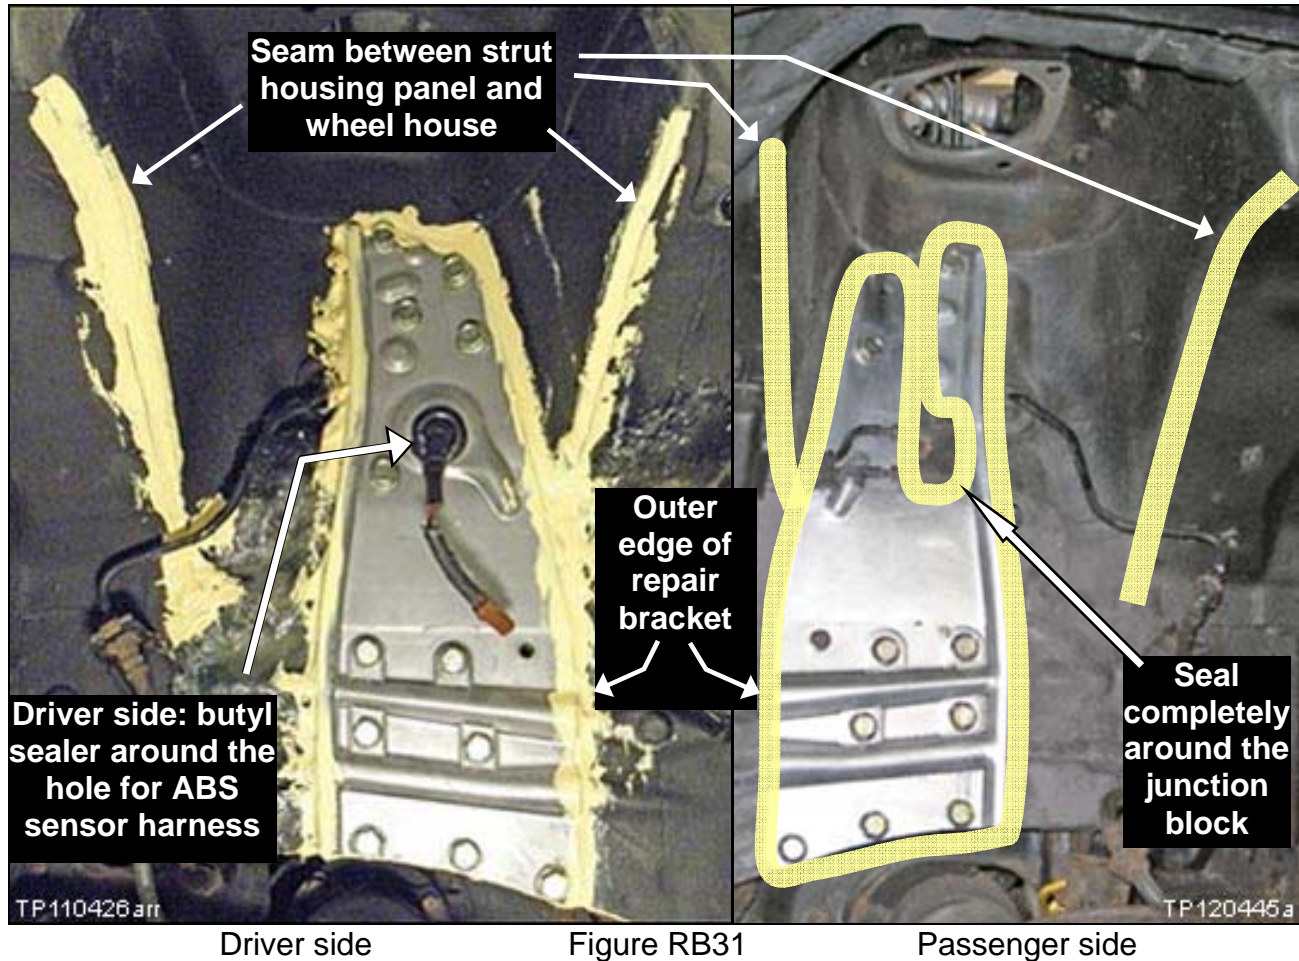
37. Apply Fusor® 800EZ (seam sealer) as shown in Figure RB31.

- Apply around the outer edges of the repair bracket. Make sure all gaps are filled.
- Apply along the seams between the strut housing panel and the wheel house.
- Use a brush or other suitable tool to smooth the sealer for good seam coverage.
- Allow seam sealer to dry for 10-15 minutes.
- Passenger side: Also apply seam sealer around the brake line junction block.

38. Driver side: Apply Butyl Sealer (P/N B6553 – 89915) around the opening for the ABS sensor harness (see Figure RB31).

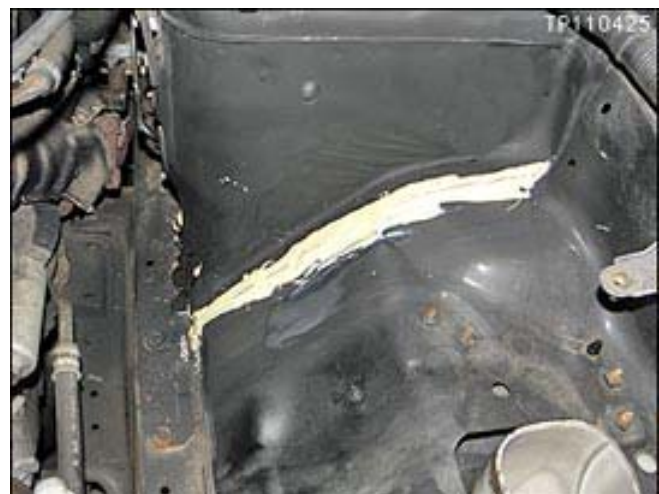
Figure RB32

Apply Fusor® 800EZ (seam sealer) as shown in Figure RB32.

- Apply along the front seam between the strut housing panel and the wheel house.
- Use a brush or other suitable tool to smooth the sealer for good seam coverage.
- Allow seam sealer to dry for 10-15 minutes.

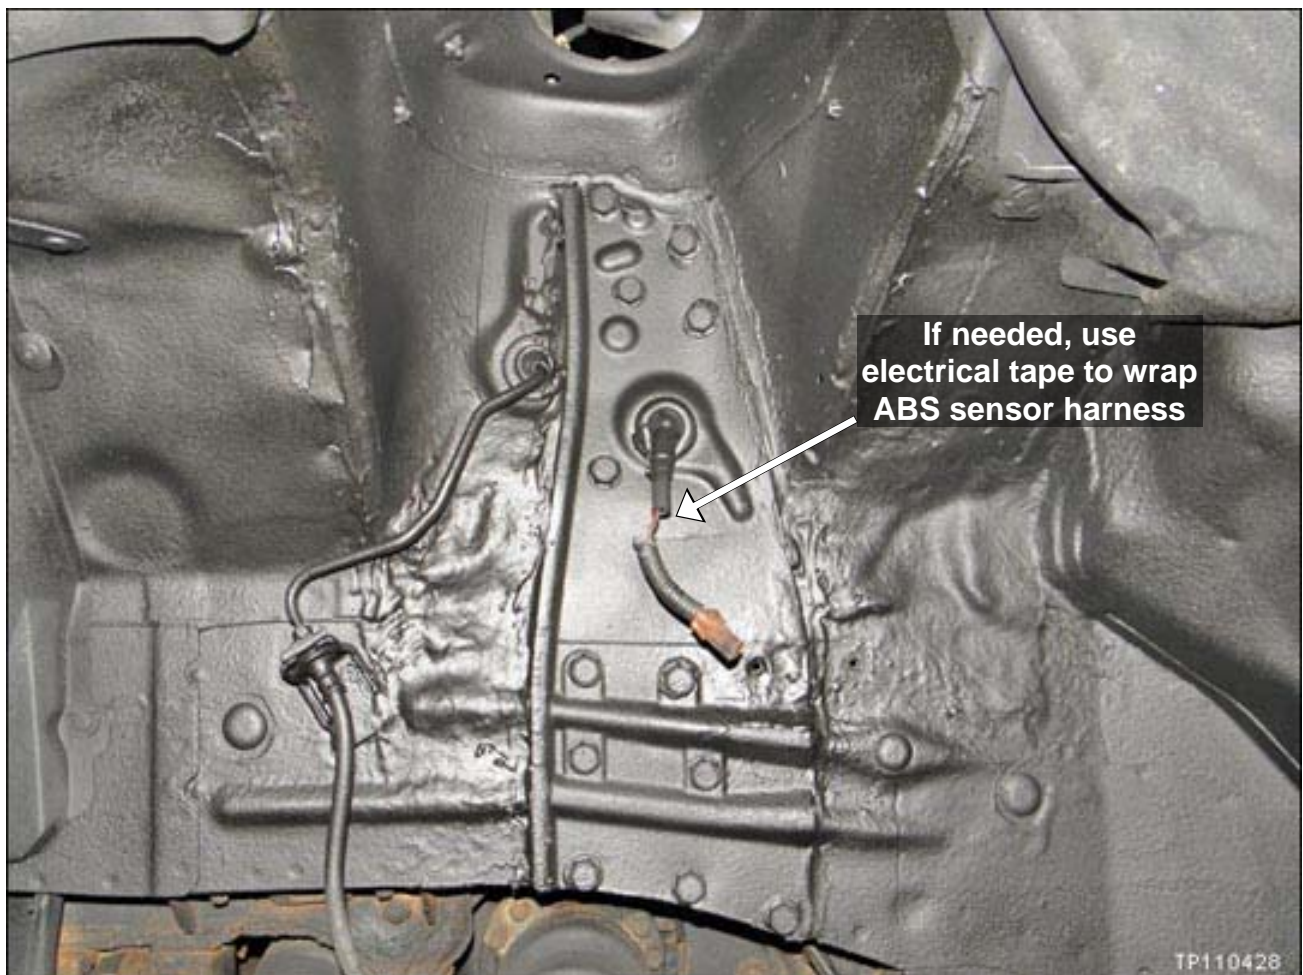
40. Completely and liberally coat the area shown in Figure RB33 (strut housing and wheel house area) with rubberized undercoat.

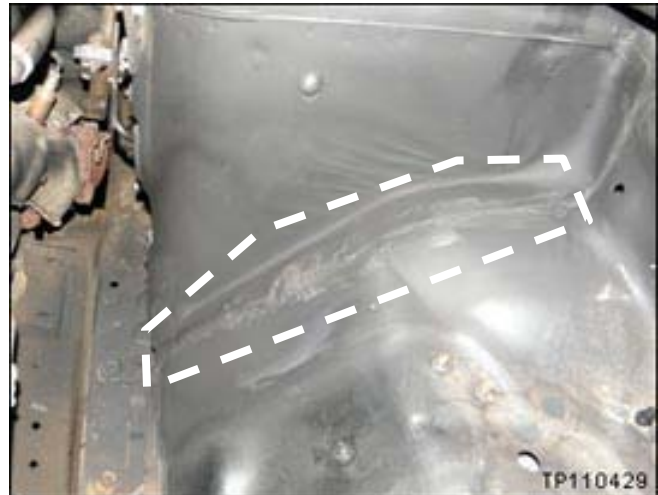
Figure RB34

- This is the under hood front of the strut housing panel.
- Use DuPont Etch Primer (P/N A-4119S™) or equivalent.
- Follow all product instructions.

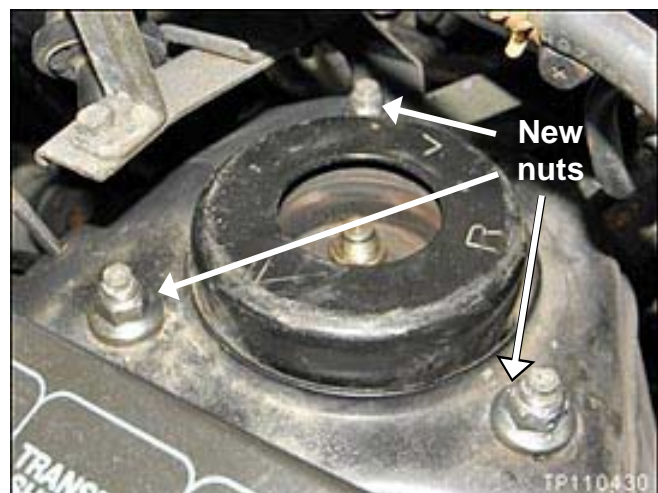
Figure RB35

- Use **new** nuts for the upper strut mount (P/N 01225 – 00231).
- Nut torque is:  
39-54 N•m (4.0 - 5.5 kg-m, **29-40 ft-lb**)

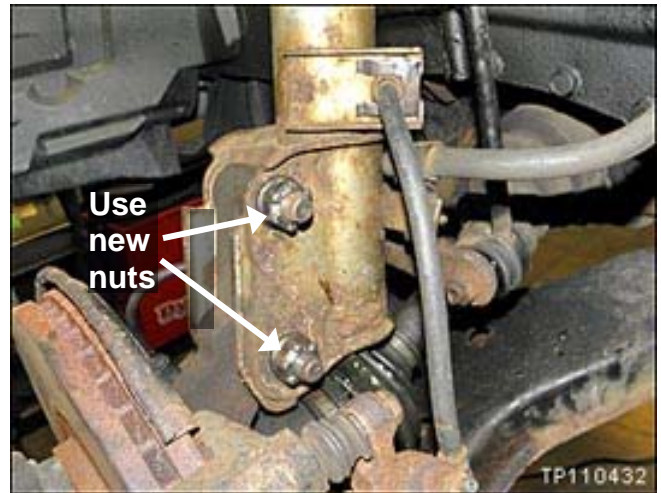
Figure RB36

- Use **new** nuts for the lower strut mount (P/N 54588 – ED00A).

**NOTE:** Reuse the original bolts.

- Torque is:  
151 – 165 N•m  
(15.4 – 16.8 kg-m, **111 – 122 ft-lb**)

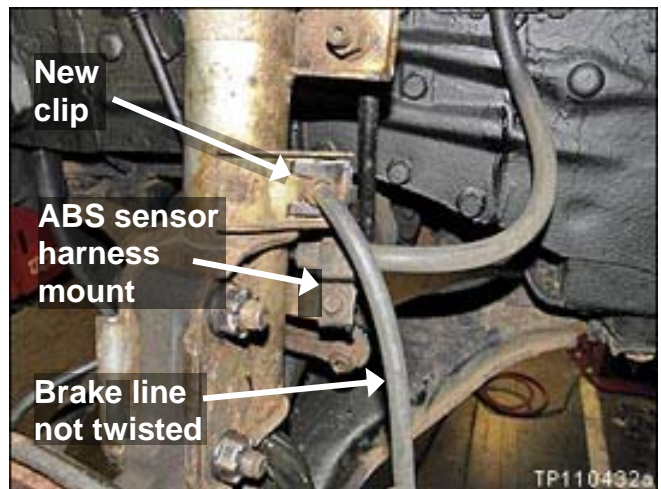
Figure RB37

- Use a new clip for the brake line mount (P/N 46206 – 2J00A).
- Confirm the ABS sensor harness is mounted correctly as shown in Figure RB37.
- Make sure the brake line is not twisted.

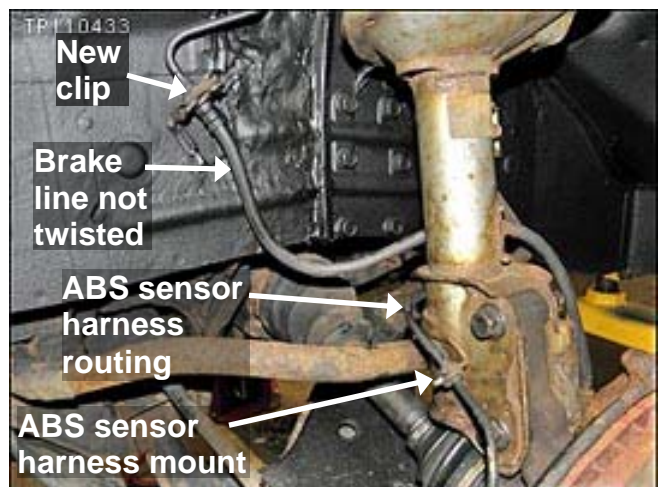
Figure RB38

- Use a new clip for the brake line mount (P/N 46206 – 2J00A).
- Make sure the brake line is not twisted.
- Confirm the ABS sensor harness is routed correctly behind the strut.
- Make sure the ABS sensor harness is mounted correctly as shown in Figure RB38.

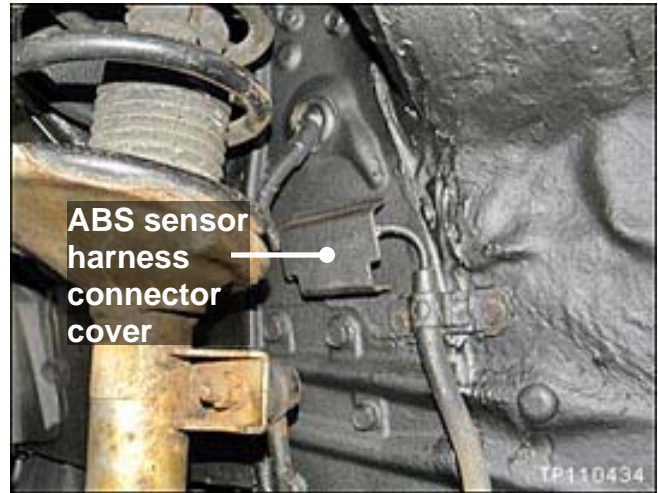
Figure RB39

- Make sure the ABS sensor harness connector cover is installed as shown.
  - If the cover is missing, install a new one.
  - Coat the cover with 3M Rubberized Undercoating (P/N 051135 – 08883); don't get any undercoat on the strut rod.

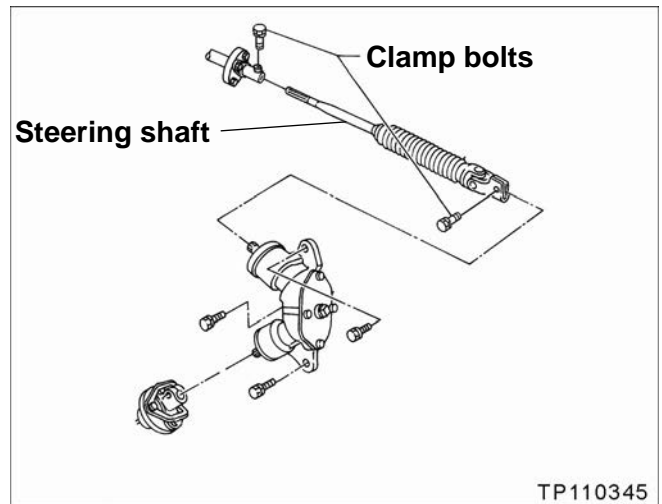
Figure SS1

2. Remove the clamp bolts at each end of the steering column upper joint (steering shaft).

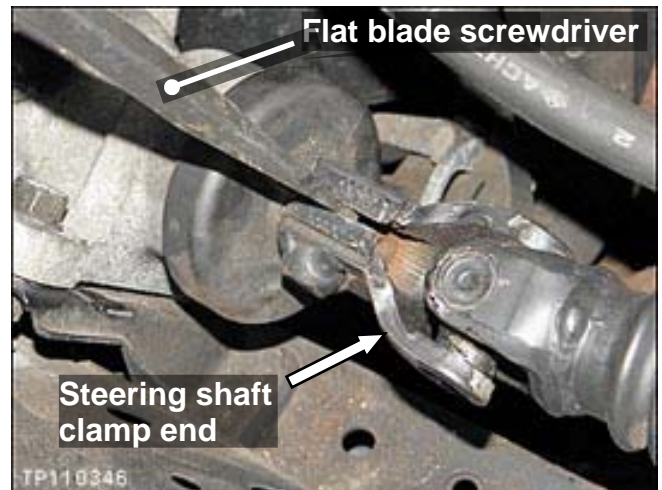
Figure SS2

3. Use a flat blade driver or other suitable tool to loosen **both** clamp ends of the steering shaft.

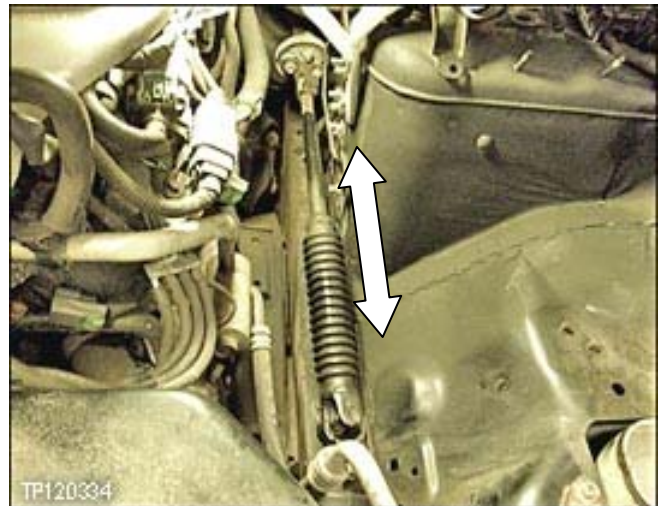
Figure SS3

4. Loosen the clamp ends enough so the steering shaft is loose at both ends.
  - Steering shaft will move back and forth a small amount.

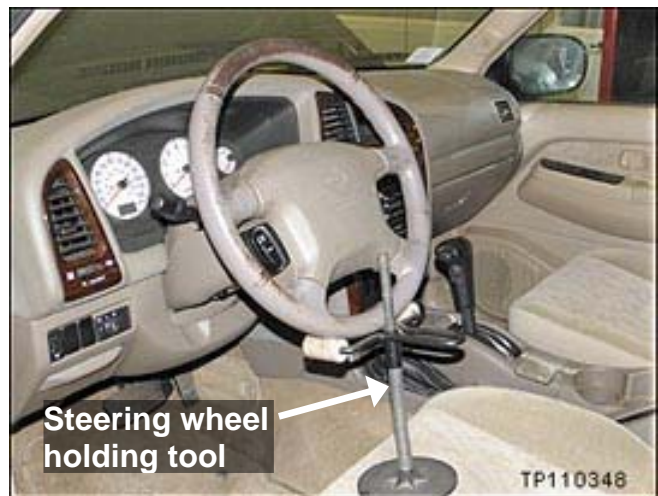
Figure SS4

5. Set the steering wheel in the straight ahead position.
6. Position a steering wheel holding tool as shown.
  - This will keep the steering wheel stationary while replacing the steering shaft.

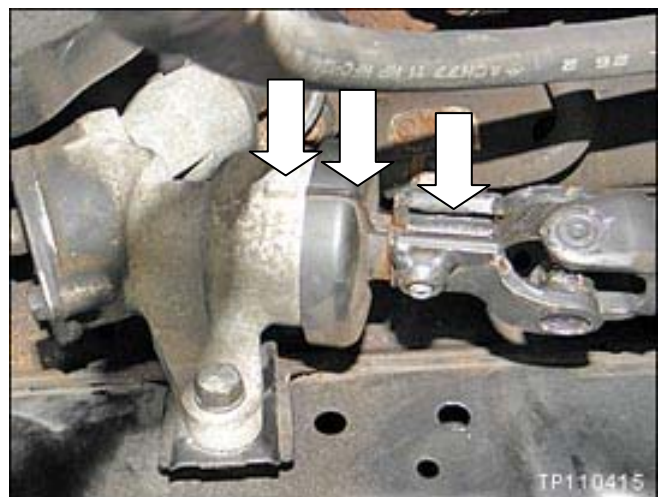
**NOTE:** The marks shown in Figure SS5 should be aligned.

- Tab on transfer gear assembly
- Raised area on rubber cover
- Gap on steering shaft clamp

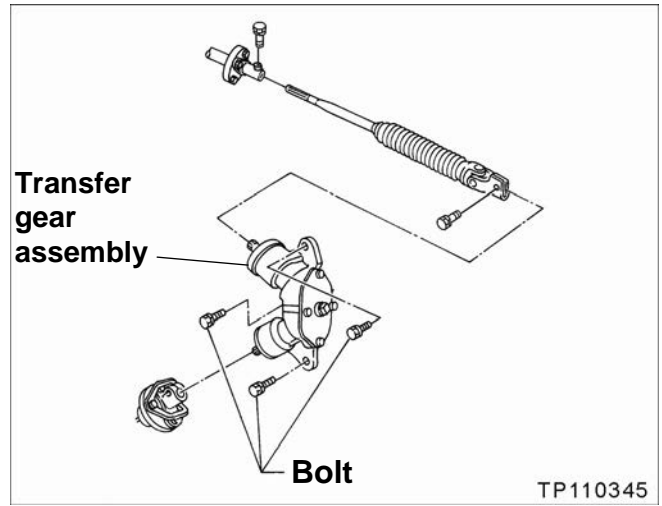
Figure SS6

7. Remove the 3 transfer gear assembly mounting bolts.

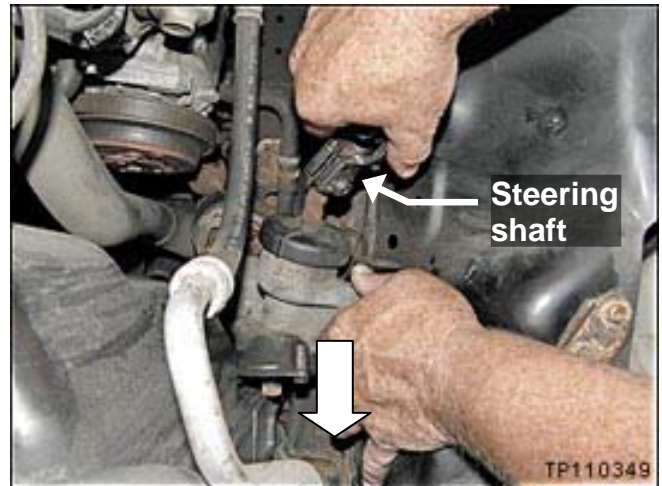
Figure SS7

8. Push the transfer gear assembly forward and remove the steering shaft.

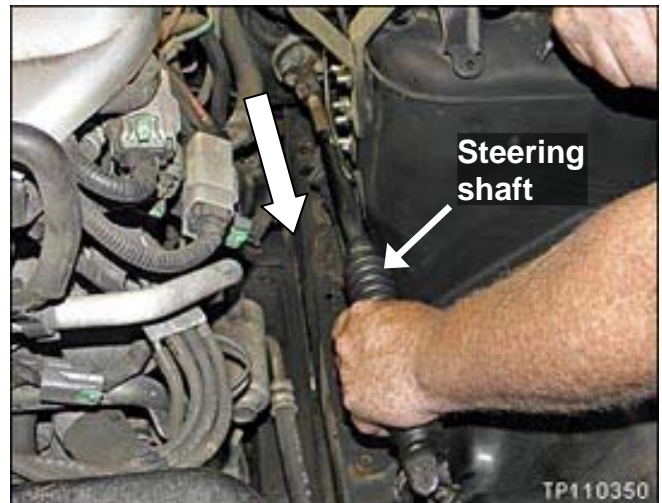
Figure SS8

9. Pull the steering shaft to remove it from the other end.

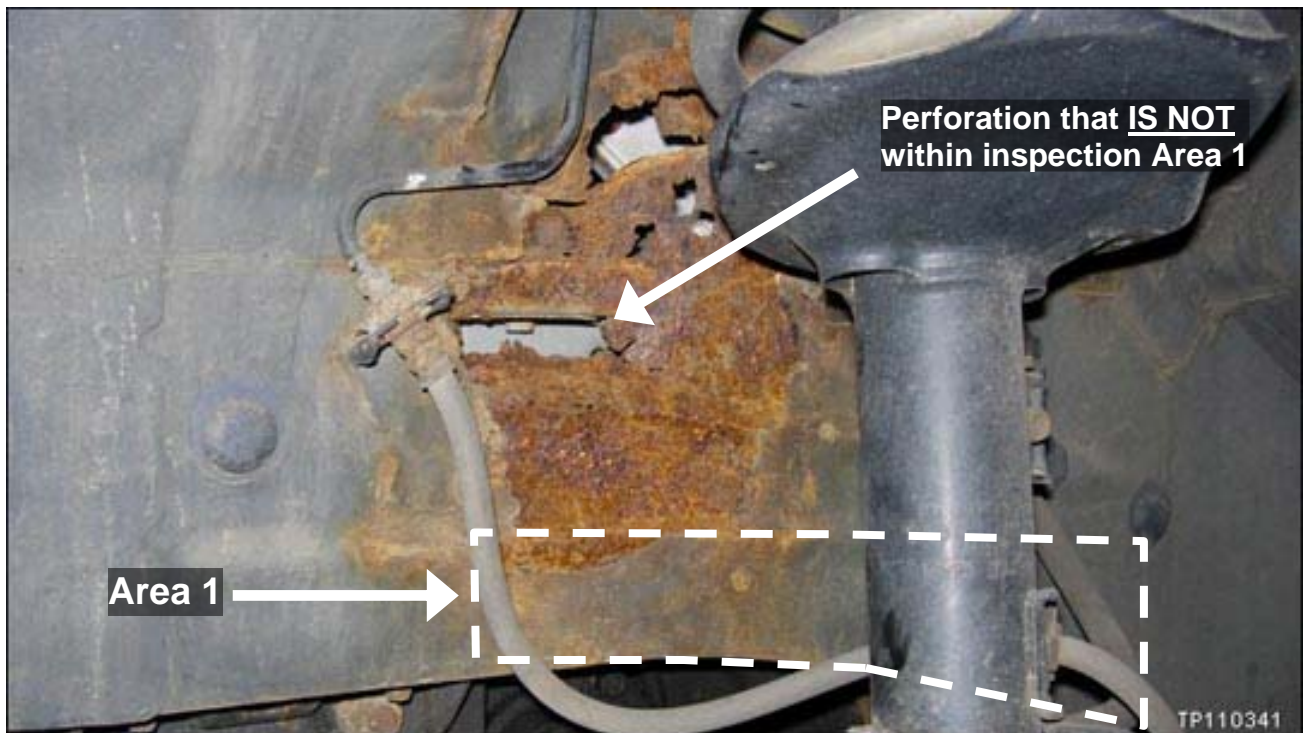
**Example (Additional Photo) of Area 1 Perforation Inspection**

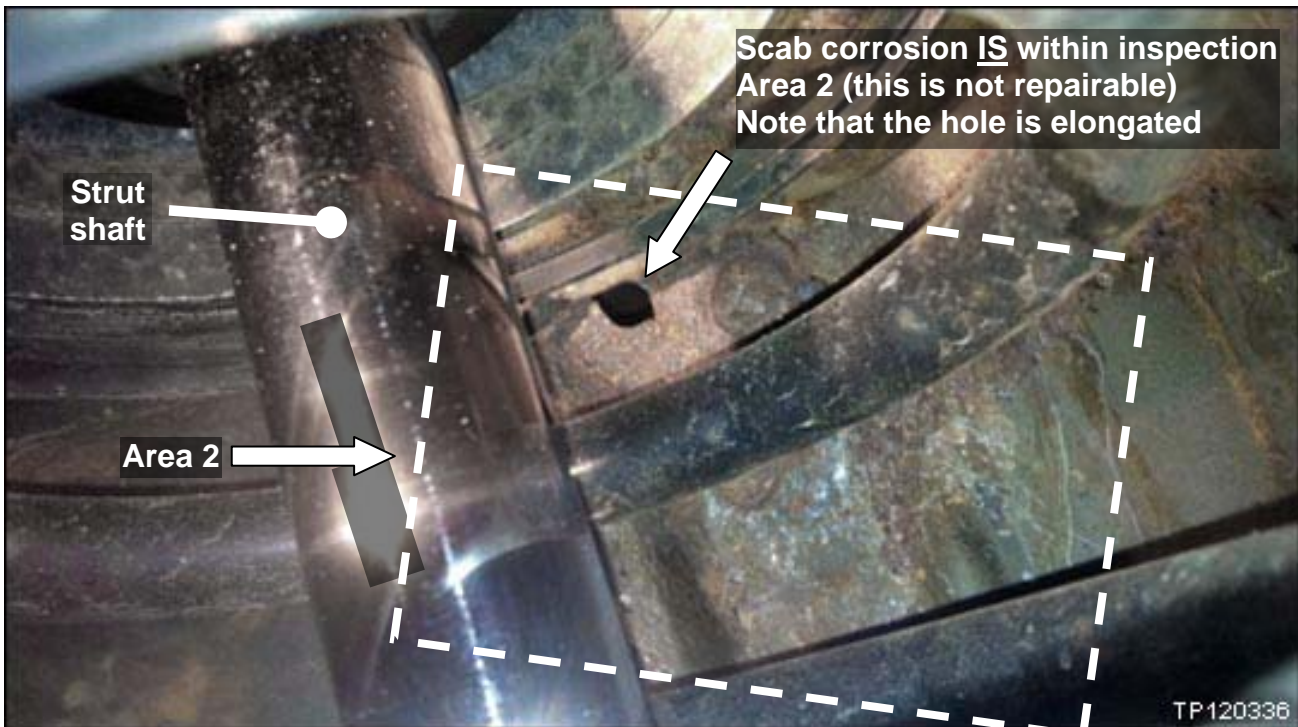
**Example (Additional Photo) of Area 2 Scab Corrosion Inspection**

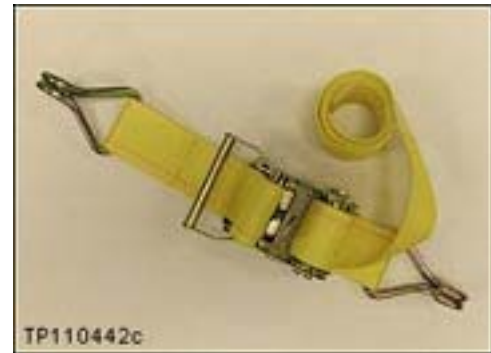
### Ratchet Strap (J-50836)

- Each dealer will be shipped, at no charge, one Ratchet Strap.
- Additional tools can be ordered from TechMate at 1-800-662-2001.

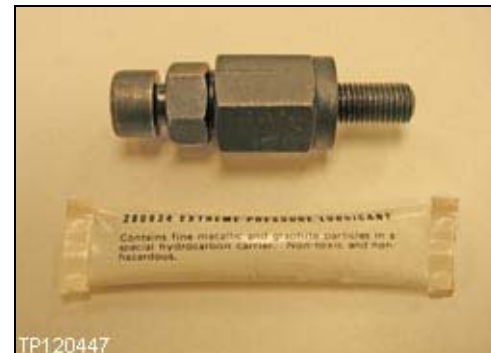
### Rivet Tool (J-50835)

- Each dealer will be shipped, at no charge, one Rivet Tool (includes high pressure lubricant).
- Additional tools can be ordered from TechMate at 1-800-662-2001.

**CAUTION: DO NOT use power tools or impact tools with the Rivet Tool – use hand tools only.**

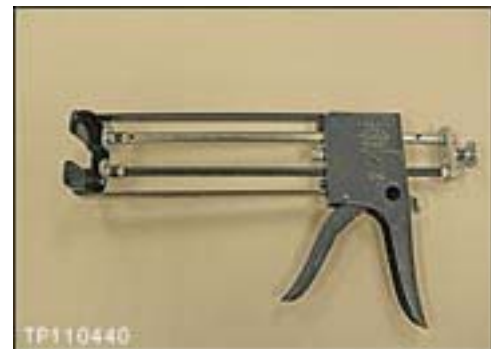
### 2:1 Dispensing Gun (J-50816)

- This tool is used to dispense LORD Fusor<sup>®</sup> 108B (structural adhesive).
- Each dealer will be shipped, at no charge, one 2:1 Dispensing Gun.
- Additional tools can be ordered from TechMate at 1-800-662-2001.

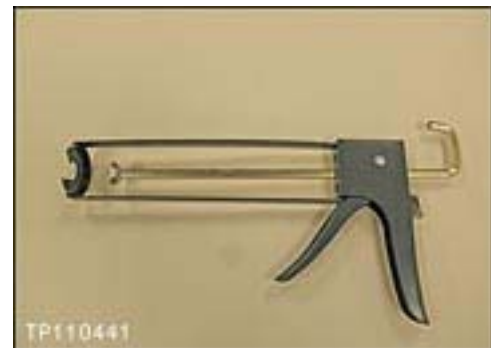
### 1:1 Dispensing Gun (Caulking Gun)

- This tool is used to dispense LORD Fusor<sup>®</sup> 800EZ (seam sealer).
- Caulking guns are commonly used for application of other automotive products. Each dealer should already have a caulking gun as a shop tool.
