## SERVICE CAMPAIGN BULLETIN

NTB11-066c

### VOLUNTARY SERVICE CAMPAIGN 1996-2004 PATHFINDER IN NON SALT STATES LEFT FRONT STRUT HOUSING CORROSION

**CAMPAIGN ID #:** R1108  
**NHTSA #:** 11V-244  
**APPLIED VEHICLES:** 1996 – 2004 Pathfinder (R50)

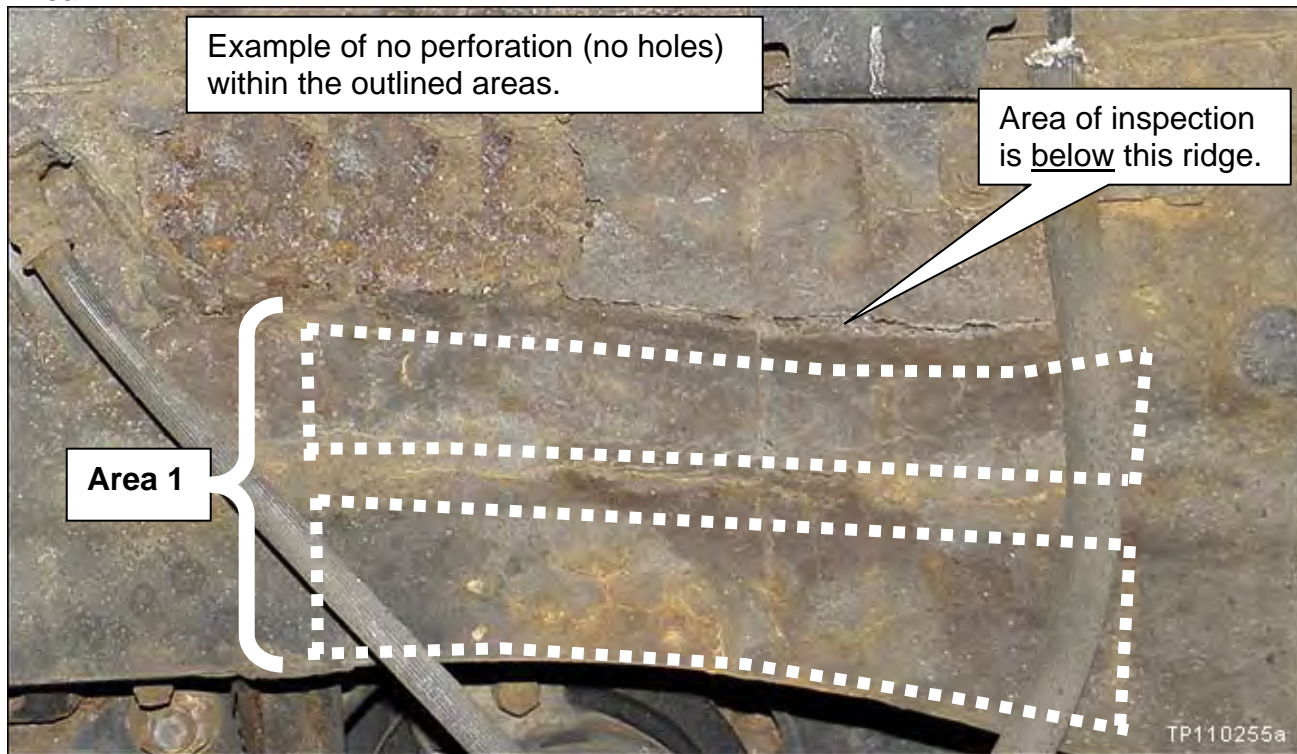
Figure 3

**Area 1:** Look for perforation (holes) in the metal only in the areas outlined above.

- a. Retain the vehicle at the dealer. (The vehicle is not repairable.)
- b. Supply the customer with a rental car.
- c. Fax a completed Non-Repairable Report to Morley (see page 55).

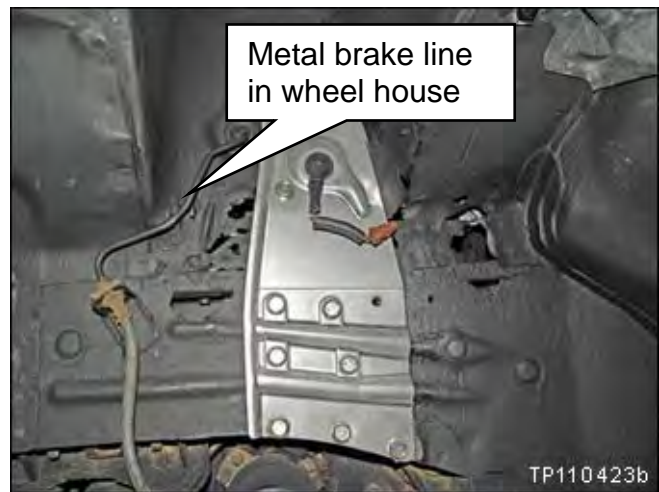
Figure RB26

30. Inspect the metal brake line for damage. If there is damage, replace the line.

- Inspect the line in the wheel house area (see Figure RB26).

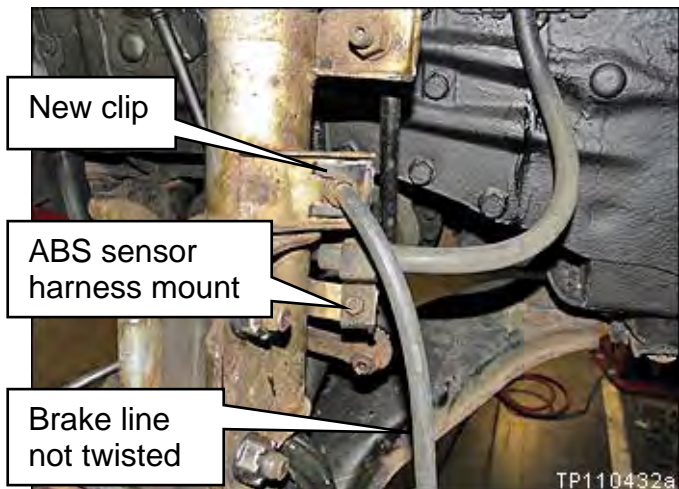
Figure RB37

- Use a new clip for the brake line mount (P/N 46206 – 2J00A).
- Confirm the ABS sensor harness is mounted correctly as shown in Figure RB37.
- Make sure the brake line is not twisted.

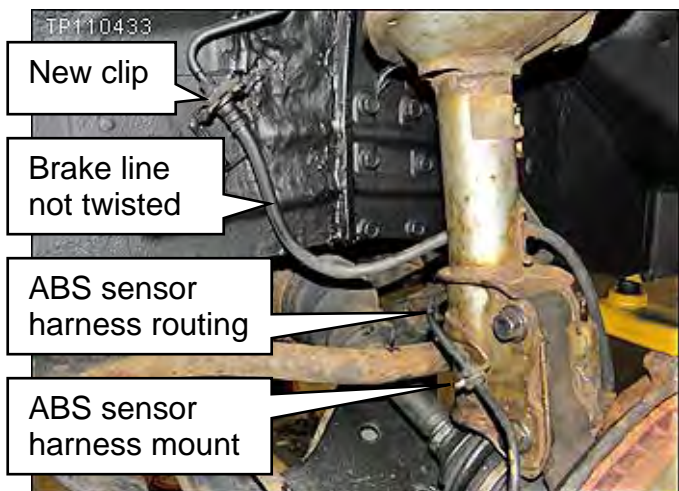
Figure RB38

- Use a new clip for the brake line mount (P/N 46206 – 2J00A).
- Make sure the brake line is not twisted.
- Confirm the ABS sensor harness is routed correctly behind the strut.
- Make sure the ABS sensor harness is mounted correctly as shown in Figure RB38.
