# SERVICE CAMPAIGN BULLETIN

NTB11-066a

## VOLUNTARY SERVICE CAMPAIGN 1996-2004 PATHFINDER IN NON SALT STATES LEFT FRONT STRUT HOUSING CORROSION

**CAMPAIGN ID #:** R1108  
**NHTSA #:** 11V-244  
**APPLIED VEHICLES:** 1996 – 2004 Pathfinder (R50)

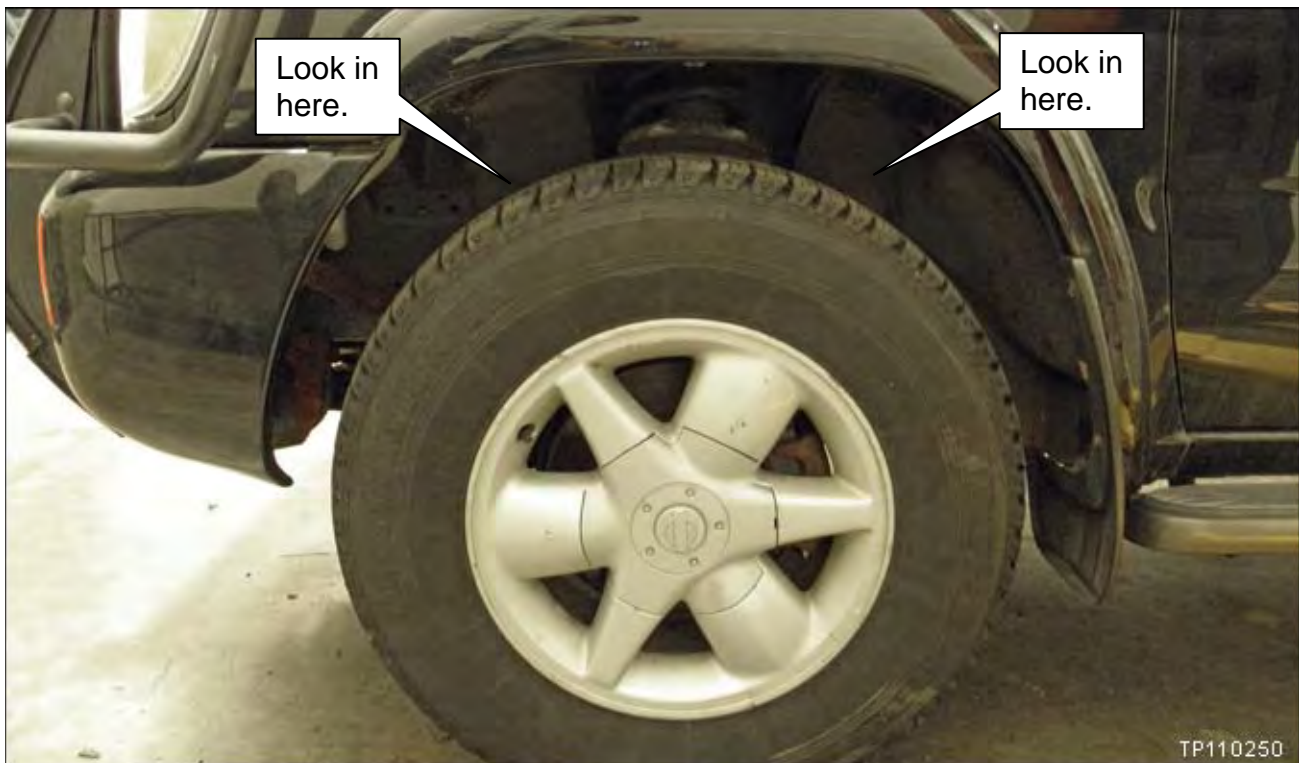
Figure A

**NOTE:** Turning the tire left and then right will allow a better view.

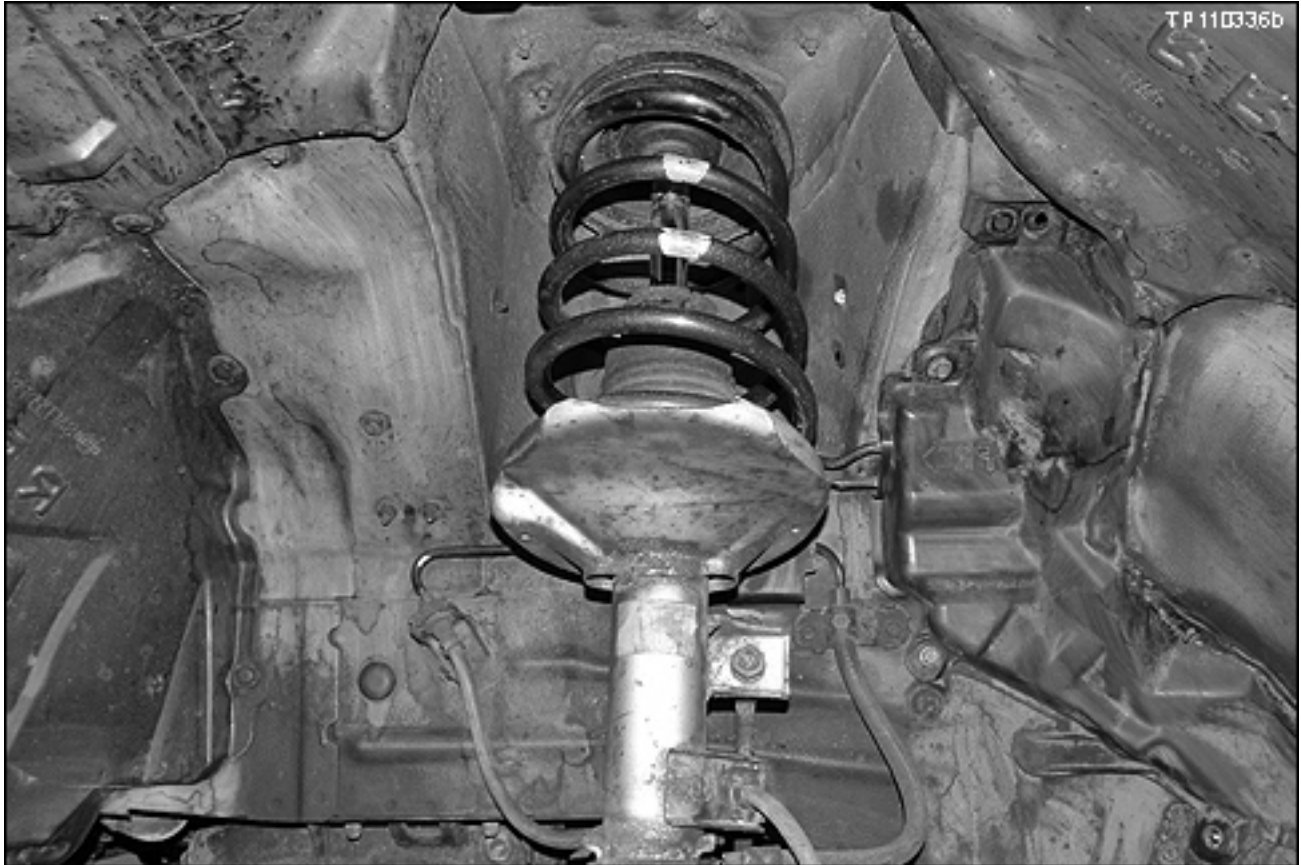
Figure B

4. Visually inspect for corrosion and rust on the wheel housing panel and the strut housing panel.
  - Inspect for corrosion and rust on the **panels only**.

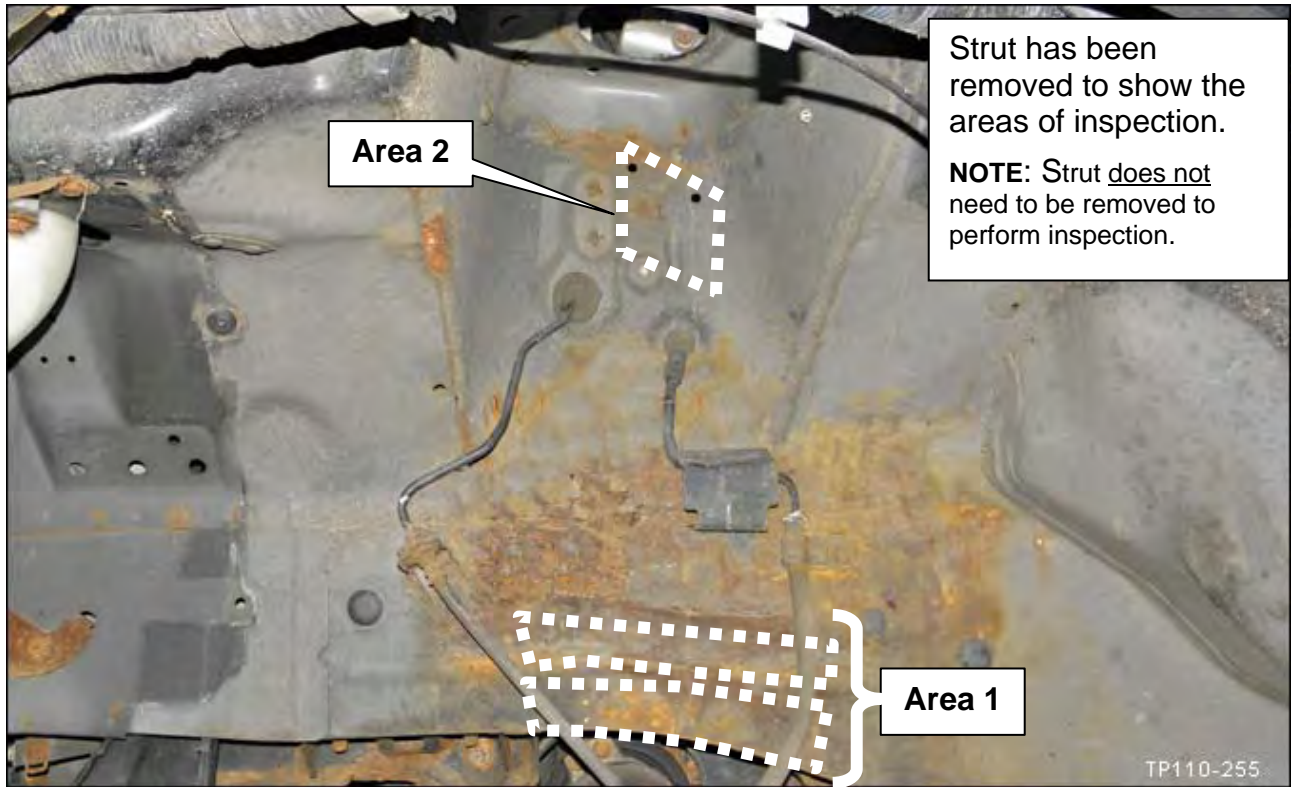
Figure 2

This photo shows the inspection areas in relation to the repair bracket installation.

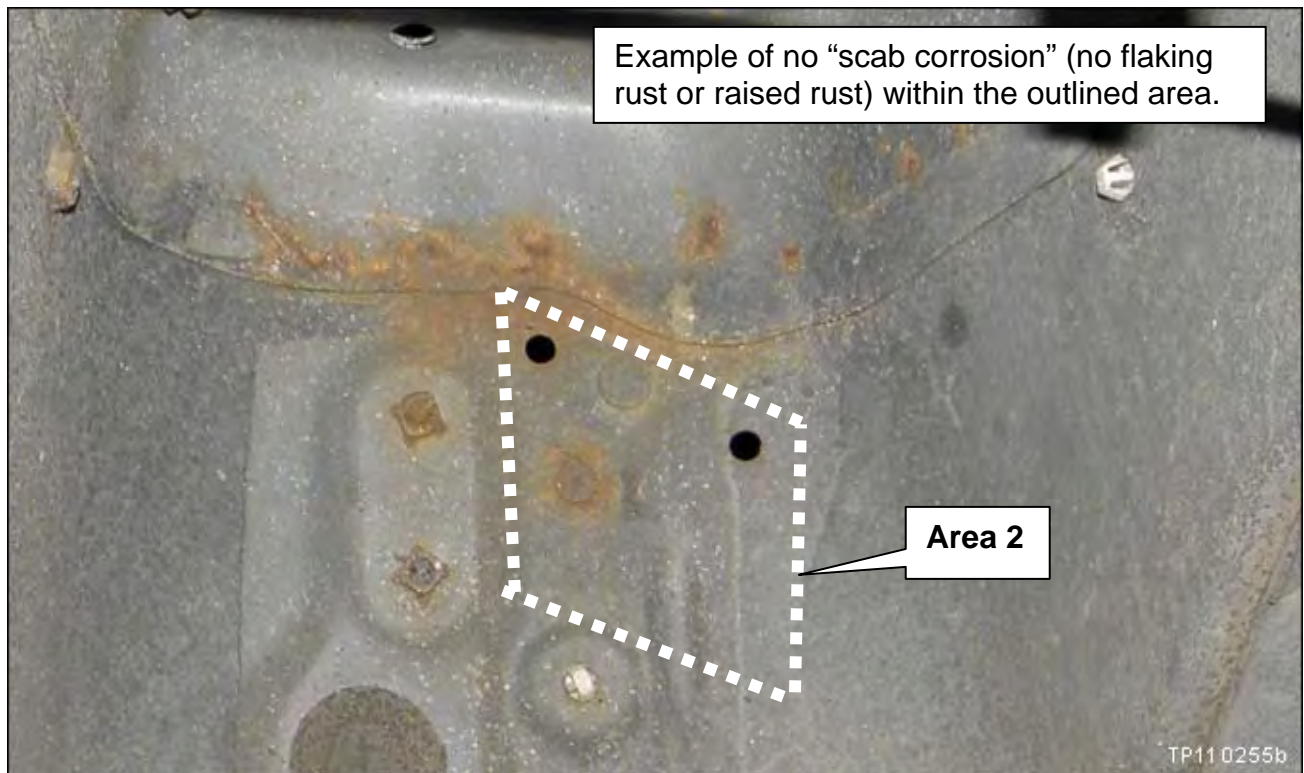
Figure 4

**Area 2:** Look for “scab corrosion” (flaking rust or raised rust) only in the area outlined above.

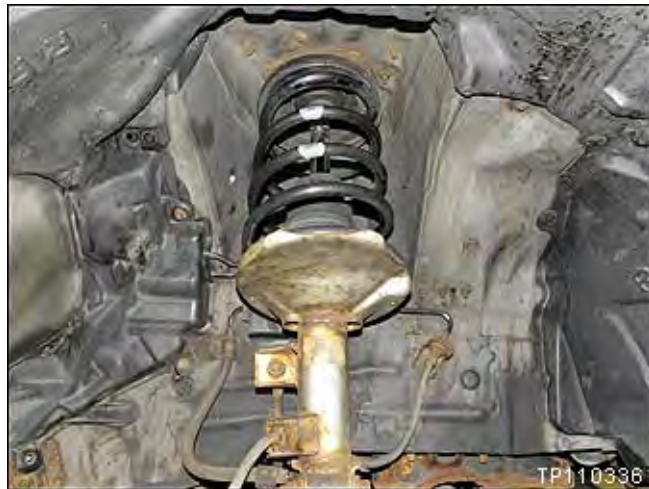
Figure 6

2. Use mild soap, water, and a brush to **thoroughly wash** the strut housing and the wheel housing in the area shown in Figure 6.

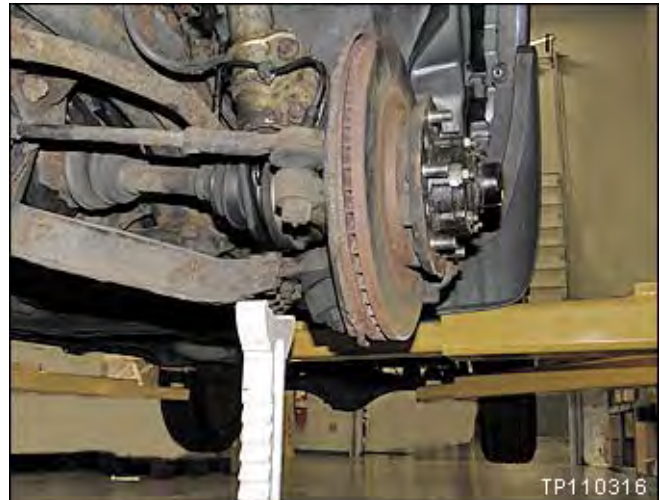
Figure SR1

1. Support the transverse link (lower control arm) with a jack stand as shown.
  - a. Position the jack stand under the lower control arm.
  - b. Lower the vehicle until the lower control arm touches the jack stand.

**NOTE:** Do not lower the vehicle beyond just touching the jack stand. Do not put tension on the coil spring.

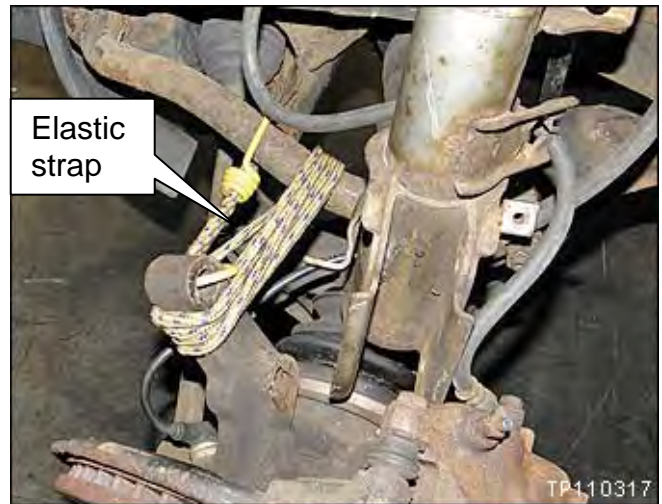
Figure SR3

4. Use an elastic strap or other suitable tool to secure the knuckle to the stabilizer bar as shown.

**NOTE:** Make sure the knuckle assembly is secure. Its weight must be supported during the entire repair process.

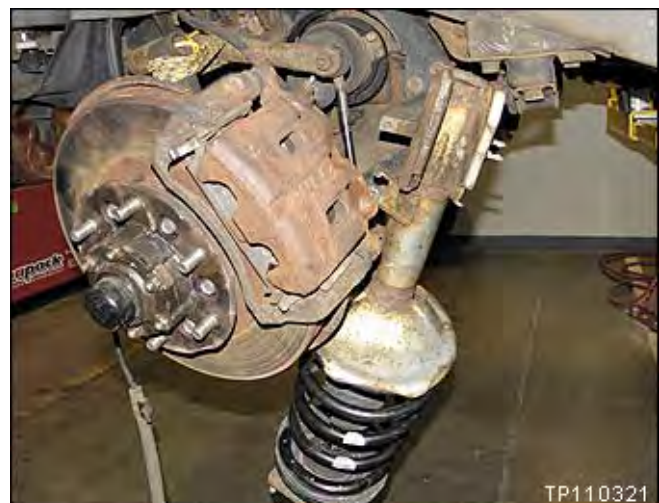
Figure SR8

11. Maneuver the strut so it is hanging upside down as shown.

**NOTE:** The weight of strut is supported by the stabilizer connecting rod.

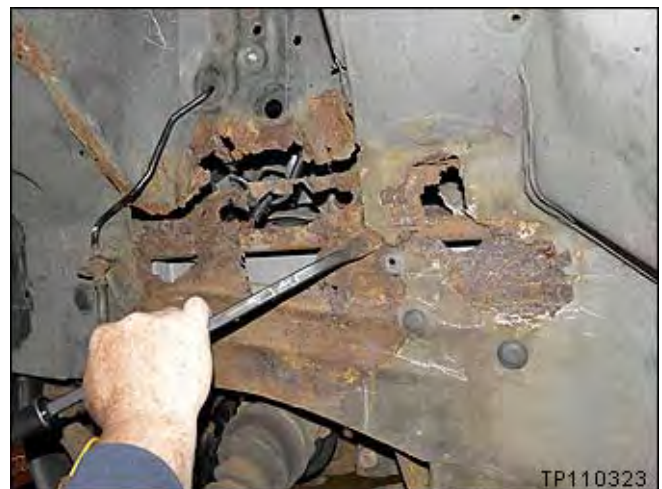
Figure RB2

3. Use a scraper bar to scrape off loose flaking rust and corrosion.

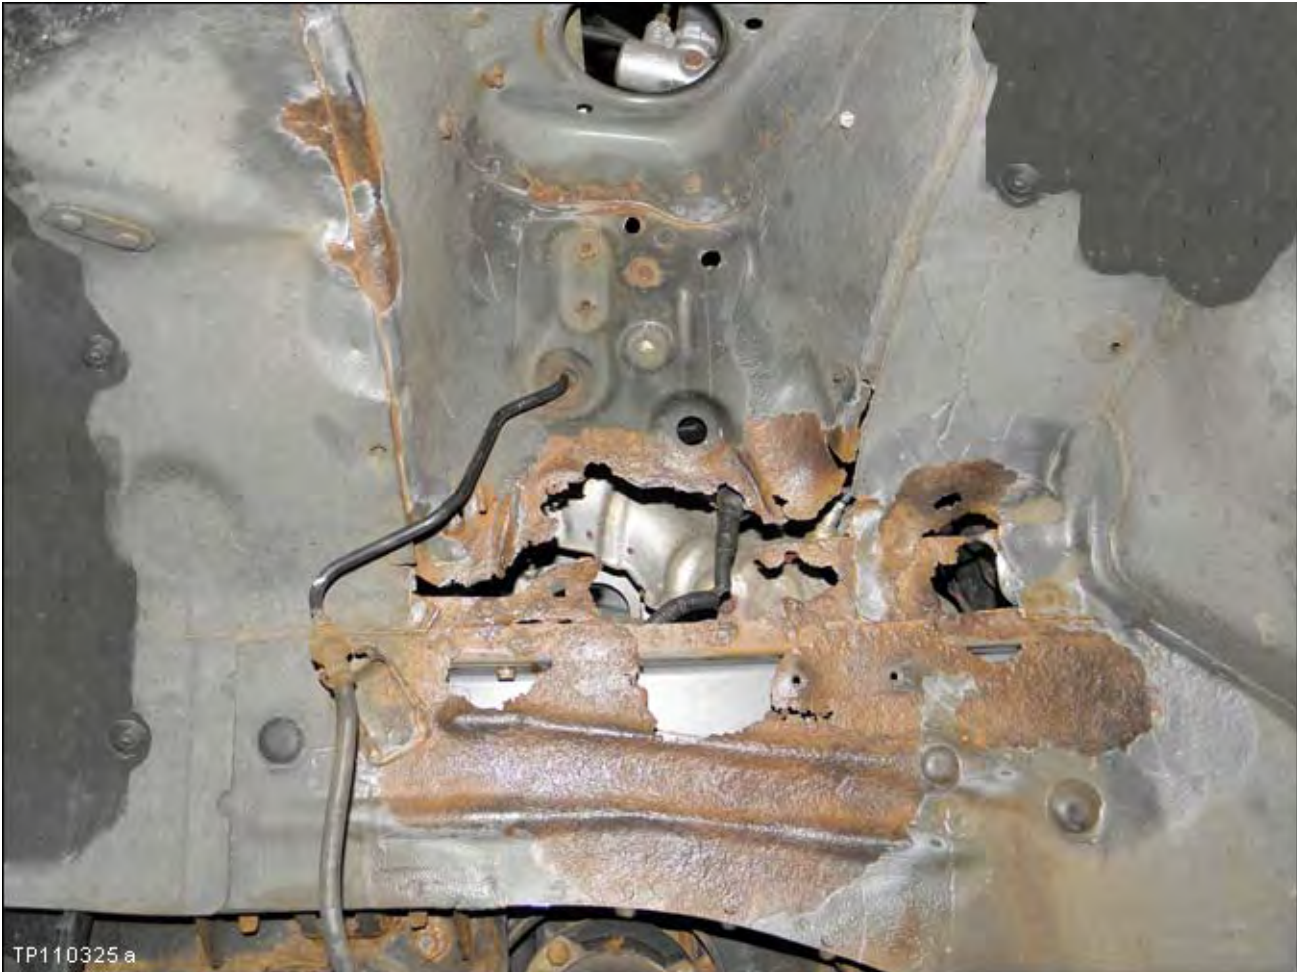
Figure RB3

4. Clean all the loose rust from the strut housing and wheel house areas (see Figure RB3).
  - Use an abrasive pad or other suitable tool.

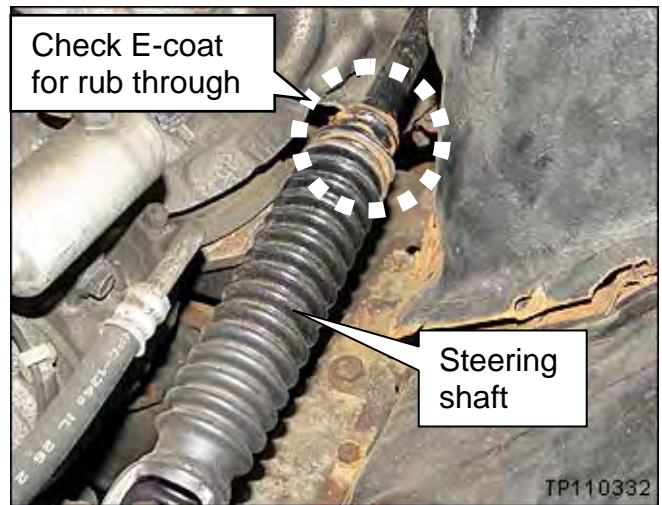
Figure RB4

- **ONLY if the E-coat has been rubbed through to bare metal**, the steering shaft will need to be replaced.
- If the steering shaft needs replacement, you will be instructed to replace it later in this procedure.

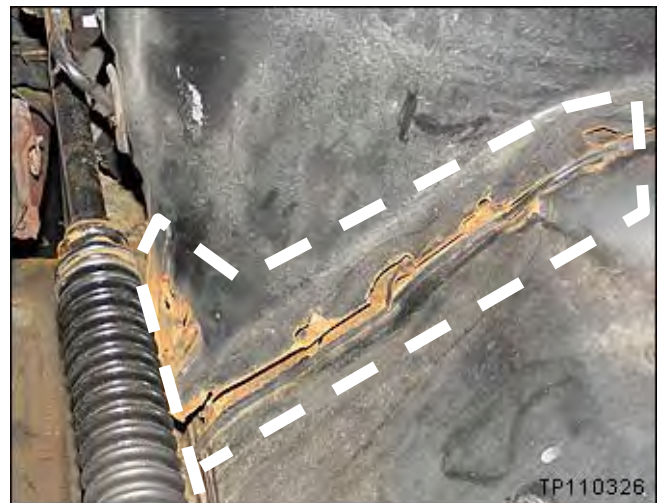
Figure RB5

7. Only if the strut housing panel is separated as show in Figure RB5:

Use a wire brush to clean any loose rust, paint, or other debris from the area shown with dashed line.

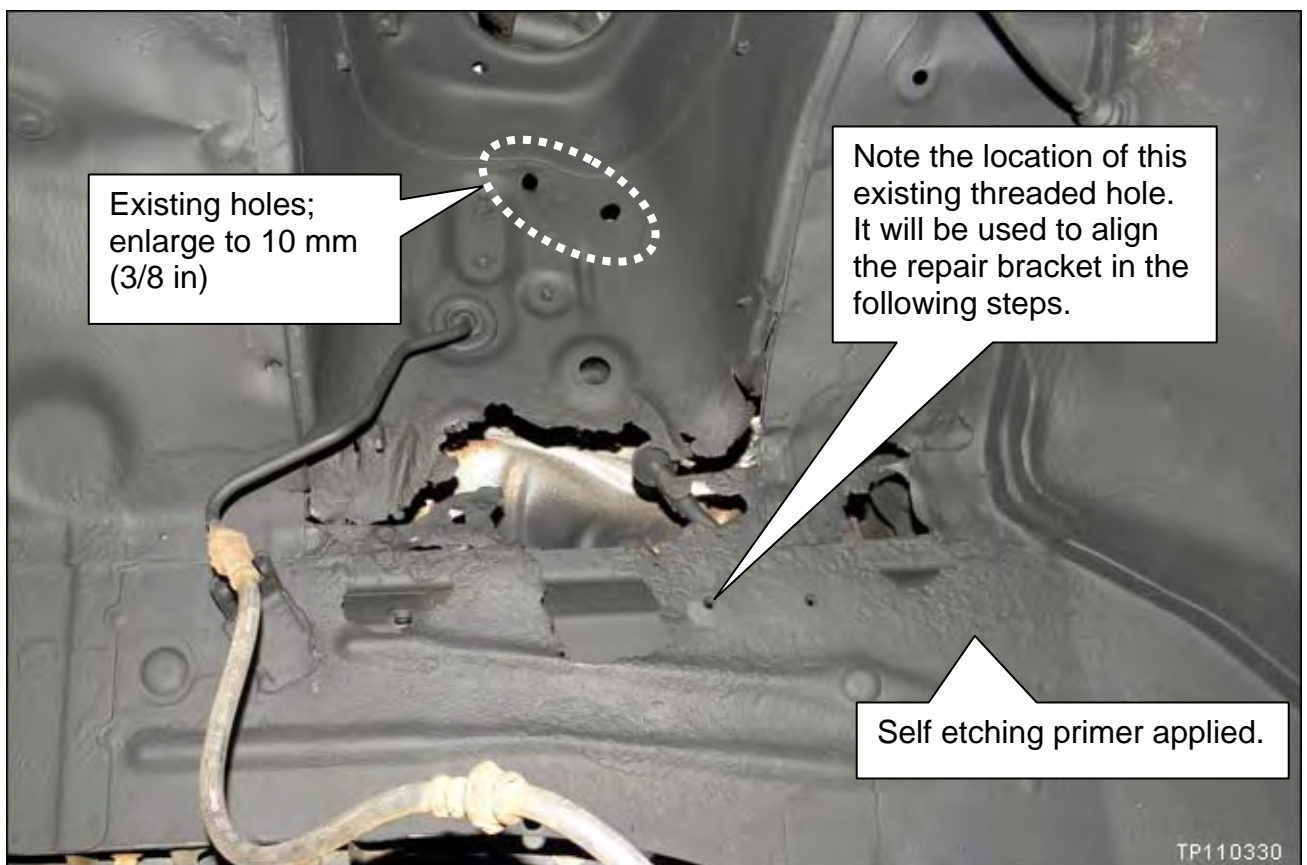
Figure RB7

13. With a drill bit, enlarge these two existing holes to 10 mm (3/8 in).

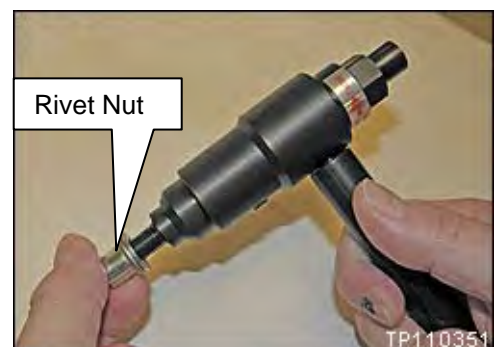
Figure RB13

- B. Screw a new Rivet Nut onto the mandrel.

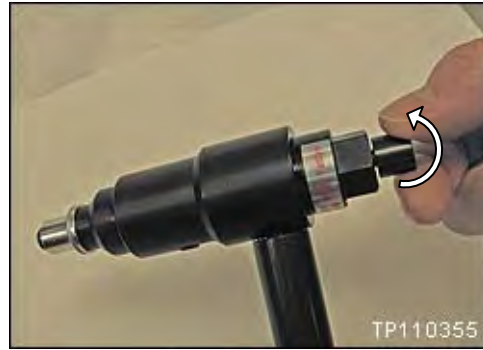
Figure RB14

- C. Turn the rear knob clockwise until it stops.

**NOTE:** Turning the rear knob sets (screws) the Rivet Nut all the way onto the mandrel.

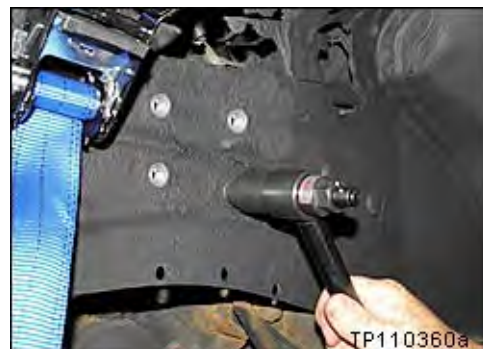
Figure RB16

- E. Place the Rivet Nut into the 13.1 mm (33/64 in) hole.

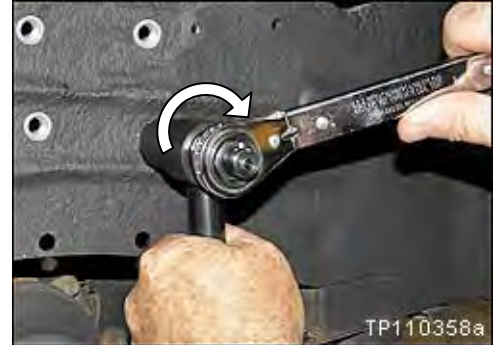
Figure RB17

G. Use a 19 mm wrench to turn the hex nut clockwise a **maximum** of 2 ½ to 2 ¾ turns.

- Use the mark (white dot) on top of the hex nut to keep track of the number of turns.

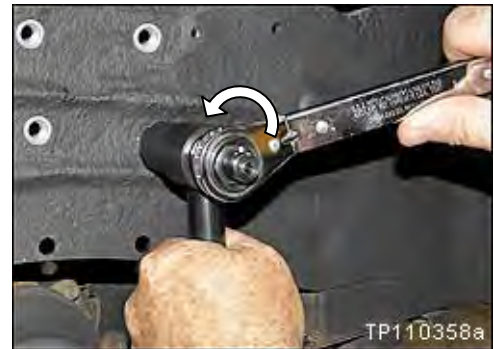
Figure RB18

H. Turn the hex nut about ½ turn counterclockwise to release the mandrel tension.

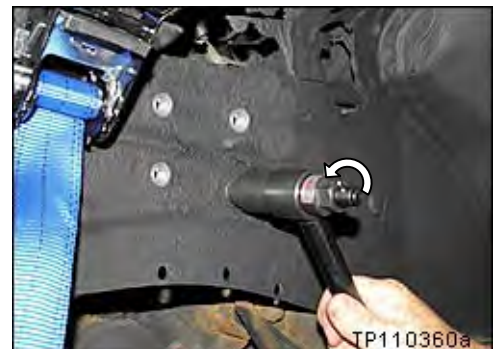
Figure RB19

I. Turn the rear knob counterclockwise to remove (unscrew) the mandrel from the Rivet Nut.

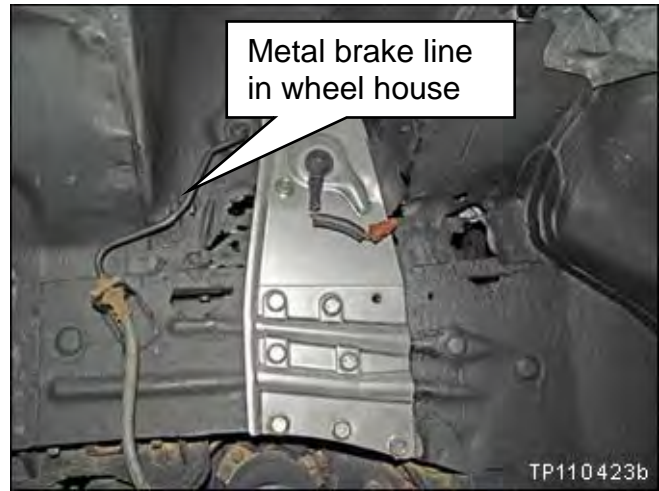
Figure RB26

30. Inspect the metal brake line for damage. If there is damage, replace the line.

- Inspect the line in the wheel house area (see Figure RB26).

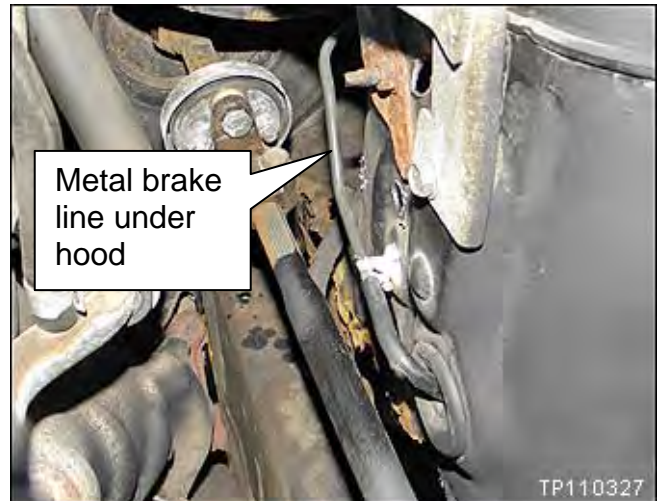
Figure RB27

- Inspect the line under the hood (see Figure RB27)
- Scratches or nicks of the E-coat are not considered damage that requires brake line replacement.
- Refer to the appropriate Service Manual for brake line replacement information.

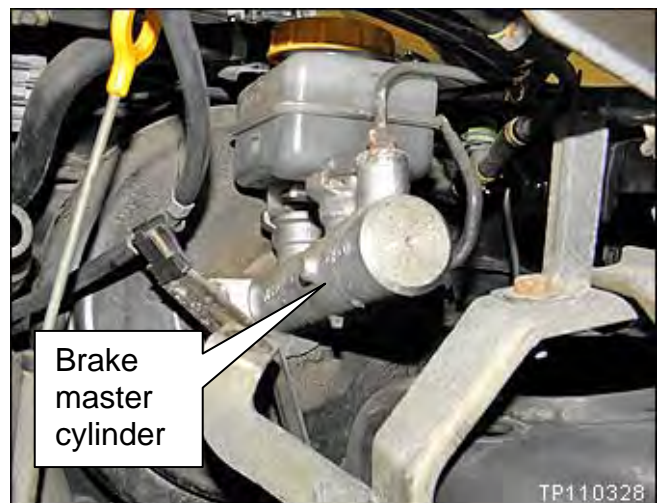
Figure RB28

31. If the strut housing was separated, inspect the brake master cylinder for damage.

- If there is damage, replace the master cylinder.
- Refer the appropriate Service Manual for brake master cylinder replacement information.

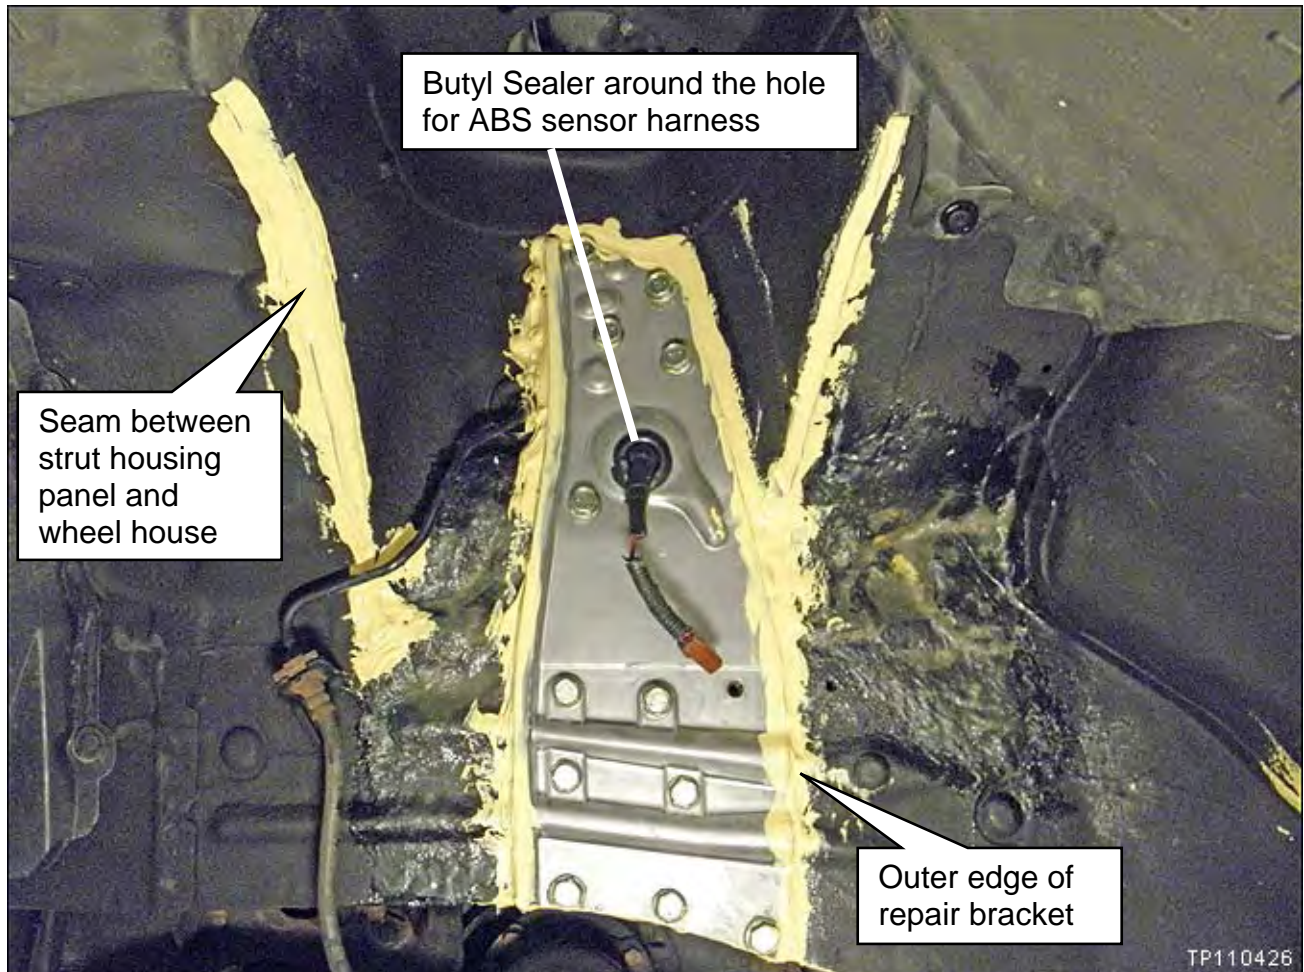
Figure RB31

37. Apply Butyl Sealer (P/N B6553 – 89915) around the opening for the ABS sensor harness (see Figure RB31).

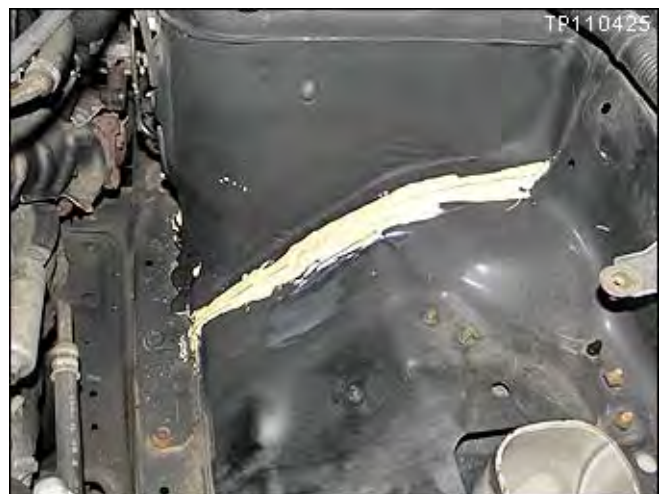
Figure RB32

Apply Fusor® 800EZ (seam sealer) as shown in Figure RB32.

- Apply along the front seam between the strut housing panel and the wheel house.
- Use a brush or other suitable tool to smooth the sealer for good seam coverage.
- Allow seam sealer to dry for 10-15 minutes.

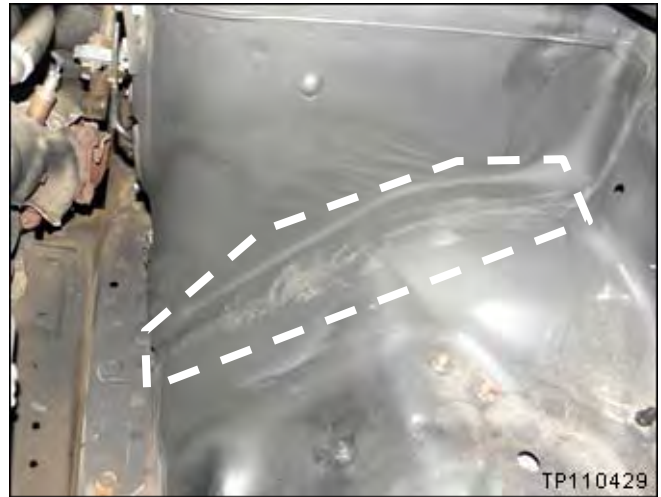
Completely and liberally coat the area shown with dashed line in Figure RB34 with self etching primer.

- This is the under hood front of strut housing panel.
- Use Dupont Etch Primer (P/N A-4119S™) or equivalent.
- Follow all product instructions.

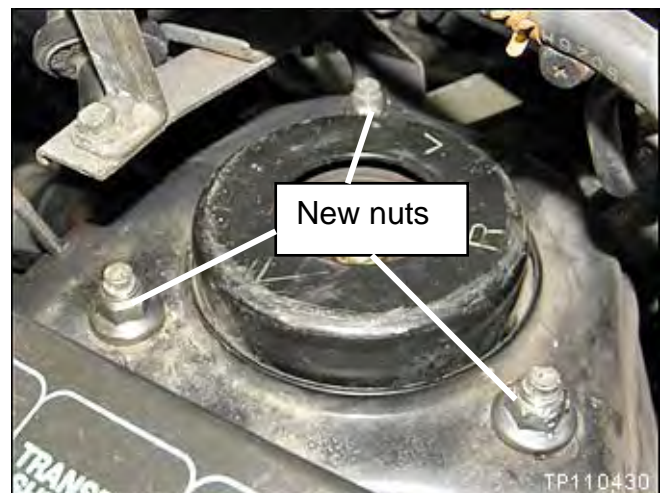
Figure RB35

44. Reinstall the strut in reverse order of removal.

- Use **new** nuts for the upper strut mount (P/N 01225 – 00231).
- Nut torque is:  
39-54 N•m (4.0 - 5.5 kg-m, **(29-40 ft-lb)**)

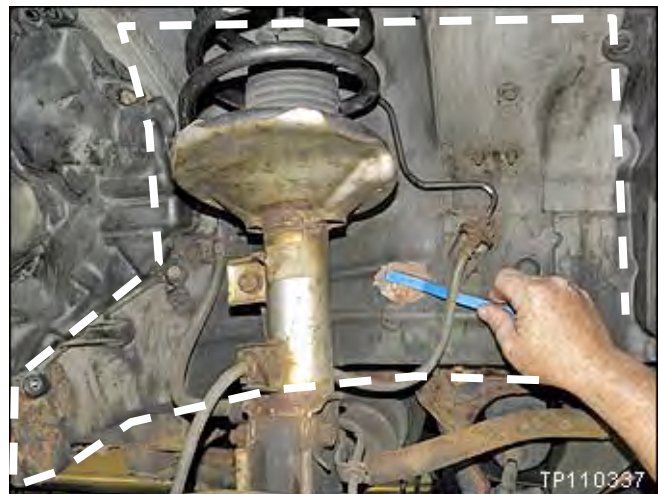
Figure PS1

1. Use a wire brush to remove loose rust in the area shown with dashed line.

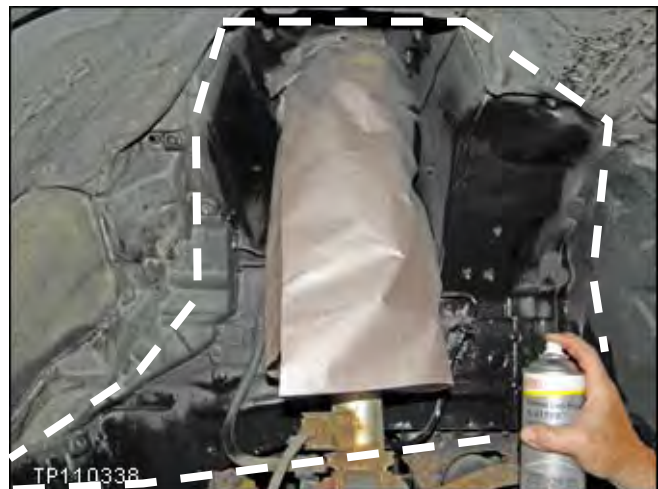
Figure PS2

4. Completely and liberally coat the strut housing and wheel house area with self etching primer.

- Use Dupont Etch Primer (P/N A-4119S™) or equivalent.
- Follow all product instructions.
- Coat all of the exposed metal areas on the strut housing and wheel house panels.

- A second coat may be needed for heavy rust spots.
- Let each coat dry for 5 minutes.

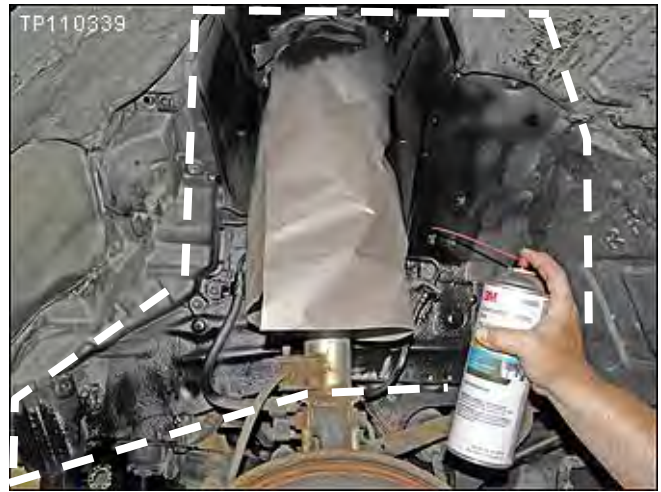
Figure PS3

5. Completely and liberally coat the wheel house, and strut housing area with rubberized undercoat.
  - Use 3M Rubberized Undercoating (P/N 051135 – 08883) or equivalent.
  - Follow all product instructions.
  - Coat all of the exposed metal areas on the strut housing and wheel house panels.
  - Use a spray nozzle to spray the areas behind the strut and other hard to reach areas.

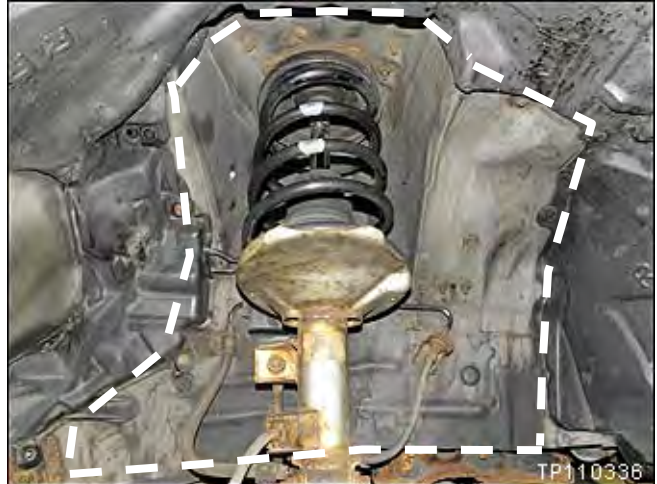
Figure PS4

- This repair is used **only** if there is metal perforation on the passenger side in the area show in Figure PS4.
- If there is no perforation, go to Level 1 repair on page 38.
- Plastic covers (fender protectors) in the wheel house area do not need to be removed.
- For 4WD vehicles: If the drive shaft boot is ripped, it should be covered to prevent debris from entering the drive shaft joint.

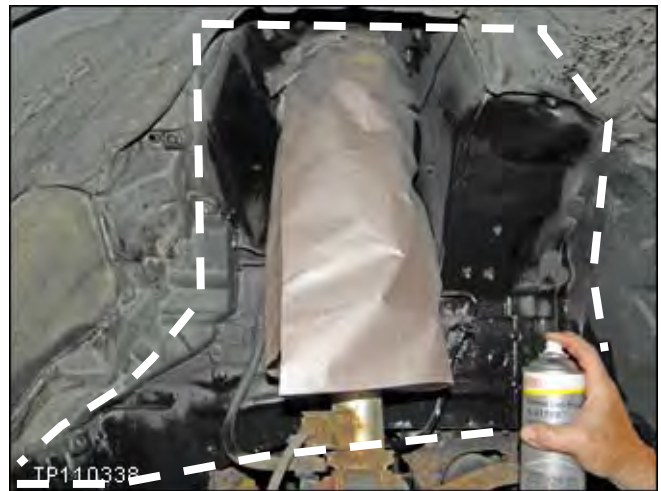
Figure PS5

4. Completely and liberally coat the strut housing and wheel house area with self etching primer (see Figure PS5).
  - Use Dupont Etch Primer (P/N A-4119S™) or equivalent.
  - Follow all product instructions.
  - Coat all of the exposed metal areas on the strut housing and wheel house panels.
  - A second coat may be needed for heavy rust spots.
  - Let each coat dry for 5 minutes.

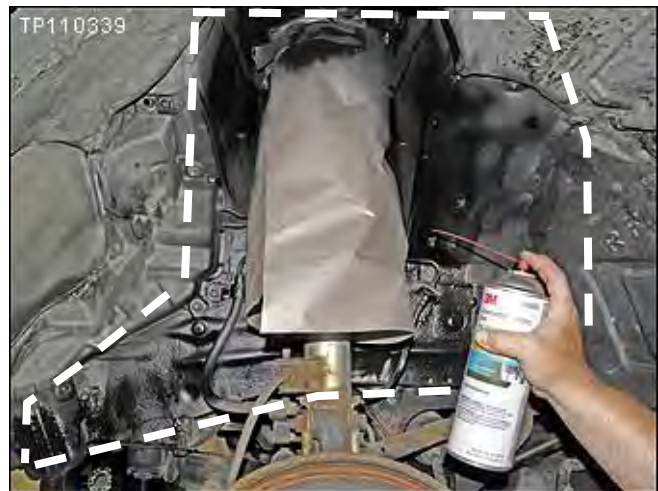
Figure PS6

**NOTE:**

- If the strut has not been removed, cover the strut so it is protected from overspray.
- Use a spray nozzle to spray the areas behind the strut and other hard to reach areas.

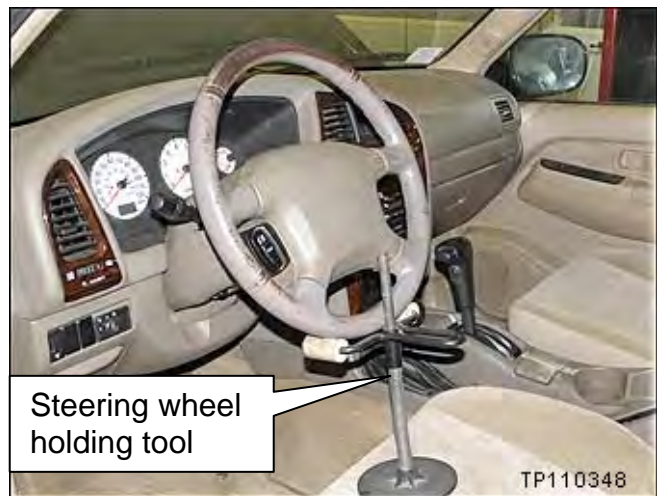
Figure SS4

5. Set the steering wheel in the straight ahead position.
6. Position a steering wheel holding tool as shown.
  - This will keep the steering wheel stationary while replacing the steering shaft.

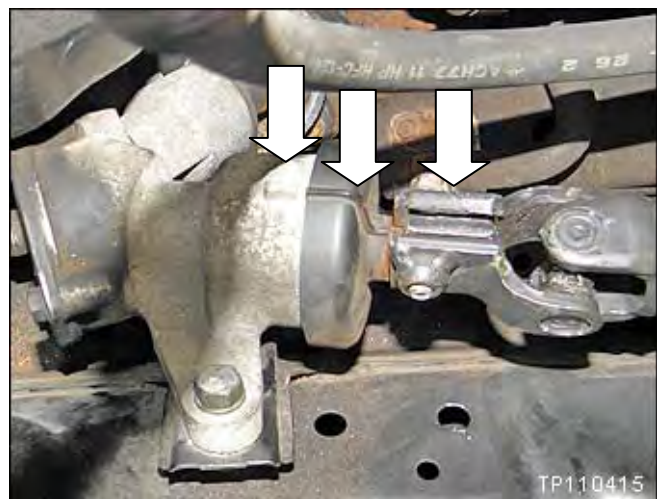
**NOTE:** The marks shown in Figure SS5 should be aligned.

- Tab on transfer gear assembly
- Raised area on rubber cover
- Gap on steering shaft clamp

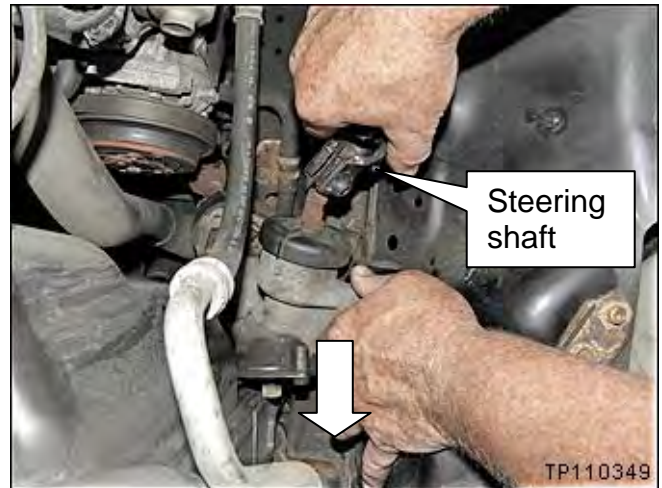
Figure SS7

8. Push the transfer gear assembly forward and remove the steering shaft.

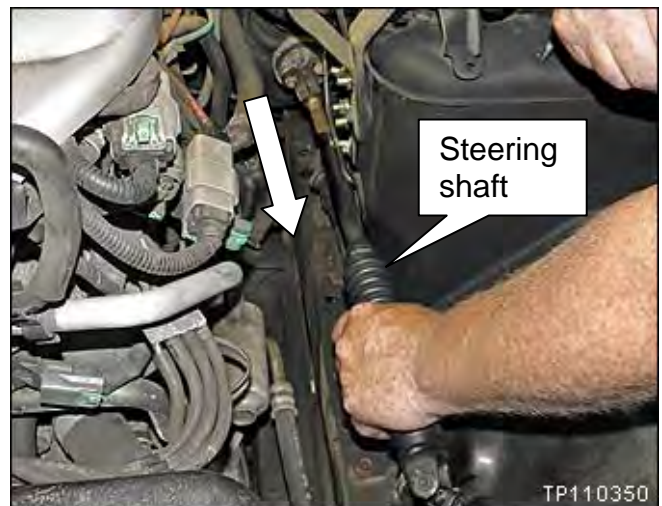
Figure SS8

9. Pull the steering shaft to remove it from the other end.

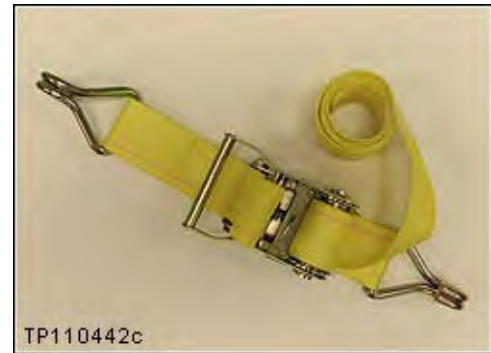
### Ratchet Strap (J-50836)

- Each dealer will be shipped, at no charge, one Ratchet Strap.
- Additional tools can be ordered from TechMate at 1-800-662-2001.

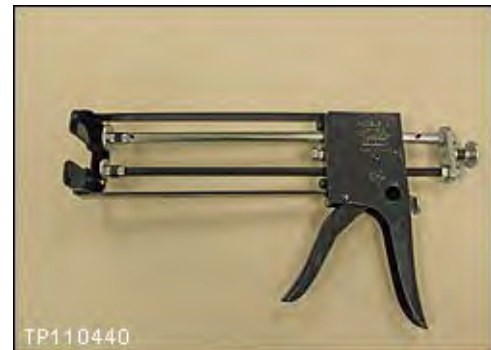
### 2:1 Dispensing Gun (J-50816)

- This tool is used to dispense LORD Fusor® 108B (structural adhesive).
- Each dealer will be shipped, at no charge, one 2:1 Dispensing Gun.
- Additional tools can be ordered from TechMate at 1-800-662-2001.

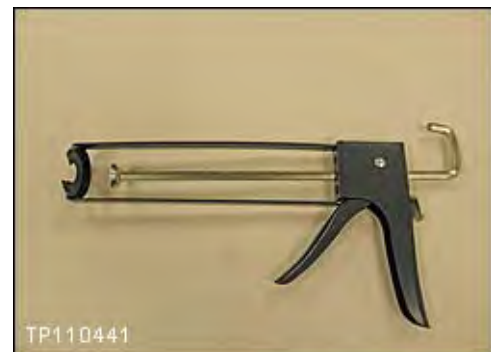
### 1:1 Dispensing Gun (Caulking Gun)

- This tool is used to dispense LORD Fusor® 800EZ (seam sealer).
- Caulking guns are commonly used for application of other automotive products. Each dealer should already have a caulking gun as a shop tool.
