Bulletin No.: 10134B

Service Bulletin

SUBJECT: Special Coverage Adjustment – Catalytic Converter Warranty Extension

MODELS: 2006-2007 Chevrolet Malibu

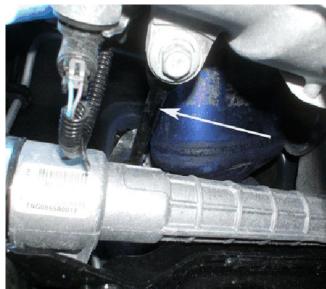
2543105

Note: When replacing the exhaust manifold/converter on 2006-2007 vehicles only, it is also necessary to install support brace, GM P/N 12617642.

Install the new brace on 2006-2007 model year vehicles, GM P/N 12617642, using a bolt, GM P/N11570734, to attach the brace to the exhaust manifold/converter. Tighten the bolt to 58 Nm (43 lb ft).

Use bolt, GM P/N 11518623, to attach other end of brace to the transmission. Tighten the bolt to 53 Nm (39 lb ft).

Caution: A new catalytic converter bracket (brace) MUST be installed on all 2006-2007 model year vehicles, even if the vehicle was not originally equipped with the brace. On 2008 model year vehicles, the original brace must be reinstalled.
