SB-10041985-4056

Title: Exhaust Bellows Damage

Applies To: DuraStar, WorkStar, PayStar, TranStar, ProStar models when equipped with bellows exhaust pipe.

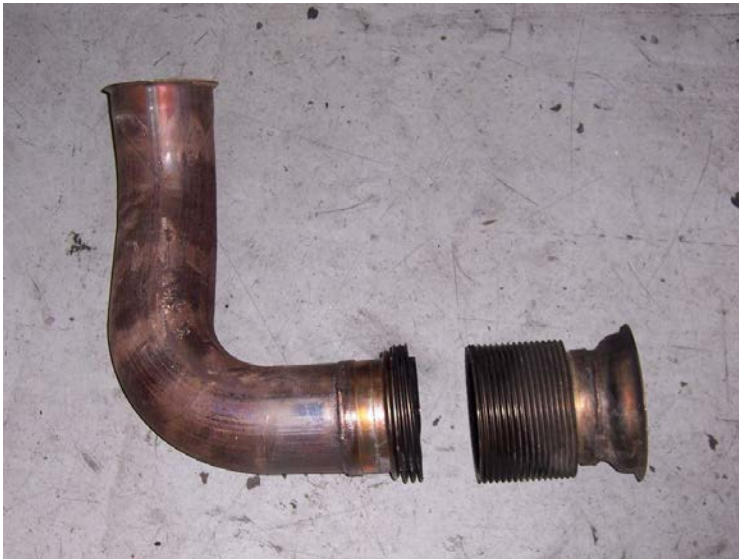
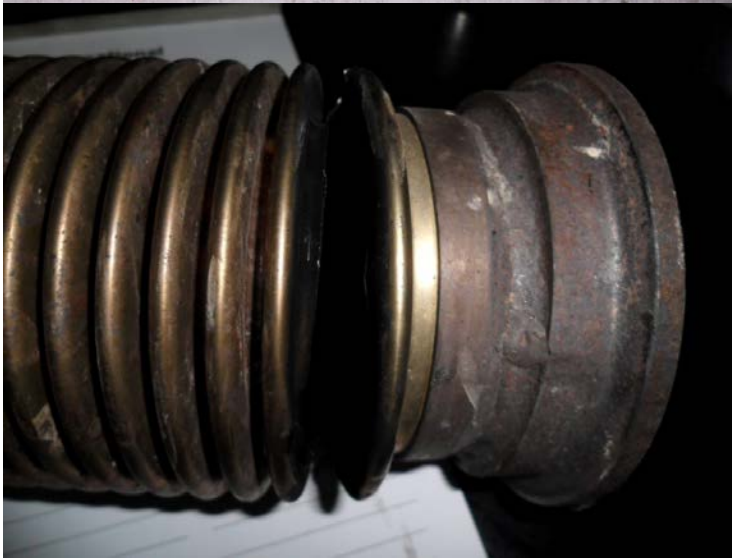
Exhaust bellows damage may occur anytime the bellows is bent out of form. Bending of bellows portion of the pipe can stress the bellows and cause premature cracking in the bellows core. Bending can be caused by improper installation or removing one end of the pipe and forcing the pipe out of position during diagnostic procedures.

- Broken or cracked bellows, Exhaust leak, Exhaust noise

1. Replace any damaged pipe taking care not to bend the bellows out of form during installation.
2. Do not bend the bellows out of form to run the engine while performing diagnostics . If necessary to run the engine with the exhaust pipe disconnected from the aftertreatment assembly remove the clamps from both ends and locate the pipe away from the area.
