# SB-10043310-1492

Bulletin No.: PI0631H

- Subject: Malfunction Indicator Lamp (MIL) On, Various DTCs Set, IPC Inoperative, Display and/ or BCM Fuse Blown
- Models: 2012-2013 Chevrolet Impala Built Prior to VIN Breakpoint D1207466

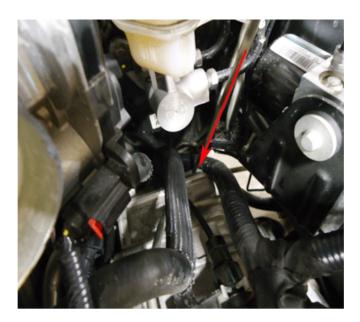
Note: The above pictures are viewed from the top of the engine compartment for reference only.
