Recall Bulletin

PRODUCT EMISSION RECALL

SUBJECT: Degraded Connection between Ignition Coil Spark Plug Boots and Spark Plugs

MODELS: 2009-2011 Chevrolet Aveo
2009-2010 Pontiac G3/Wave
Equipped with a 1.6L Gas Engine (LXV)

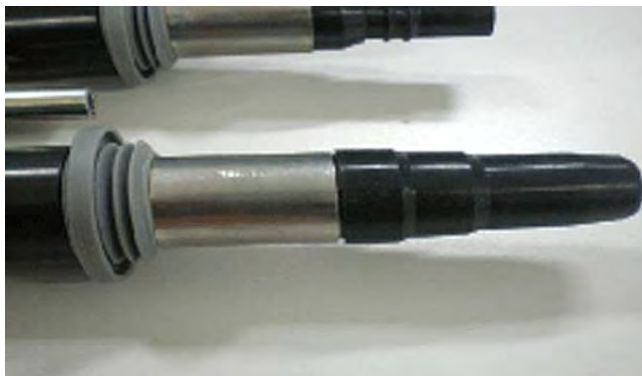
2733897

1. Remove the ignition coil assembly. Refer to *Ignition Coil Replacement* in SI.
2. Remove the spark plugs. Refer to *Spark Plug Replacement* in SI.
3. Install the four new spark plugs included in the spark plug kit.

Tighten the spark plug to 25~30 N·m (18.4 ~ 22.1 lb-ft).

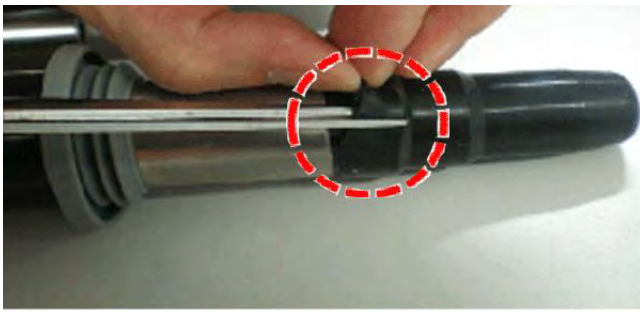
2733899

4. Place the removed ignition coil on table.

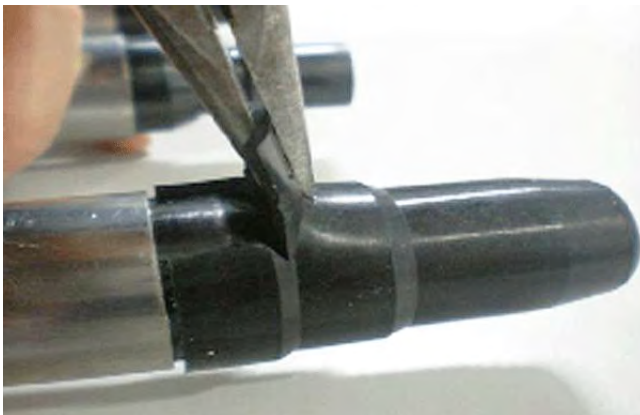
2733901

5. Using a scissors, cut bottom of boot as shown in the illustration.

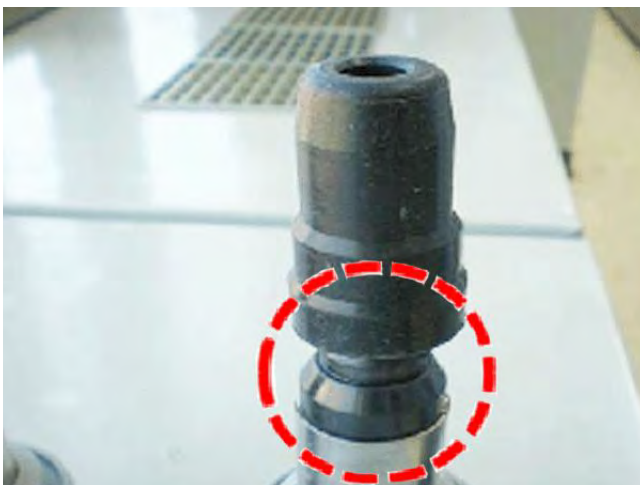
2733902

6. Remove the boot using long-nose pliers as shown in the illustration.

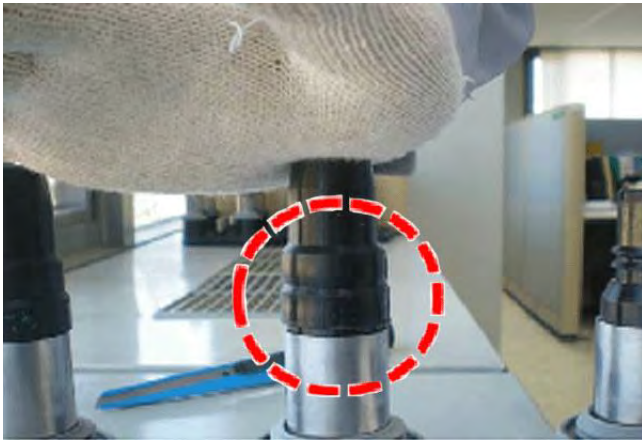
2733903

7. Insert new boot onto the ignition coil tower partially.

8. Insert the new boot onto the ignition coil tower fully.

Note: Be careful of boot damage during installation because boot damage can cause a weakened dielectric strength.
