Recall Bulletin

PRODUCT EMISSION RECALL

SUBJECT: Degraded Connection between Ignition Coil Spark Plug Boots and Spark Plugs

MODELS: 2009-2011 Chevrolet Aveo
2009-2010 Pontiac G3/Wave
Equipped with a 1.6L Gas Engine (LXV)

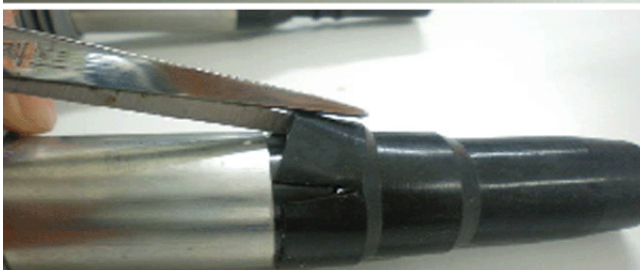
2733899

4. Place the removed ignition coil on table.

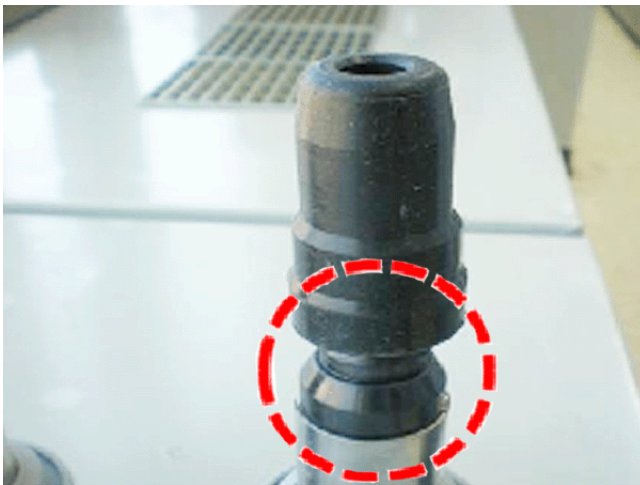
2733902

6. Remove the boot using long-nose pliers as shown in the illustration.
