T-SB-0069-12

# SRS Airbag Light "ON" - B0111/B0116 Open Side Squib Circuit

YEAR(S)	MODEL(S)	ADDITIONAL INFORMATION
2005 – 2009	Sienna

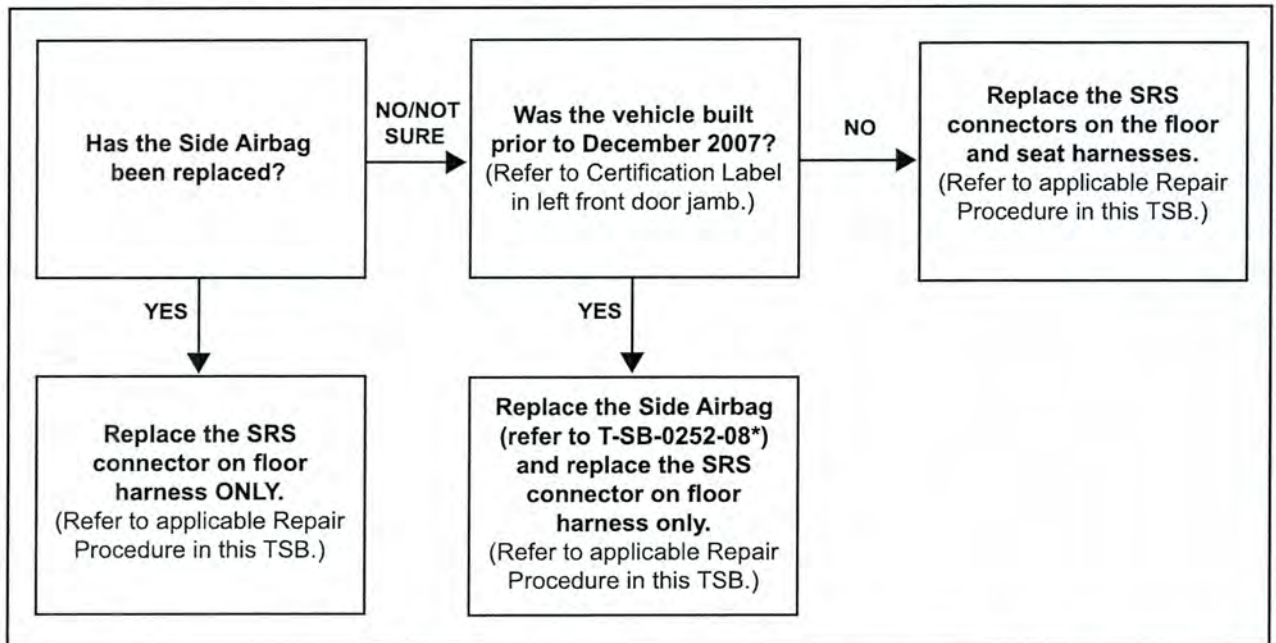
To determine if side airbag replacement is needed, refer to the chart below.

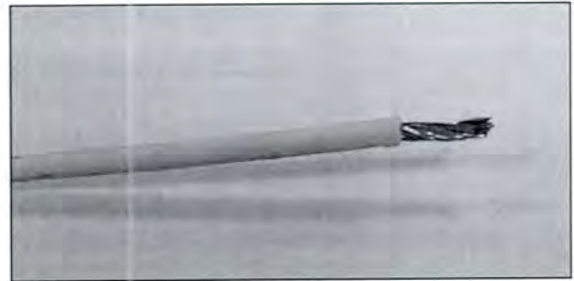
Figure 5.

4. Remove 8 mm (0.32 in.) of insulation from the ends of the 2 floor harness wires.
