PREVOST

WARRANTY BULLETIN

WB13-04

DATE :	FEBRUARY 2013	SECTION :	22 - HVAC
EXPIRATION:	FEBRUARY 2015		
SUBJECT :	LOW A/C PRESSURE MESSAGE - BYPASS ADDITION, SMALL AC SYSTEMS ON H3 VIP

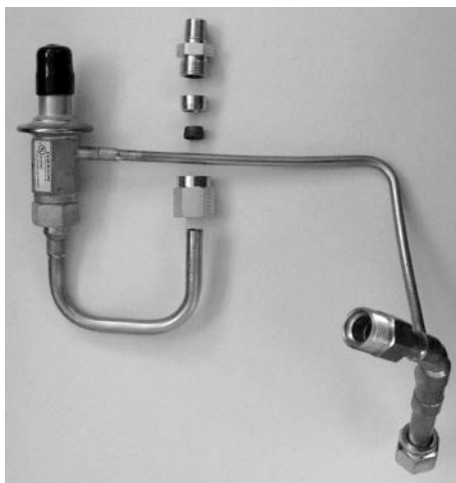
Installing the bypass tube assembly.
