SERVICE CAMPAIGN BULLETIN

NTB13-025

VOLUNTARY SERVICE CAMPAIGN 2011 QUEST TOW HITCH INSPECTION

CAMPAIGN I.D.: PC196

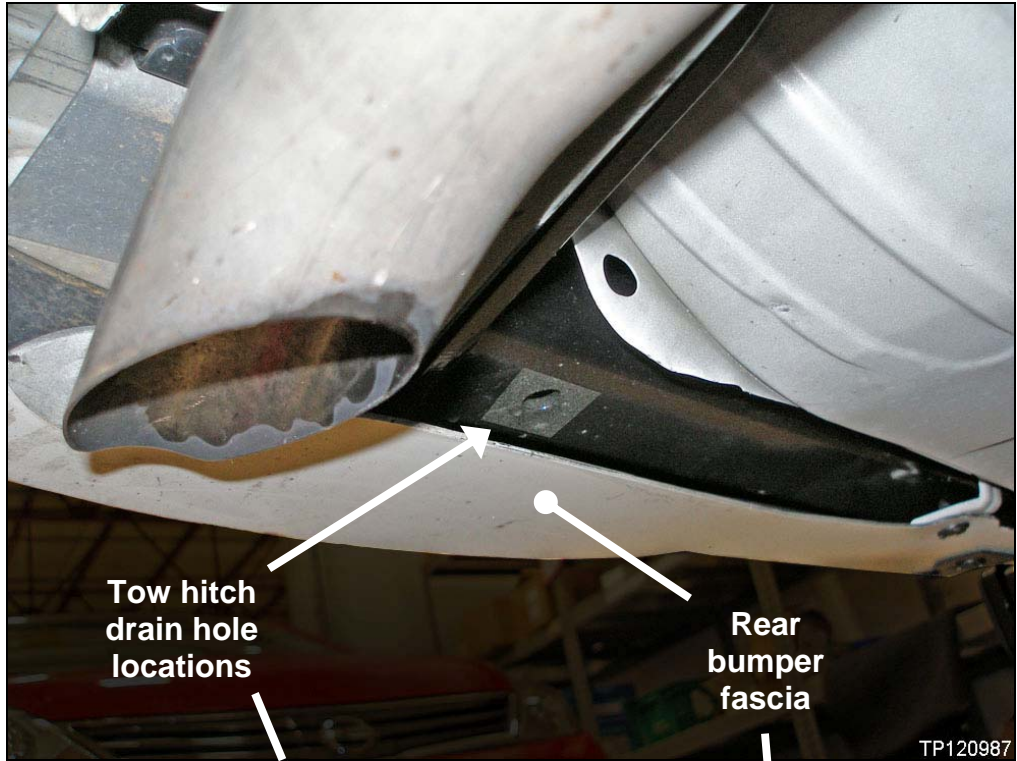
Passenger side

- The tow hitch does not have drain holes where shown on the next page.
 - If both apply, a part order approval is needed.
 - For part order approval, send the VIN, your dealer code and “facing” PDC, and clear pictures of the genuine Nissan accessory tow hitch without holes to nafgasupport@nissan-usa.com. You will get a return confirmation of approval to order the replacement tow hitch.

WARNING: Be careful if inspecting from the passenger side. The exhaust tail pipe may be hot.

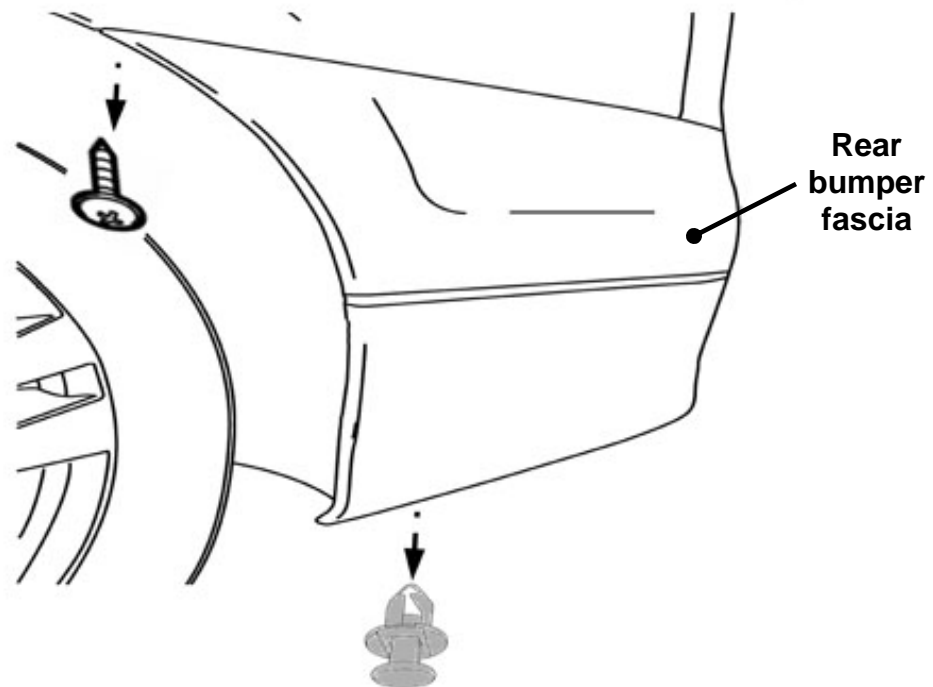
Figure 1

1. Remove the two (2) rear bumper fascia fasteners on each side.

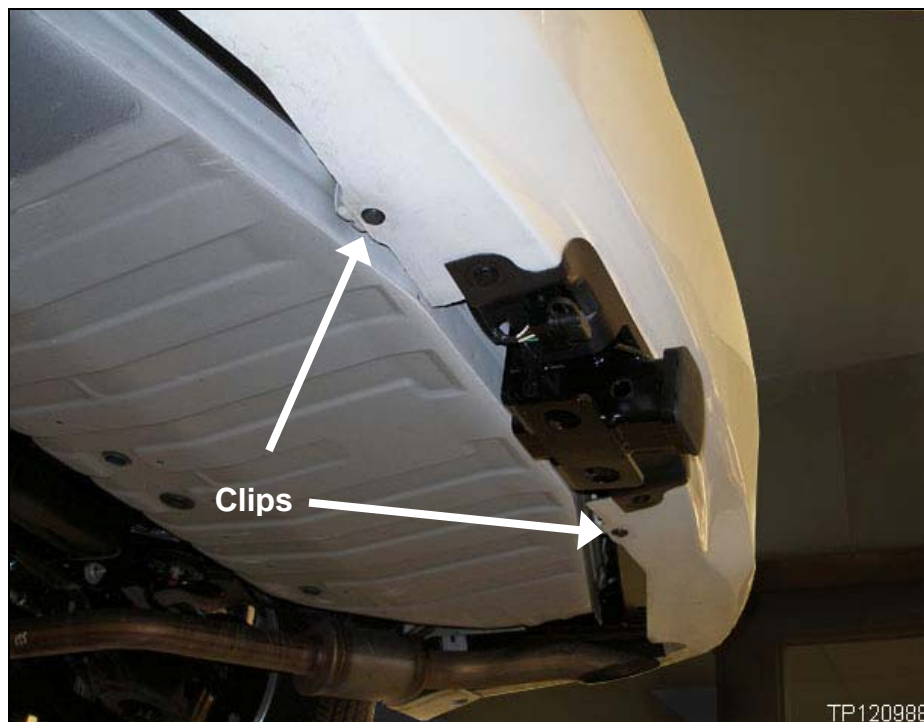
Figure 2

2. Remove the two (2) clips shown in Figure 2.

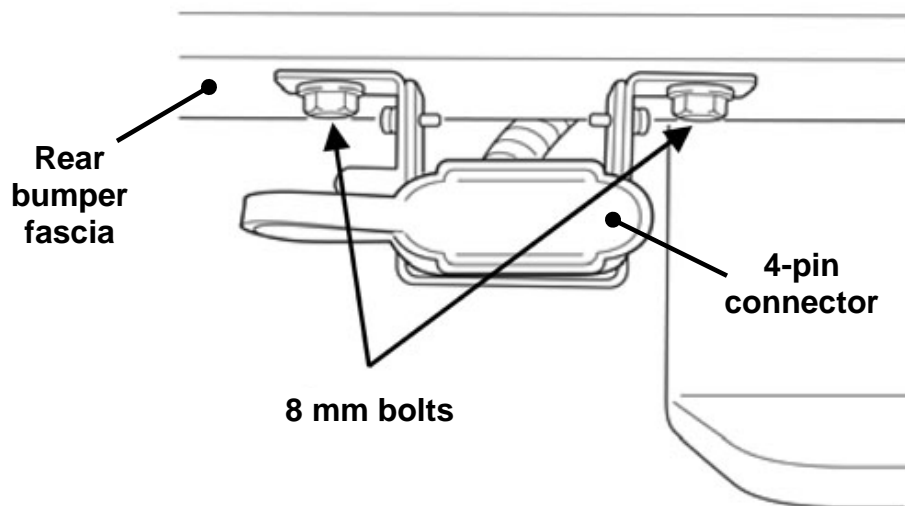
Figure 3

4. Remove the 4-pin connector.

4-pin connector bolts torque: 3.9 N•m (0.39 kg-m, **35 in lbs**)

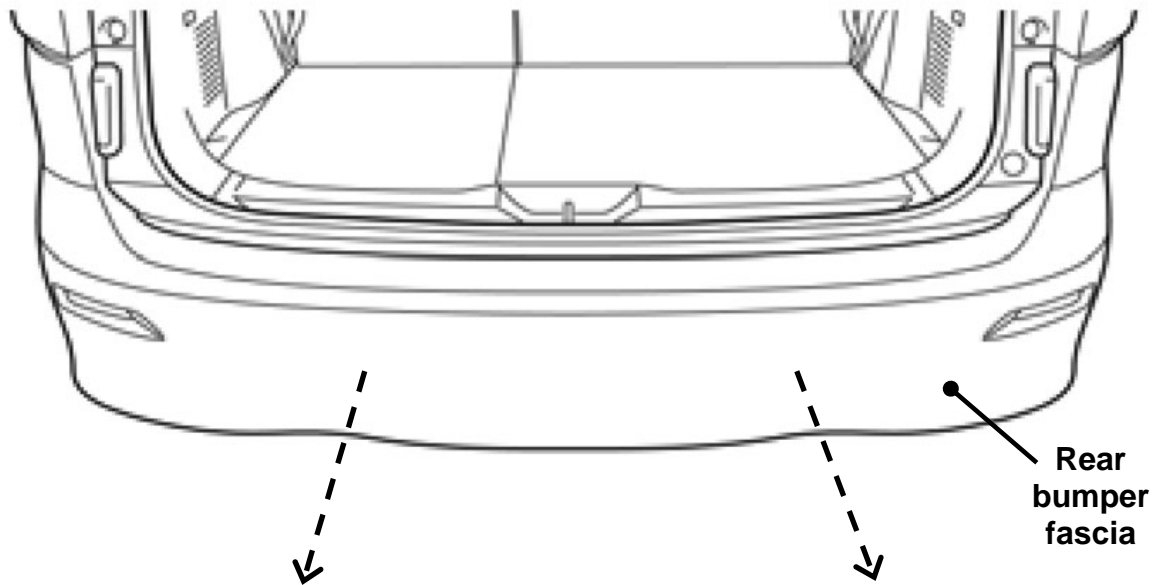
Figure 5

5. Carefully remove the rear bumper fascia.

NOTE: This is a two-person job.

CAUTION: Store the rear bumper fascia in a place where it will stay clean and undamaged.

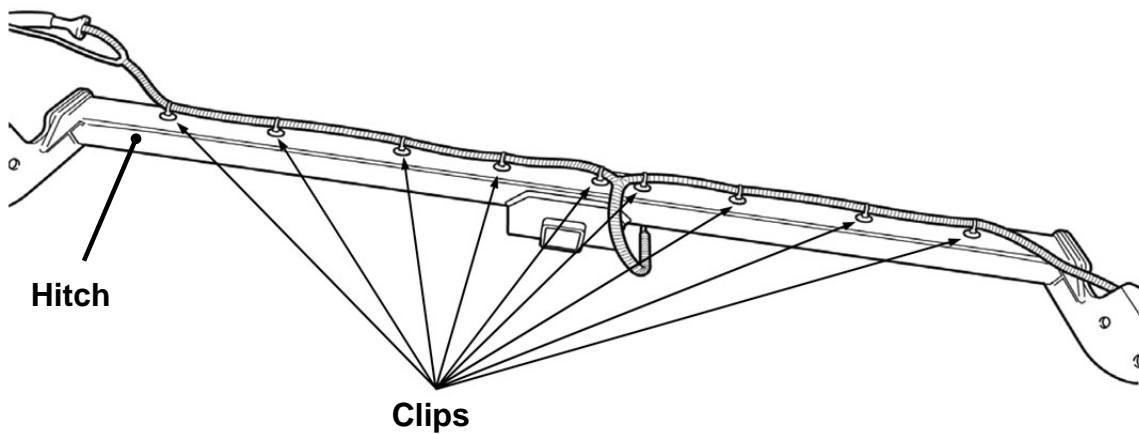
Figure 6

3. Unfasten all nine (9) harness clips from the hitch.

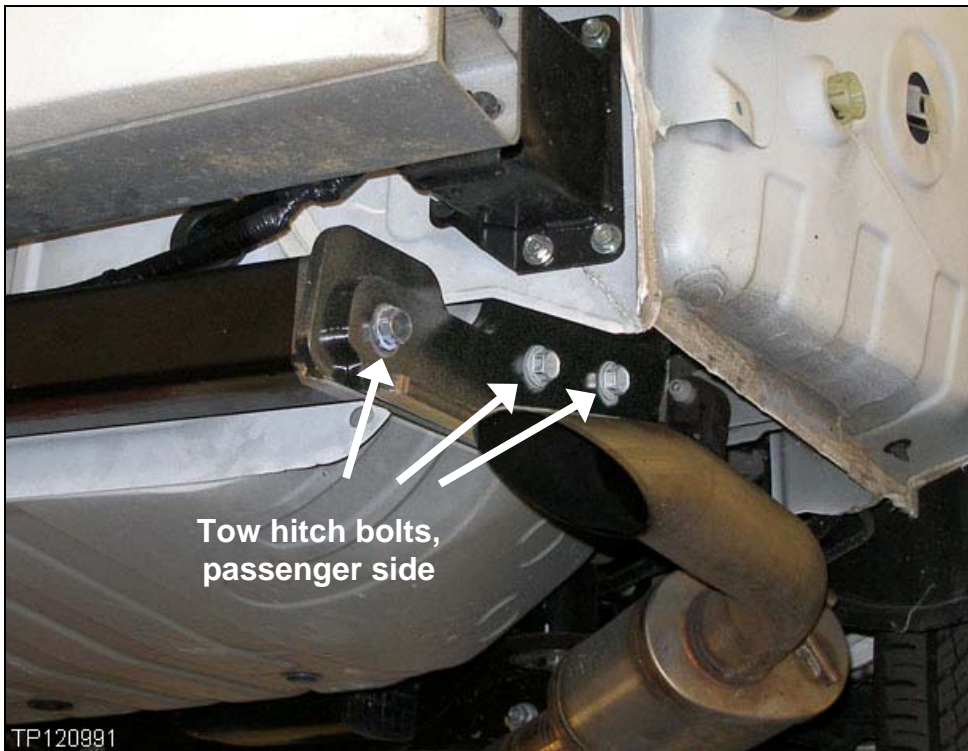
Figure 8

6. Unbolt the three (3) bolts on each side, and then remove the tow hitch.

NOTE: This is a two-person job.

7. Install the new tow hitch in reverse order of removal.

Tow hitch bolts torque: 110-150 N•m (11.2-15.3 kg-m, **73-96 ft lbs**)
