SERVICE CAMPAIGN BULLETIN

NTB12-011c

VOLUNTARY SERVICE CAMPAIGN 2007-2012 ALTIMA SEDAN & COUPE BRAKE MASTER CYLINDER

CAMPAIGN ID #: PC125

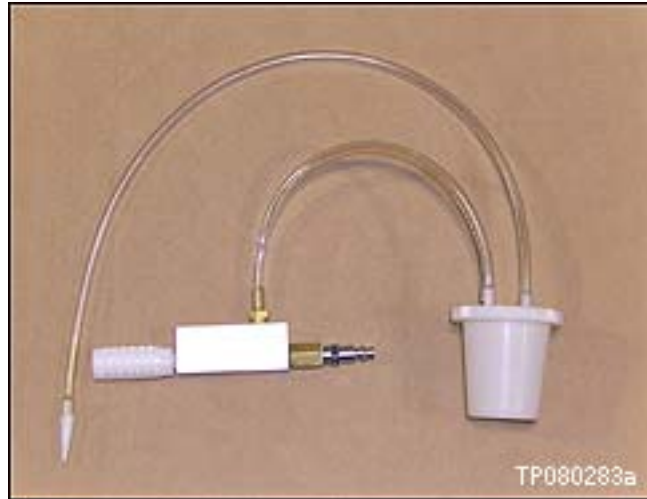
Figure A

REQUIRED SPECIAL TOOL J-49749

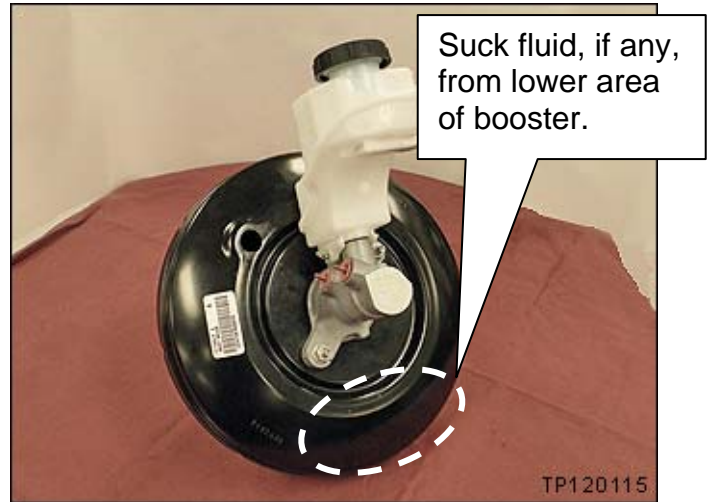
Figure 4

6. Move/position the suction tube inside the brake booster so that any fluid in the lower area of the brake booster is sucked into the collection container.

NOTE: If there is fluid in the lower area of the booster:

- Keep the collection container upright.
- If the collection container fills to within ½ inch of the top, empty it and then continue.
- Continue suction until all of the fluid is removed.

7. After you have removed any / all fluid from the brake booster, disconnect the tool and check the collection container.

NG - Any amount of fluid in the container:

- Replace the Brake Master Cylinder – Instructions starting on the next page.
- Check and fill (top-off) under hood fluids (e.g. washer fluid, coolant, brake fluid).
- Review results of the Multi-Point Inspection with the customer.
