Service Bulletin

Bulletin No.: PI0703B

Subject: Service Rear Axle Message Displayed on Driver Information Center (DIC), DTC C0407 with Symptom Code 64 or C0403 Symptom Code 62 Set

Models: 2010-2012 Buick LaCrosse
2010-2012 Cadillac SRX
Equipped with All-Wheel Drive (AWD)

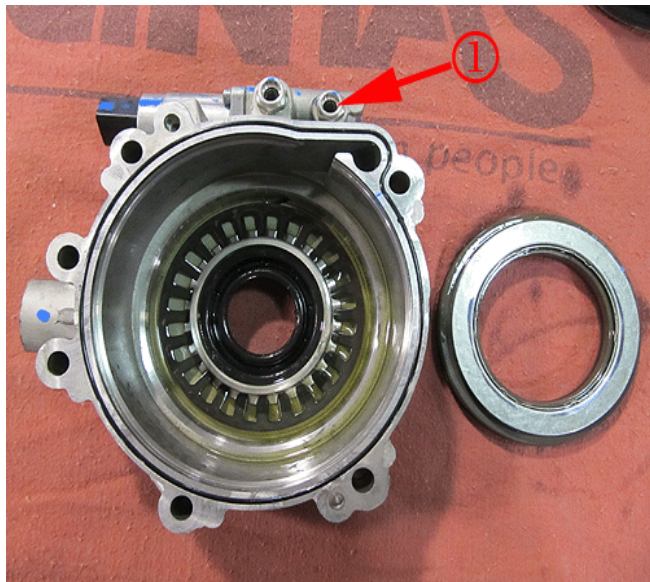
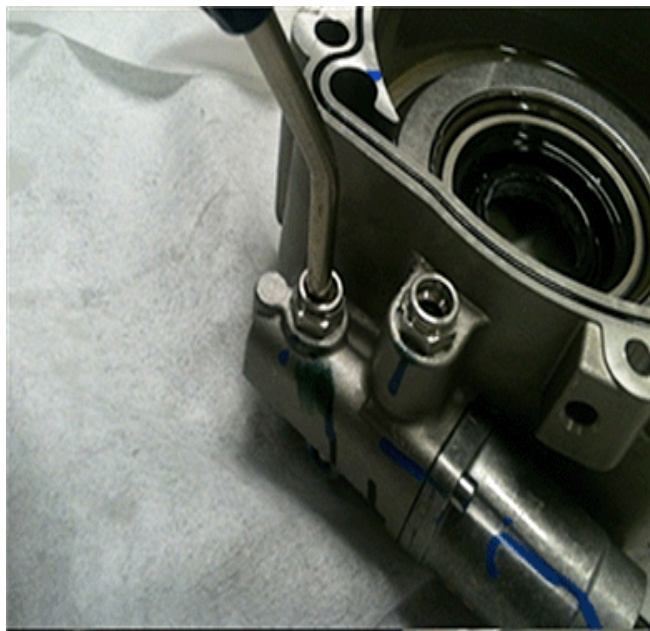
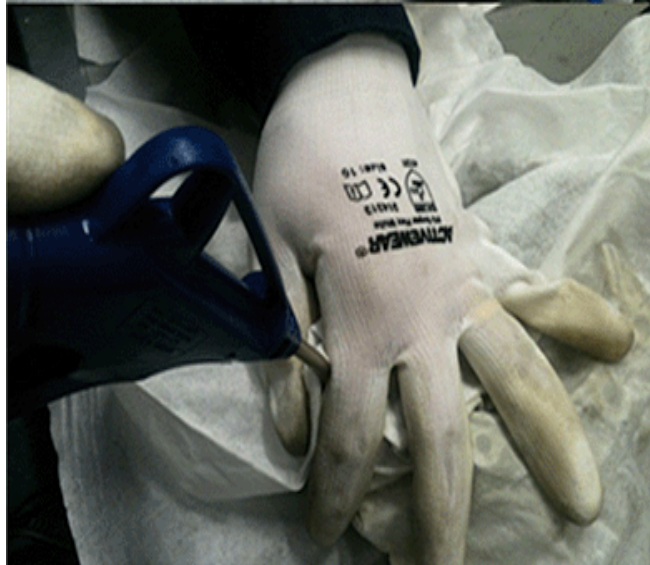
2806109

11. Apply compressed air to the low pressure pipe connector port to release the piston from the differential clutch housing.
12. Remove the eLSD clutch piston from the housing.

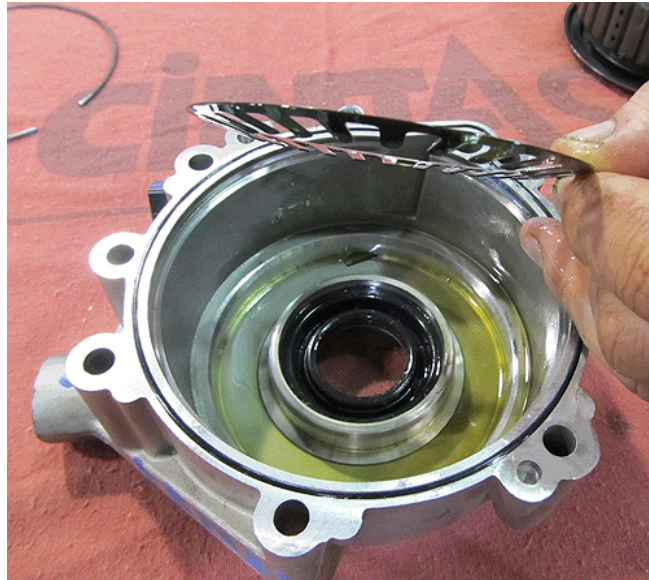
2789546

Note: If the piston spring is removed, ensure proper orientation when reinstalling. Spring fingers must be positioned as shown above.

13. Install the new eLSD clutch piston into the housing. Push down to seat.
14. Reinstall the differential clutch pack into the housing.
15. Reinstall the retaining ring that secures the differential clutch pack to the clutch housing.
16. Remove the low and high pressure pipe connectors from the limited slip differential clutch. Discard the connectors and pipe spring clips.
17. Install the NEW low and high pressure pipe connectors and spring clips to the limited slip differential clutch.

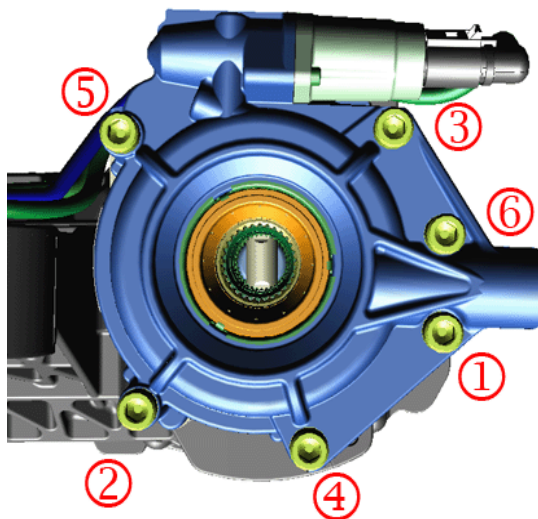
2806114

19. Reinstall the limited slip differential clutch bolts (Qty: 6).

Tighten the bolts in proper sequence to 30 N•m (22 lb ft).

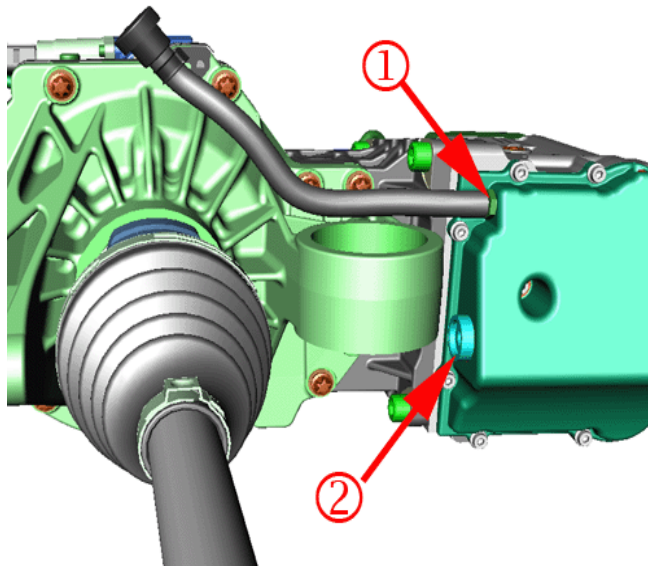
2806115

22. Remove the TTD clutch cover fill plug (2) and add 140 ml (0.15 qts) of eLSD clutch fluid. Install the fill plug and tighten to 14 N•m (10 lb ft).
Note: 140 ml (0.15 qts) if only the piston was replaced and 300 ml (0.32 qts) if the piston and filter were replaced. May be easier to get the required fluid into the unit if the assembly is tilted up on the pinion nose.

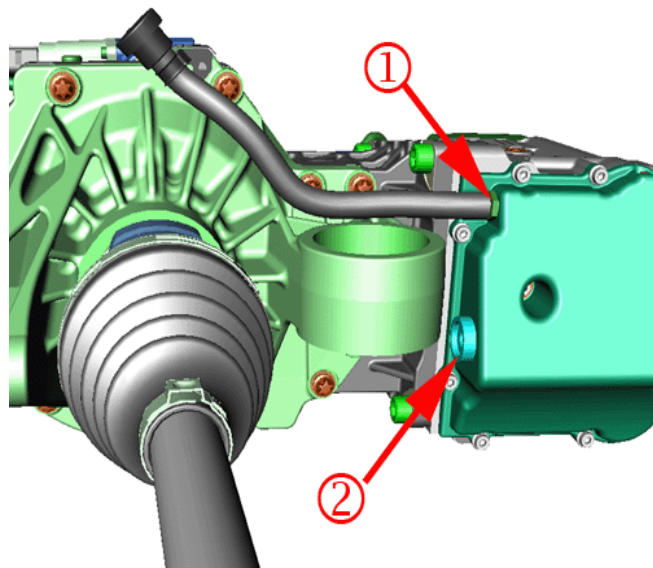
2806115

The TTD clutch is properly filled when the fluid level is level with the bottom of the TTD clutch cover plug and the pump cavity (4) is full. The pump cavity is full when the pump motor current is between 2.5-3.5A while the engine is running and the pump motor is running. The current cycles from 0 to 2.5-3.5A as the pump turns off/on. Both conditions MUST be met. If the pump motor current is consistently below 2.5A, then the pump motor cavity (4) is low on fluid.

Important: When filling the eLSD clutch housing after repairs, the fluid must be able to flow over the top of the internal wall of the pump cavity (3 and 4), making it imperative that the fluid is filled through the vent opening (1) with the cover plug (2) installed. The bottom of the cover plug opening (2) and the internal wall (3) are at the same level. If the cover plug (2) is not installed, the fluid will fill the eLSD clutch oil sump (5) and run out of that opening (2) before it can flow over the wall (3) into the pump cavity (4).

3. Remove the vent hose (1) from the fitting.
4. Attach the fill hose to the vent fitting and fill the TTD clutch through the vent opening on the cover. Ensure that the fill plug (2) is installed prior to adding fluid through the vent fitting.
