Subject: Isringhausen Seat Slide Stops

Models Affected: Specific Freightliner Cascadia vehicles manufactured April 1, 2012, through September 3, 2012.

Daimler Trucks North America LLC, on behalf of its Freightliner Trucks Division, is initiating Field Service Campaign SF477AB to modify the vehicles mentioned above.

February 2013
SF477AB

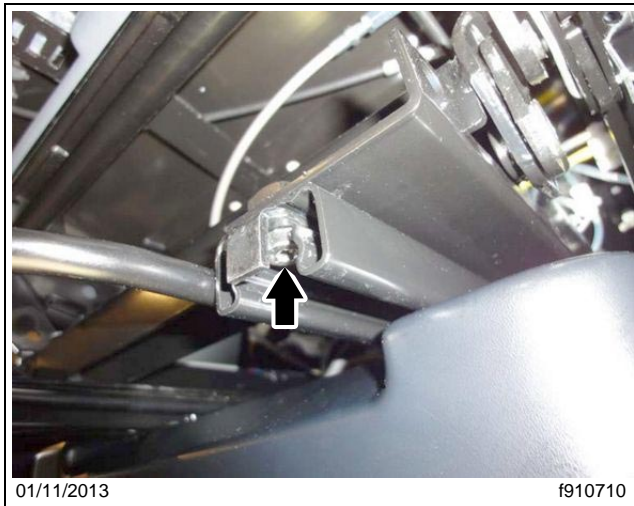
Fig. 1, Stop Bracket Mounting Screw

1. Check the base label (Form WAR259) for a completion sticker for SF477 (WAR261) indicating this work has been completed. The base label is usually located on the passenger-side door about 12 inches (30 cm) below the door latch. If a completion sticker is present, no work is needed. If a completion sticker is not present, continue with the next step.
2. Shut down the engine, set the parking brake, and chock the tires.
3. Adjust the seat all the way forward.
4. Remove the stop-bracket mounting screw and stop bracket from the forward end of the slide rail (both slide rails, if both are equipped with stop brackets). See **Fig. 1**.
5. Adjust the seat all the way back.
6. Remove the stop screws. See **Fig. 2**.
7. Install new stop screws (long head) from the kit. See **Fig. 3**. Tighten the screws 16 lbf·ft (22 N·m).
8. Adjust the seat all the way forward.
