## Vehicle Owner Notification

**To:** All Dealers  
**From:** Tracy Daniels  
Warranty Department  
**Subject:** VON # 80- Heater/Defroster 1 Fuse Replacement  
**Date:** January 31, 2013

## VEHICLE OWNER NOTIFICATION #80

**SUBJECT:** HEATER / DEFROSTER FUSE REPLACEMENT

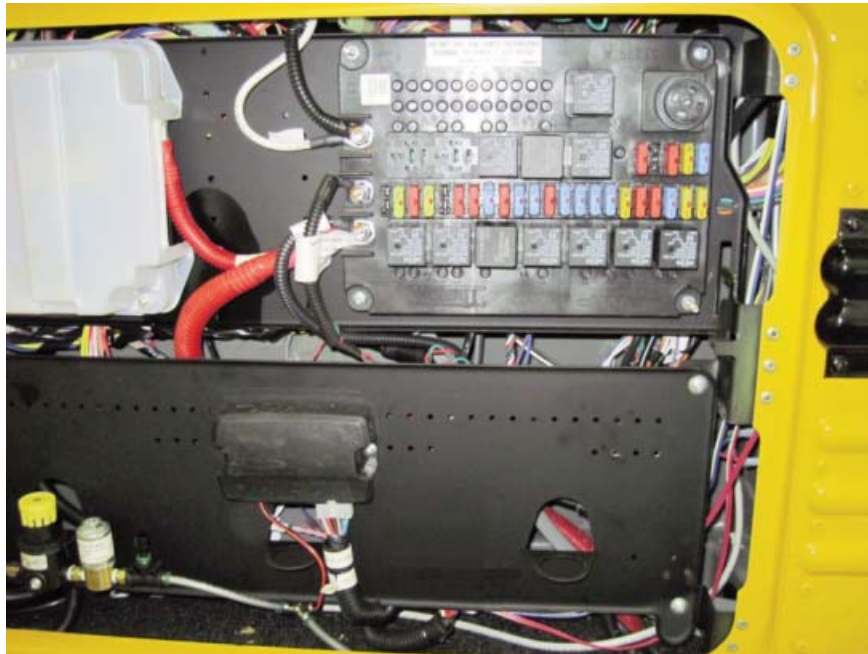
**FIGURE 1**

1. Turn the ignition key to the "Off" position. Chock the tires and disconnect the batteries.
2. Open the exterior electrical panel access door below the driver's window.
3. Remove the PC Board #1 cover, if present. **Figure 1**

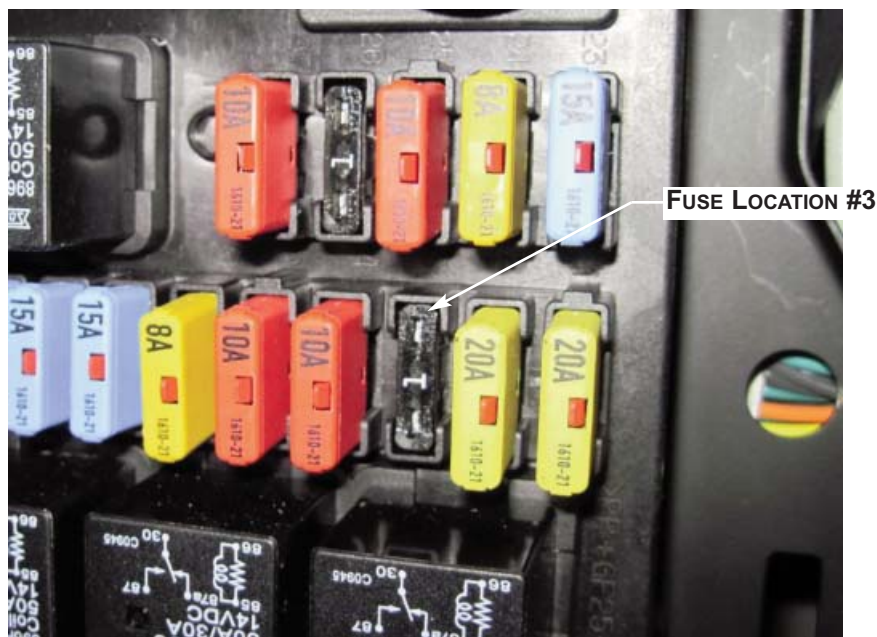
**FIGURE 2**

4. Locate the fuse or circuit breaker in locations #3 on PC Board #1 and replace it with a 1 amp fuse - TBB 151450. **Figure 2**

5. Reinstall the PC Board cover, if present, and close the exterior electrical panel access door.
6. Connect the batteries and remove the tire chocks.
