## **Vehicle Owner Notification**

**Subject:** VON #82 – Heater/Defroster 2 Fuse Replacement

## VEHICLE OWNER NOTIFICATION #82

**SUBJECT:** HEATER / DEFROSTER FUSE REPLACEMENT

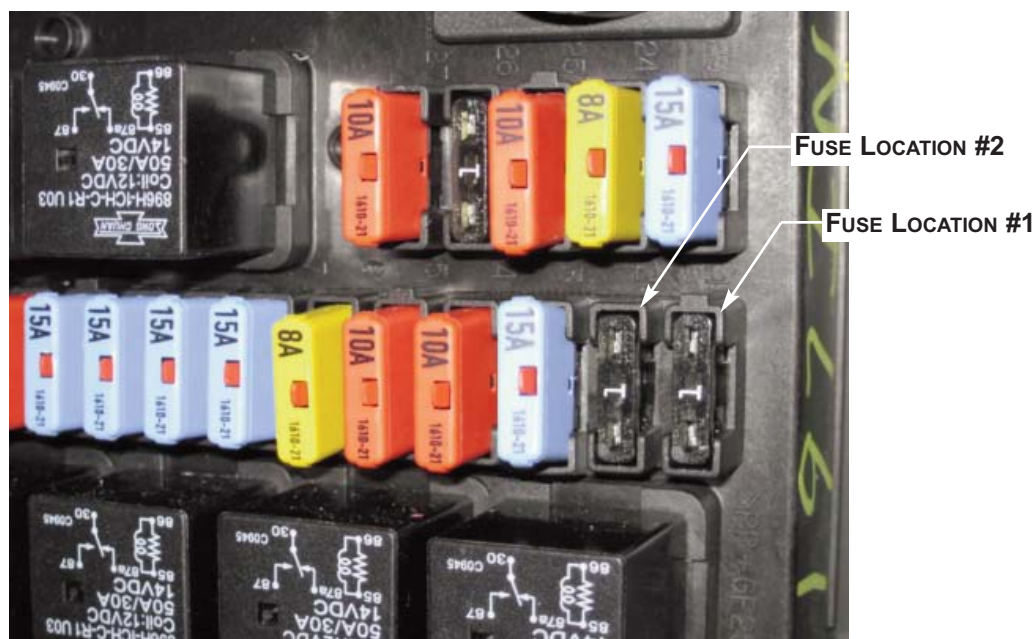
4. Locate the fuse or circuit breaker in locations #1 and 2 on PC Board #1 and replace it with a 1 amp fuse - TBB 151450. **FIGURE 2**

Enclosed is a copy of the customer notification letter being prepared for your customers who have purchased certain Saf-T-Liner MVP-EF units manufactured from October 6, 2003 through May 5, 2008. It has been determined that the fuse for the heater/defroster is the incorrect size. The correct fuse is a 1 AMP.

The procedure is to replace the existing fuse with a one amp fuse. The time allowed is .1 hour per fuse for repair. The PFP is 151450, SRT code is 174-6534A. Thomas will ship the necessary fuse(s) free of charge direct to each customer along with their notification listing each VIN involved.
