## Vehicle Owner Notification

**Subject:** VON # 81- Heater/Defroster 3 Fuse Replacement

## VEHICLE OWNER NOTIFICATION #81

**SUBJECT:** HEATER / DEFROSTER FUSE REPLACEMENT

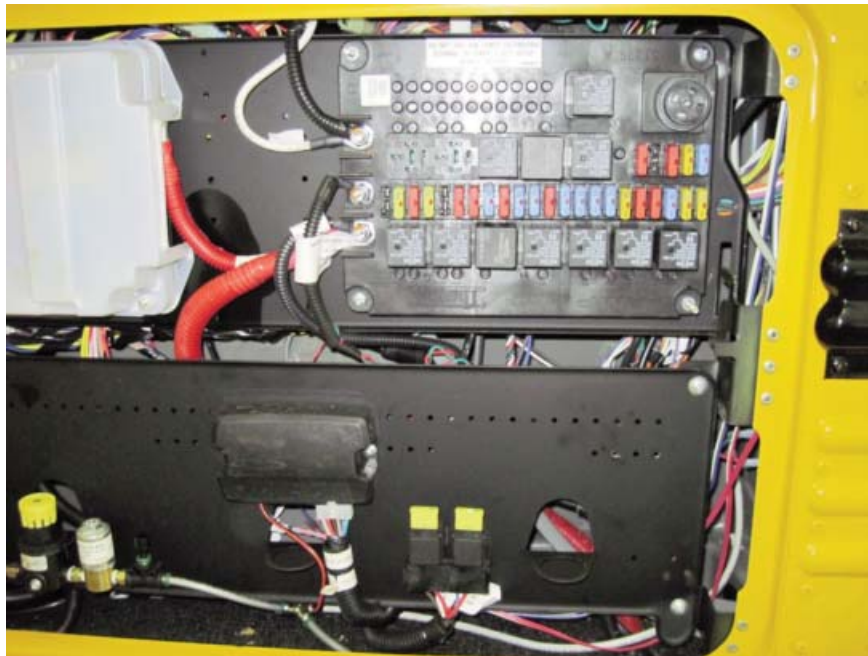
**FIGURE 1**

1. Turn the ignition key to the "Off" position. Chock the tires and disconnect the batteries.
2. Open the exterior electrical panel access door below the driver's window.
3. Remove the PC Board #1 cover, if present. **Figure 1**

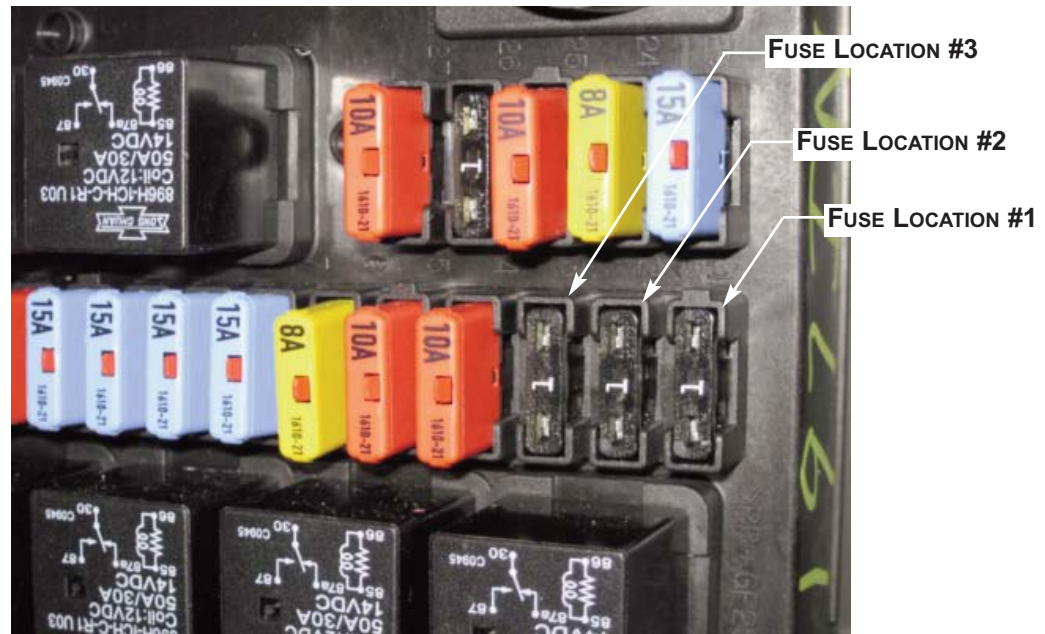
4. Locate the fuse or circuit breaker in locations #1, 2 and 3 on PC Board #1 and replace it with a 1 amp fuse - TBB 151450. **FIGURE 2**

Enclosed is a copy of the customer notification letter being prepared for your customers who have purchased certain Saf-T-Liner HDX units manufactured from October 6, 2003 through May 5, 2008. It has been determined that the fuse for the heater/defroster is the incorrect size. The correct fuse is a 1 AMP.

The procedure is to replace the existing fuse with an one amp fuse. The time allowed is .1 hour per fuse for repair. The PFP is 151450, SRT code is 174-6534A. Thomas will ship the necessary fuse(s) free of charge direct to each customer along with their notification listing each VIN involved.
