GROUP Engine	MODEL 2012MY Optima Hybrid (TF HEV)
	NUMBER 128	DATE February 2013
TECHNICAL SERVICE BULLETIN		
SUBJECT: PCSV INSPECTION AND REPLACEMENT (SA142)

This bulletin provides the procedure to inspect and, if necessary, replace the PCSV (purge control solenoid valve) on some 2012MY Optima Hybrid vehicles produced from September 18, 2012 to November 18, 2012. Kia is requesting the completion of this Service Action on all affected vehicles in dealer stock prior to delivery. Before conducting the procedure, verify the vehicle is included in the list of affected VINs.

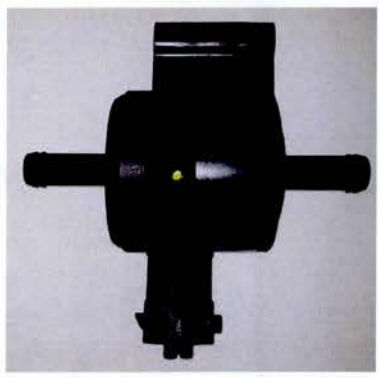
Part Name	Part Number	Figure
Valve-Purge Control	28910 3E100QQK
