# SERVICE CAMPAIGN BULLETIN

NTB13-052

## VOLUNTARY SERVICE CAMPAIGN 2013 ALTIMA SEDAN HEATED SEATS

**CAMPAIGN ID:** PC212**APPLIED VEHICLE:** 2013 Altima Sedan (L33)**Check Service COMM to confirm campaign eligibility.**

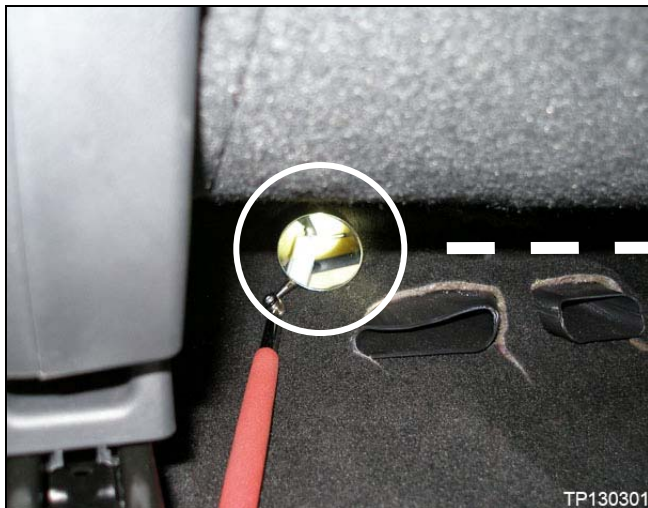
Figure 1; seat viewed from bottom rear

1. Move both front seats fully forward and recline the seatbacks forward.
2. From the rear of the front seats using a mirror and flashlight, look for a 3-wire harness connector under the seat frame assemblies (see Figure 1).
  - The wire colors are green, yellow, and black.
