# UPDATE Technical Bulletin

## UPDATE – 97Z5 Engine Wiring Spacer Ring (NVLW)

Model(s)	Year	Engine Code	Trans. Code
Touareg	2013	CNRB (3.0L TDI)	All

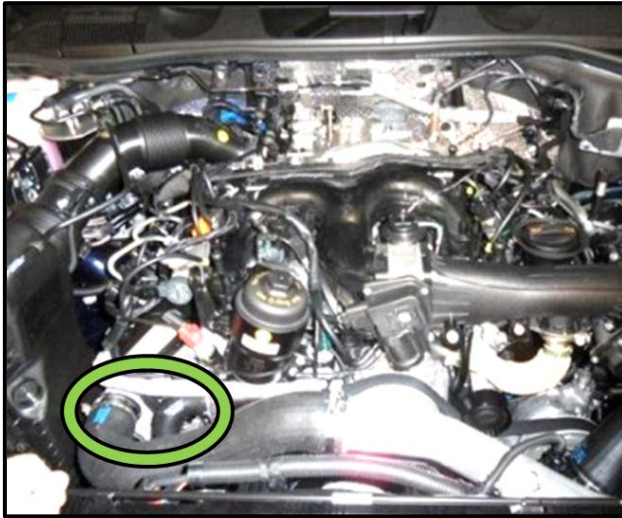
- Open hood and remove engine cover
- ⇐ Locate engine harness in area marked <circle>.

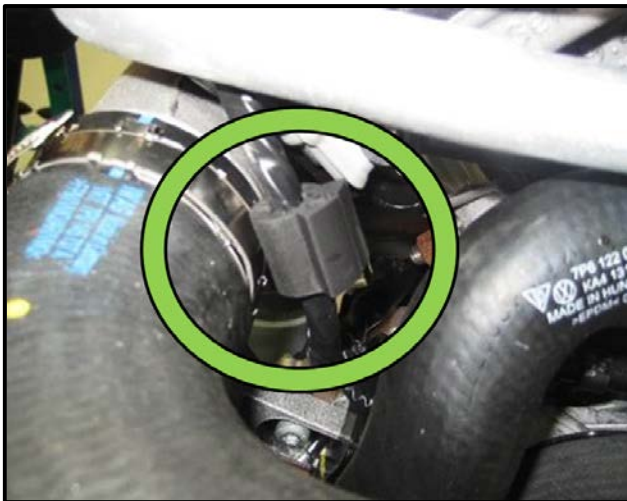
On all affected vehicles the engine harness can rest and chafe on the clip of the pressure pipe.

- ⇐ If spacer ring is already installed as shown <circle>, WORK COMPLETE, otherwise Continue work procedure.
- ⇐ If spacer ring is not already installed, install spacer ring part number (N 107 162 01) as shown <circle>.
- Reinstall engine cover and close hood
