## Emissions Recall

**Subject: Exhaust Gas Recirculation (EGR) Pipe Cover Kit Installation**

**Bulletin: RCB-007-11**

**Campaign #: A7610**

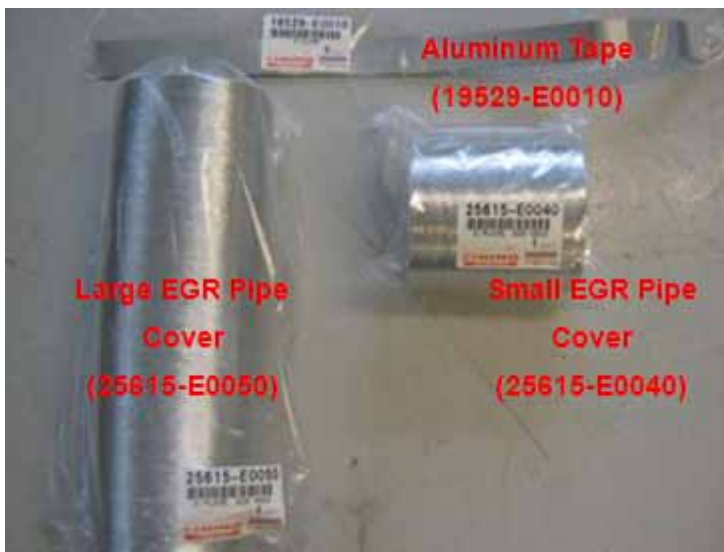
| PART NUMBER | DESCRIPTION | QUANTITY |
| 04001072E0 | A7610 EGR Kit | 1 |

| Kit Contents | |
| 25615E0050 | Large EGR Pipe Cover |
| 25615E0040 | Small EGR Pipe Cover |
| 19529E0010 | Aluminum Tape |

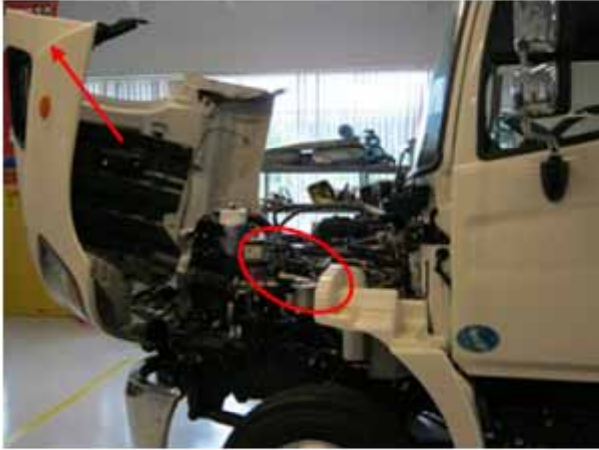
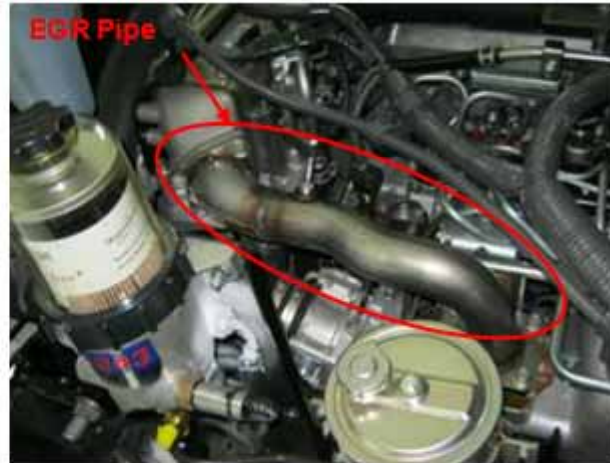
6. Raise the hood and find the Exhaust Gas Recirculation (EGR) pipe. A two piece insulating cover will be installed onto this EGR pipe.

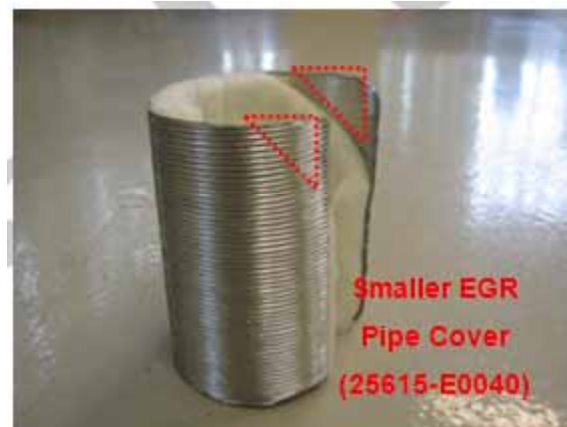
7. Locate the smaller of the two EGR pipe covers (25615E0040). This smaller cover will need to be trimmed before it can be installed onto the EGR pipe.

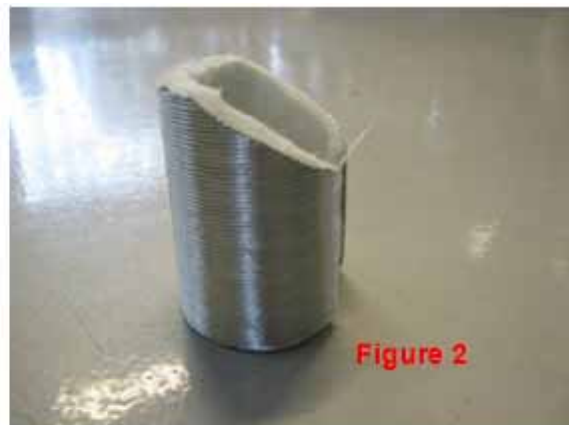
8. Trim the flexible aluminum exterior cover on the smaller EGR pipe cover to match the border of the inner white insulating wrap. Cut along the red dotted line as illustrated in figure 1. Confirm that the smaller EGR pipe cover is correctly cut as illustrated in figure 2.

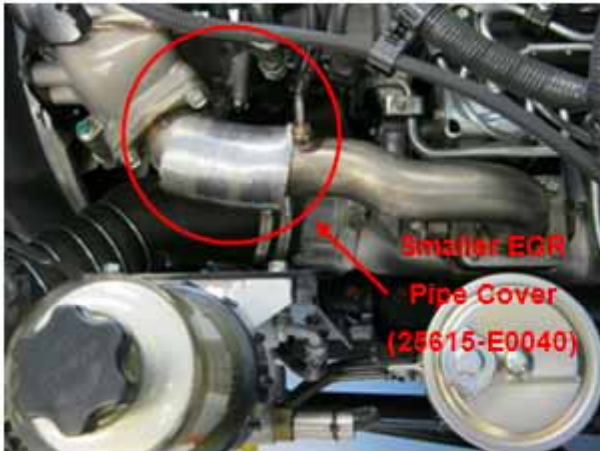
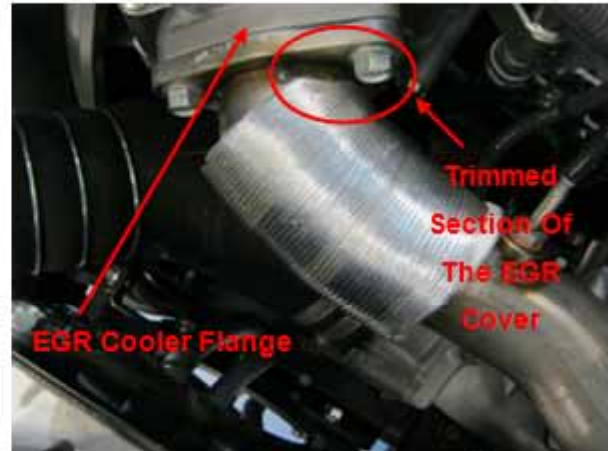
9. Install the smaller of the two EGR pipe covers (25615E0040) onto the forward section of the EGR pipe. The edge of the EGR pipe cover that was trimmed in step 8 will need to be positioned against the EGR cooler flange as shown in the photographs below.

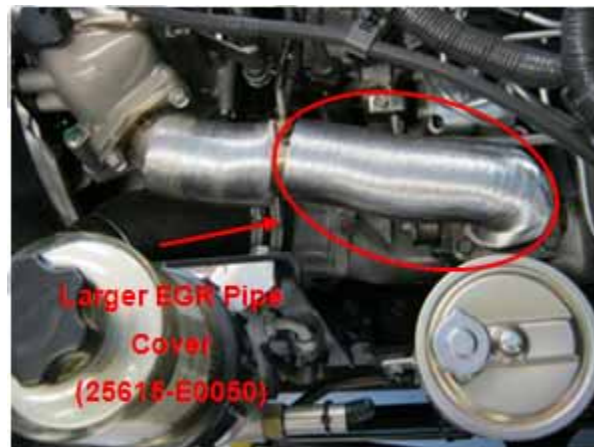
10. Install the remaining larger EGR pipe cover (25615E0050) onto the EGR pipe and after positioning the EGR pipe cover with the open slit facing downward then squeeze both the small and large covers around the EGR pipe. By squeezing them around the EGR pipe, you will be able to better form and insulate the wrap around the pipe.

**NOTICE:** The open slit on the EGR pipe covers should always be positioned so the opening is facing downward as described above. Most, if not all of this slit will be closed when the cover is squeezed together and then taped closed.

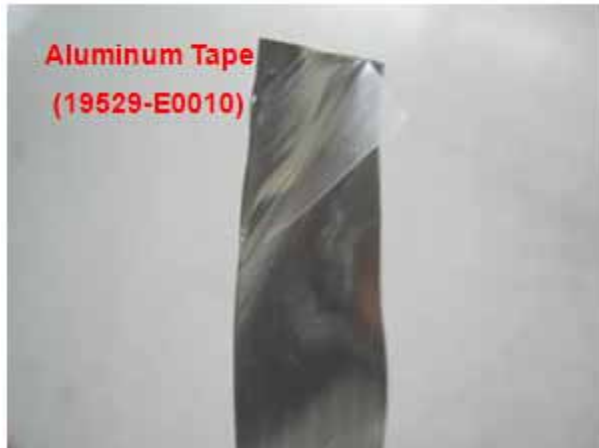
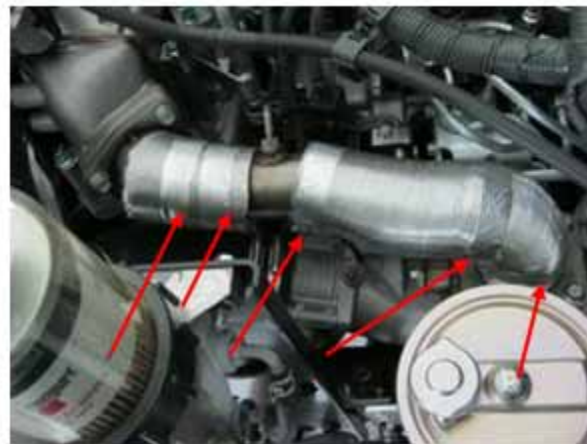
**11.** Peel back the clear backing from the aluminum tape (19529E0010) and wrap the two EGR pipe covers one location at a time. Care must be taken in order to wrap the EGR pipe covers in the 5 separately listed locations, 3 on the larger EGR pipe cover and 2 on the smaller EGR cover. It is recommended that the clear backing material for the aluminum tape should only be peeled back as it is being wrapped around the EGR pipe.
