## VOLUNTARY CAMPAIGN BULLETIN

<b>SUBJECT:</b>	Diesel Particulate Regeneration (DPR) Igniter Plugs
<b>DATE:</b>	03/01/2013
<b>BULLETIN NO:</b>	RCB-001-13
<b>CAMPAIGN NO:</b>	A8560
<b>AFFECTED MODELS:</b>	Certain 2011 through 2013 model year NE8J, NJ8J, NV8J models equipped with a J08 engine.

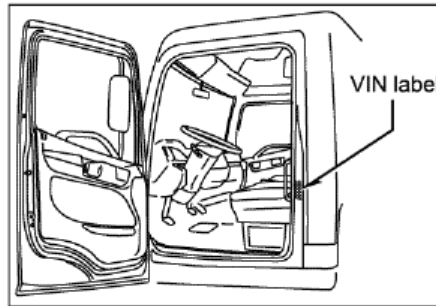
Complete a recall sticker and affix to the left door jam above the V.I.N. decal.

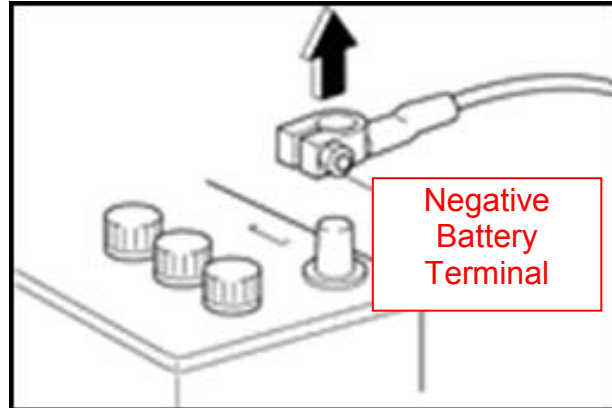
1. Disconnect the negative battery terminal.

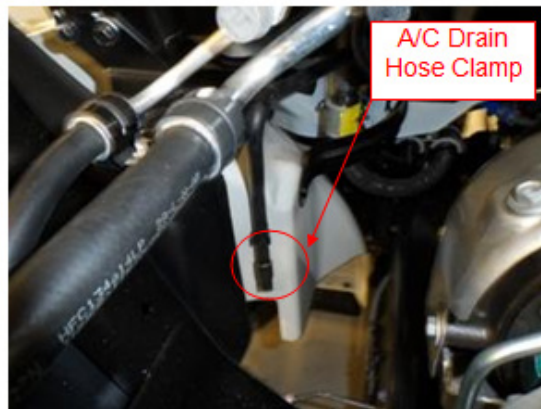
Make certain the A/C drain hose is removed, located on the engine side of the right fender.

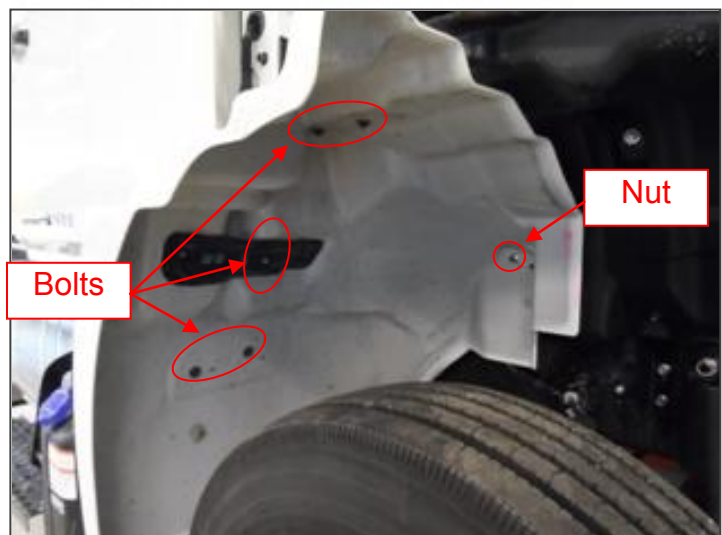
Remove one (1) nut and six (6) bolts (shown in the illustration to the right) that secure the right front fender. Remove the right front fender from the vehicle.

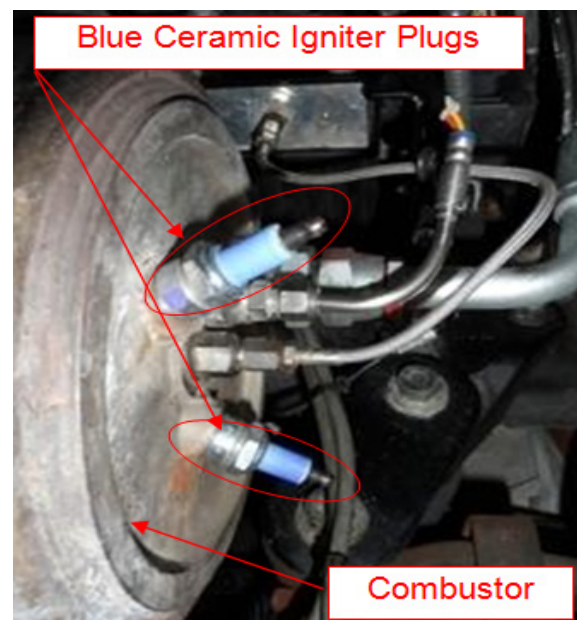
5. Install two (2) new blue ceramic igniter plugs into the combustor and torque to the specified torque.

**Specified Torque:** 22.0 lb-ft (29.8 Nm)

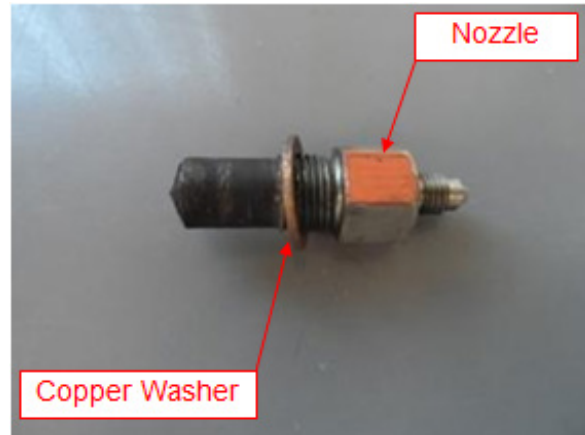
6. Remove the steel braided fuel/air supply line, nozzle and copper washer. Discard the copper washer.

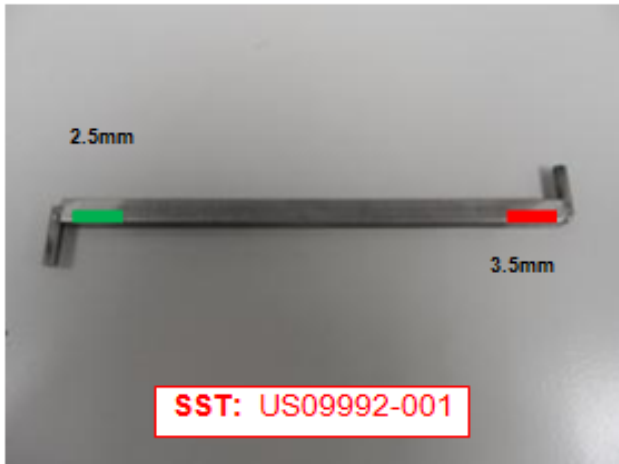
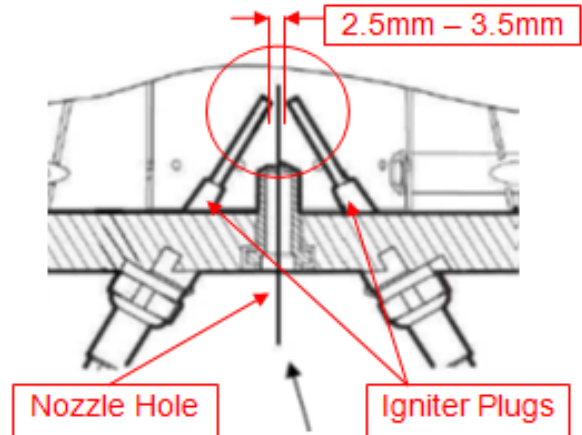
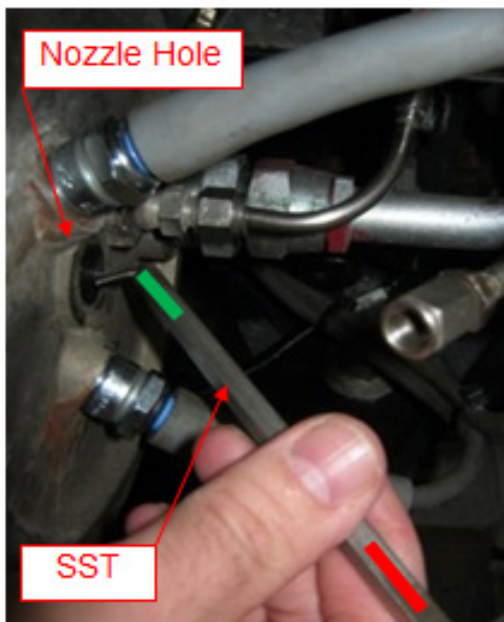
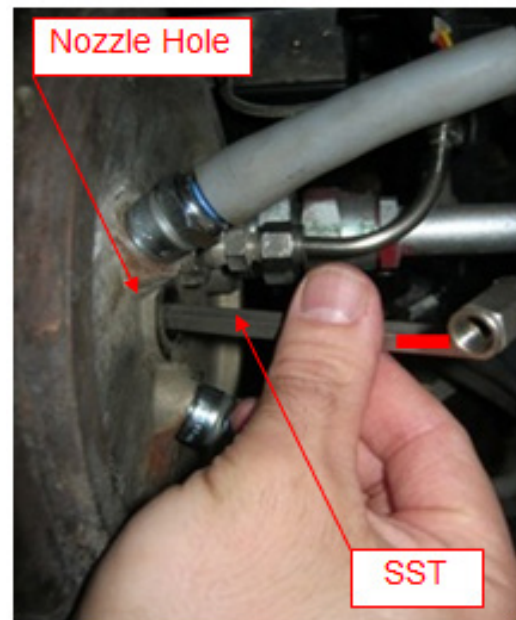
7. Using the SST to check igniter plug gap:

The SST is a “Go - No-Go” gauge to check the igniter gap at the tips. The tool has a 2.5mm gauge on one end and a 3.5mm gauge on the other end. The 2.5mm end should be able to pass between the igniter tips while the 3.5mm end should not.

**Igniter Gap Specification: 2.5mm – 3.5mm**

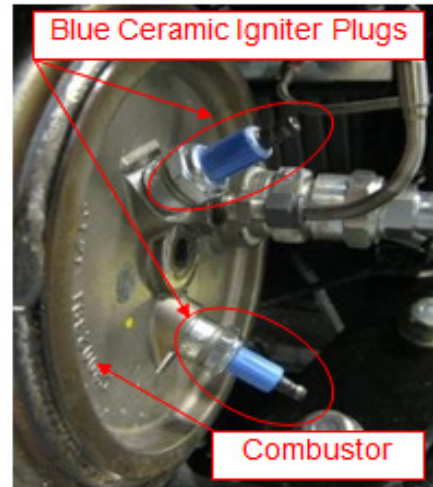
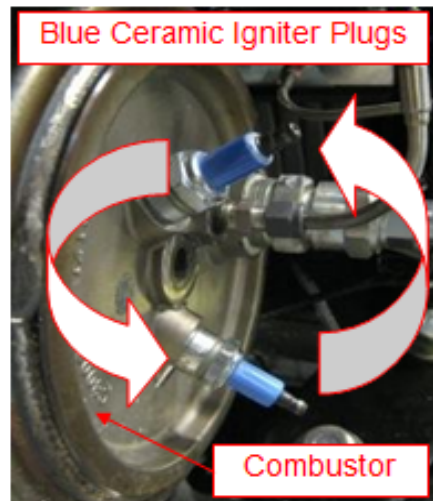
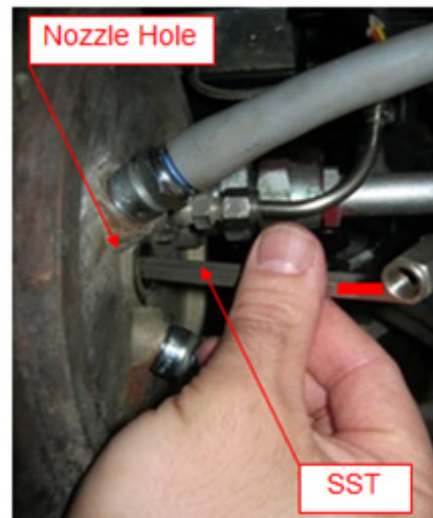
11. Remove one (1) igniter from the combustor and exchange it with another new one. Due to manufacturing variability of igniters it may be necessary to replace one of the two igniters to bring the gap within specification.

Install the replacement igniter plug into the combustor then torque to the specified torque. Confirm the igniter gap meets the specification then got to Step 12. Retain the removed igniter plug for use in another vehicle.

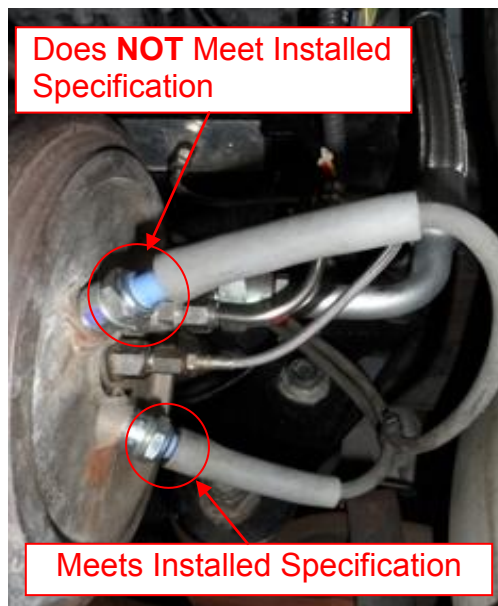
14. Check the exposed ceramic surface of each igniter plug. If not within the installed specification, adjust the ignition wire boot to meet the installed specification.

**Installed Specification:** 0.28 inch (7mm) or less

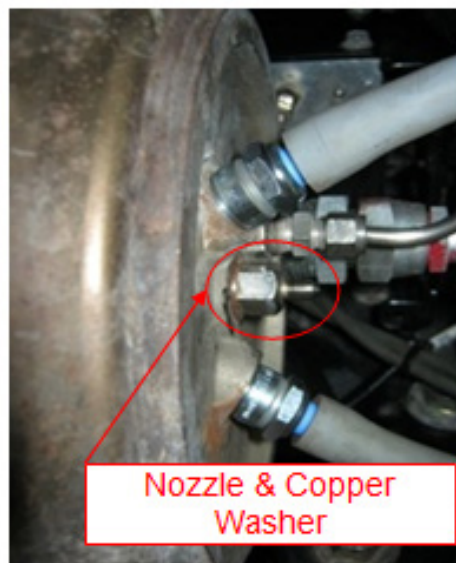
15. Using a new copper washer, install the nozzle and tighten to the specified torque.

**Specified Torque:** 19.9 lb-ft (27.1 Nm)

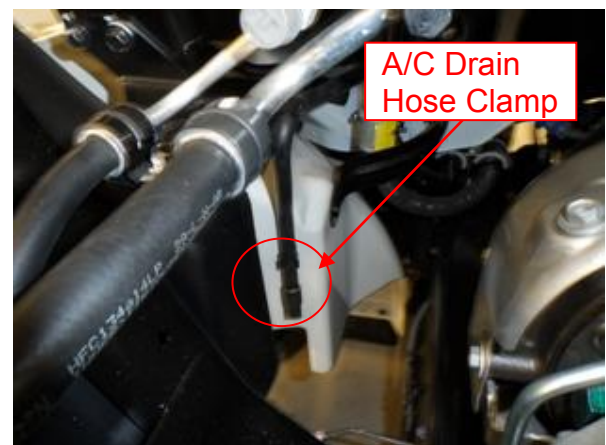
18. Make certain the A/C drain hose is secured by the clamp located on the engine side of the right fender.
