**Subject: Qualcomm TrailerTRACS Wiring**

**Models Affected: Specific Freightliner Cascadia vehicles manufactured January 1, 2010, through January 14, 2013.**

Daimler Trucks North America LLC, on behalf of its Freightliner Trucks Division, is initiating Field Service Campaign SF480A to modify the vehicles mentioned above.

May 2013  
SF480A

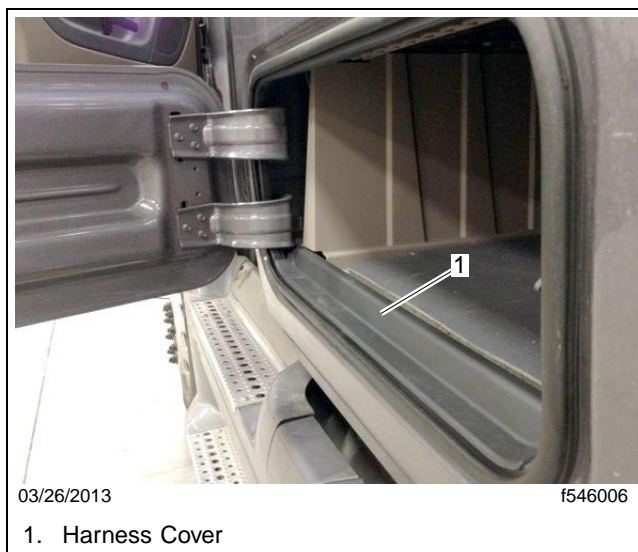
**Fig. 1, Driver-Side Luggage Compartment (without auxiliary heater option)**

- On vehicles equipped with a driver-side luggage compartment, the wiring harness cover is located on the inside front edge of the compartment. See **Fig. 1**. Open the compartment and remove all the stored items. Remove the fasteners from the harness cover, then remove the cover.
- On vehicles without a driver-side luggage compartment, the harness is under the side panel located beneath the lower bunk. Raise the bunk and remove the support panel. Remove the bolt that secures the side panel to the cab floor, then remove the side panel. See **Fig. 2**.
- On daycabs, the harness is located behind the back wall upholstery panel. Remove this panel.

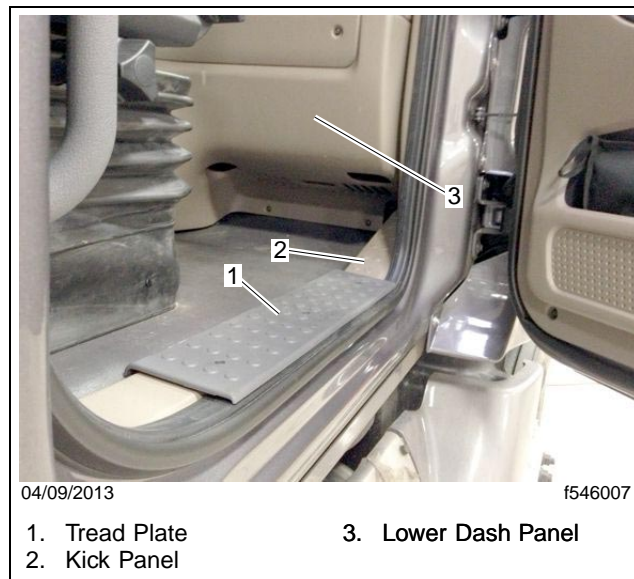
**Fig. 3, Passenger-Side Tread Plate and Kick Panel**

4. Inspect circuit 45 to make sure that the wiring modification was not completed prior to this campaign. If the procedure was already performed, circuit 45 will be spliced with an 18-gauge wire and routed as shown in **Fig. 5**. If the procedure has already been done, clean a spot on the base label (Form WAR259). Attach a completion sticker (Form WAR261) for campaign SF480 to the base label. Otherwise, proceed with the next step.
5. Remove the tread plate, kick panel, and lower dash panel from the passenger side of the vehicle. See **Fig. 3**.

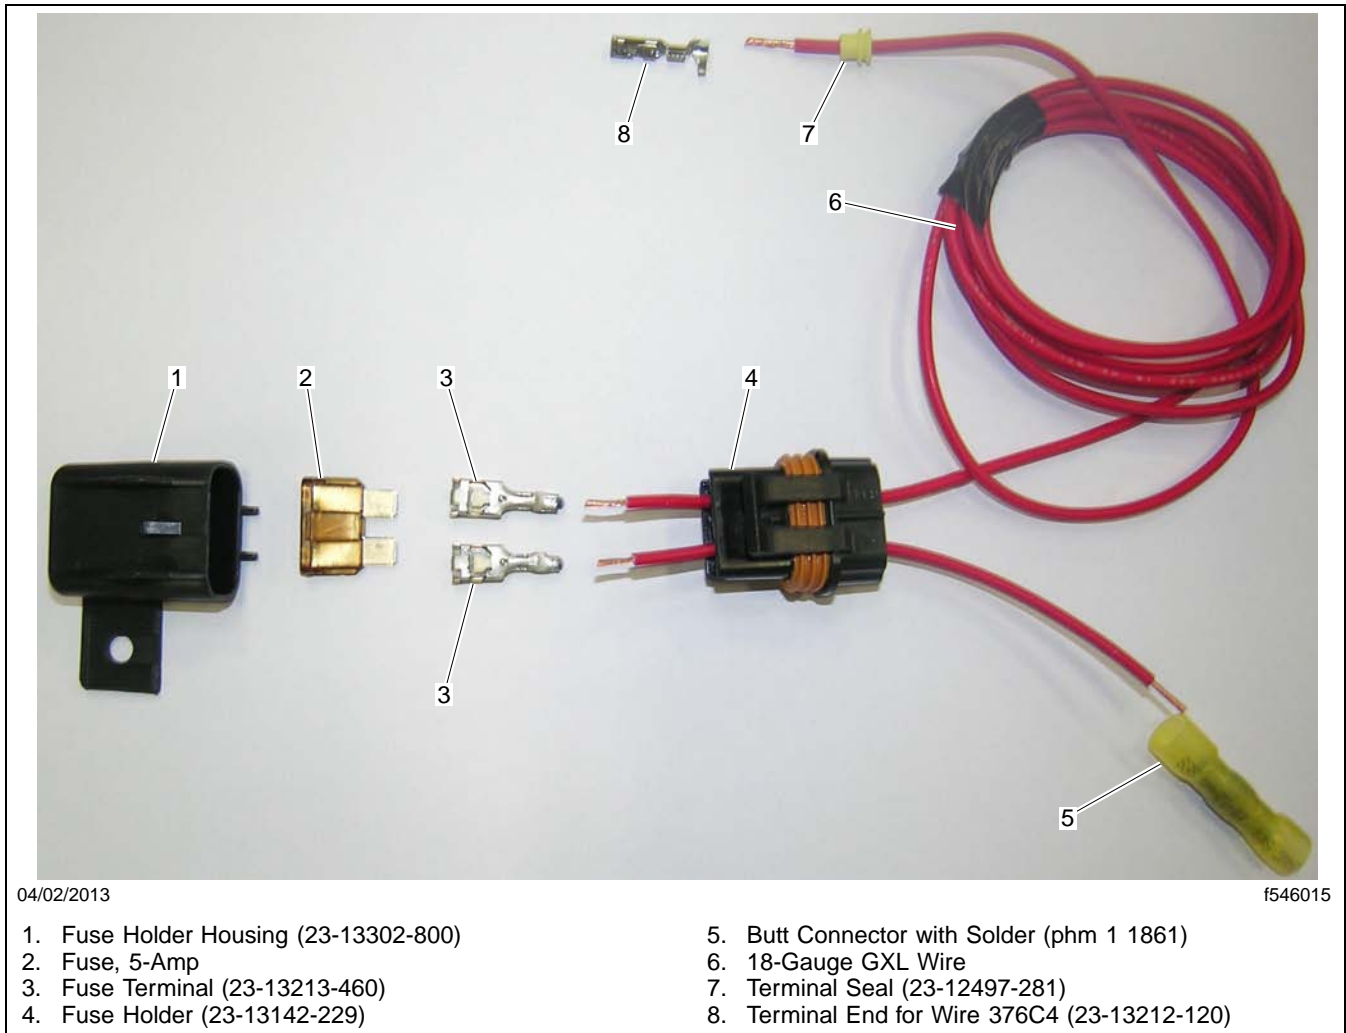
**Fig. 4, Wiring Modification Parts**

6. Assemble the harness from the parts provided in the kit. See **Fig. 4**
  - 6.1 Measure and cut enough 18-gauge wire to extend from the driver-side wall under the bunk to the passenger-side wall, and under the passenger-side kick panel to the Qualcomm ECU connector under the dash.

- 6.2 Feed the wire through the fuse holder. Strip the wire, then crimp on the fuse holder terminal end.
  - 6.3 Cut a 4 to 6 inch (10 to 15 cm) strand of wire.

- 6.4 Feed the short strand of wire through the fuse holder. Strip the wire on both ends, then crimp on the fuse holder terminal end.
7. Inside the cab, cut and strip the circuit 45 blue wire.

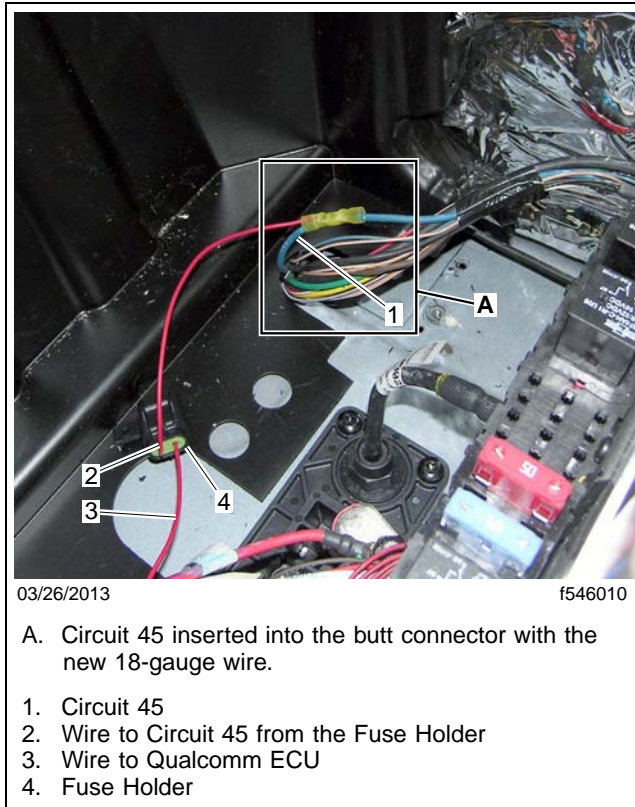
**Fig. 5, Wire Re-Routed to Qualcomm ECU**

8. Splice the new wire into circuit 45. See **Fig. 5**.
  - 8.1 Slide a butt connector onto the the end of circuit 45 that leads to the SAM Chassis.
  - 8.2 Slide the new wire and the other end of circuit 45 into the opposite end of the butt connector.

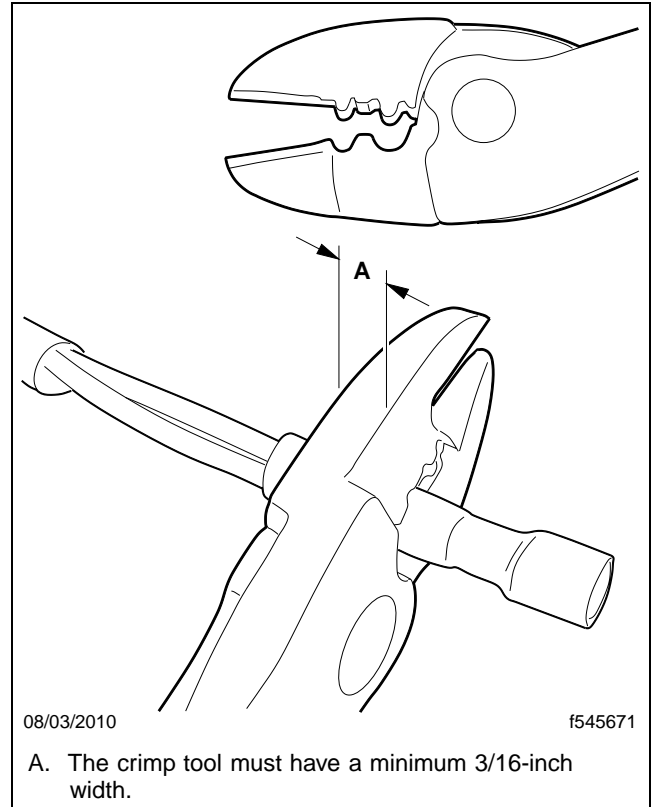
**Fig. 6, Crimp Tool**

- 8.3 Crimp each end of the butt using a crimp tool to secure the wires. See **Fig. 6**.
  - 8.4 Pull test the wires by hand to ensure the crimp is mechanically solid.

- 8.5 Heat the splice using a heat gun rated at 1,000°F (538°C) until the sleeve has completely shrunk against the wire and the solder inside the butt connector flows.

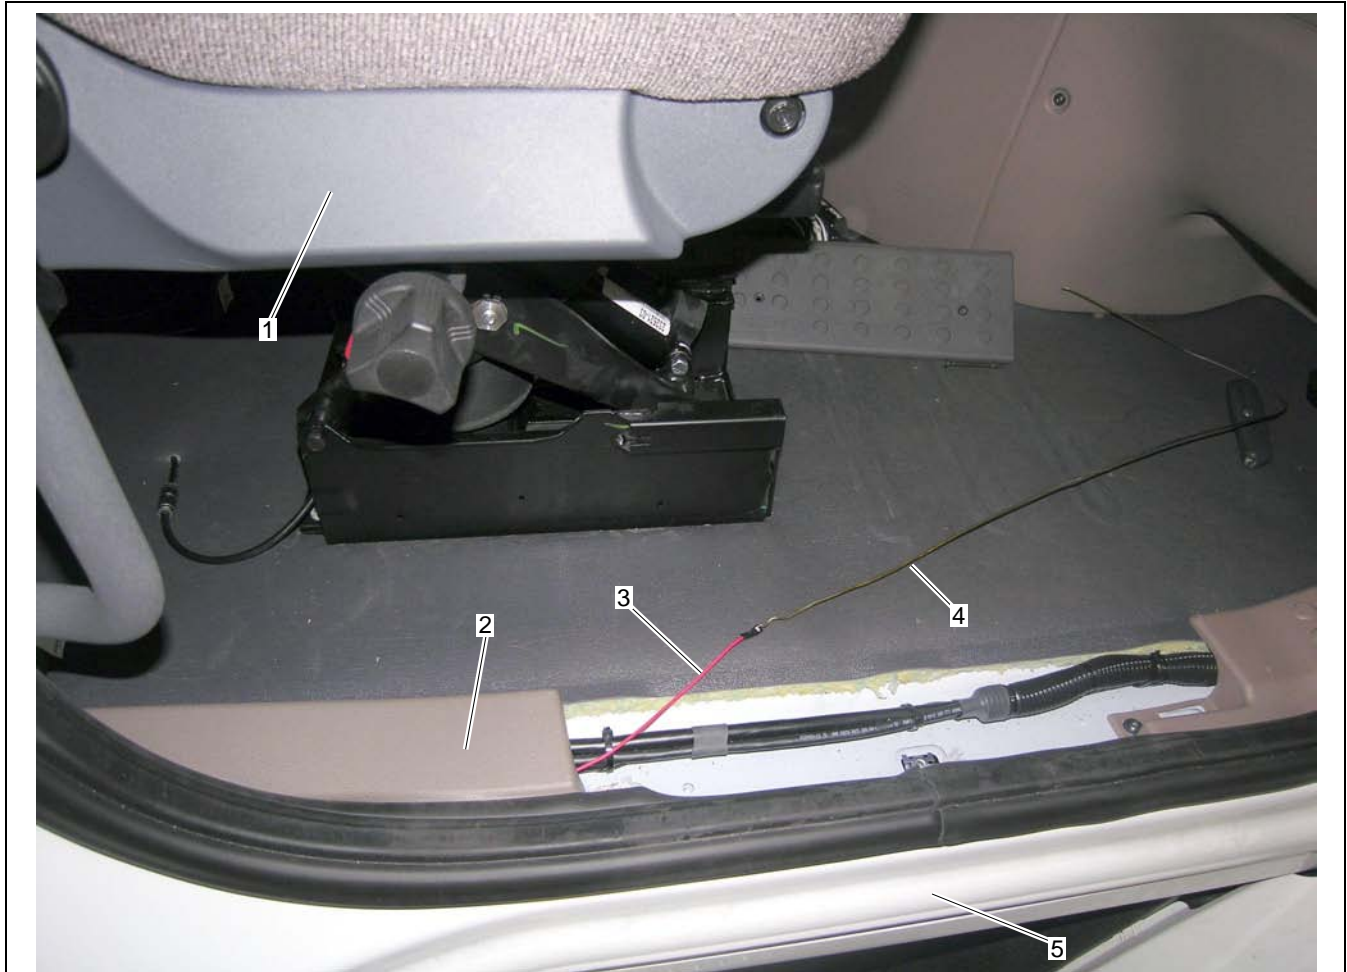
**Fig. 7, Passenger-Side Wire Routing (tread plate removed)**

9.2 Route the wire behind the passenger side B-pillar panel and under the harness cover using fish tape or a wire guide. See **Fig. 7**.

- 1. Passenger Seat
- 2. Harness Cover

- 3. 18-Gauge Wire
- 4. Wire Guide

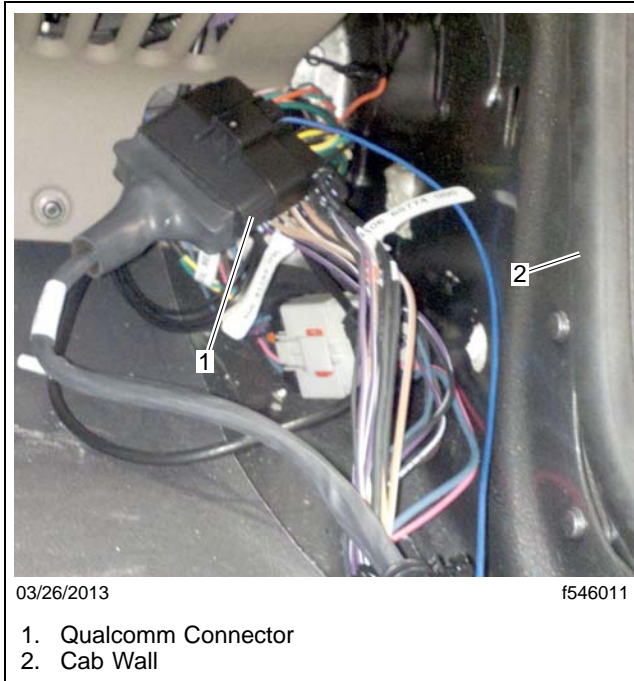
**Fig. 8, Qualcomm Connector**

10. Disconnect the 14- or 16-pin Qualcomm ECU connector. It is located on the passenger-side of the vehicle, behind the kick panel. See **Fig. 8**.
11. Remove wire 376C4 (orange) from the Qualcomm connector. Refer to module 330 for terminal details.
12. Insert the new wire into the Qualcomm connector in the same cavity where wire 376C4 was connected. See **Fig. 9**.
13. Tape down the new wire along the inner bunk support, along the cab wall and the passenger-side door frame. See **Fig. 10**.
14. Install the kick panel, tread plate, and lower dash panel on the passenger-side of the vehicle.
15. Install the harness cover on the driver side of the vehicle.
16. On daycabs, install the back wall upholstery panel.
17. Clean a spot on the base label (Form WAR259). Attach a completion sticker (Form WAR260) for campaign SF480 to the base label.

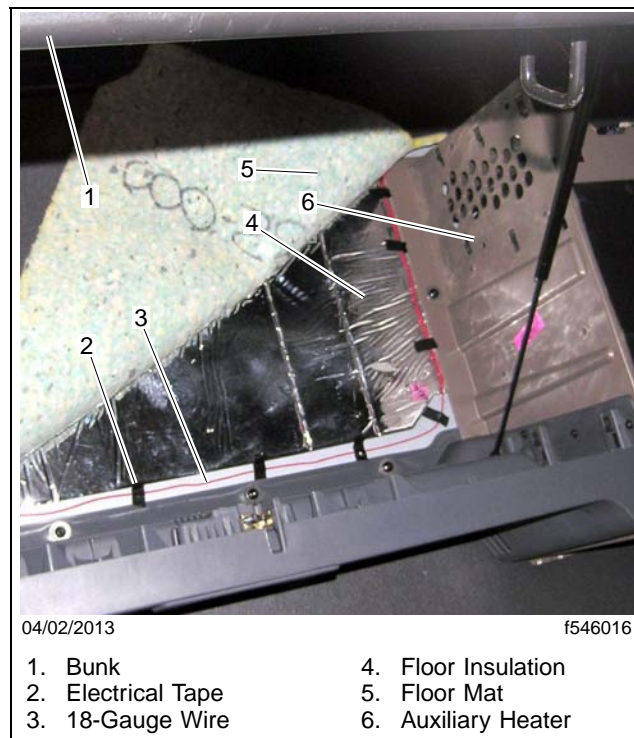
**Fig. 10, Wire Routing Under Bunk (auxiliary heater installation shown)**

9.1 Route the wire underneath the bunk along the bunk support wall and underneath the floor mat.

NOTE: On Sleepercabs with a driver side luggage compartment, the wire needs to be routed along the cab wall, underneath the harness cover.
