**SB-10052404-1223**

**Title:** Bus Entrance Door Body Area

**Applies To:** CS, IC and CE Models, Units Built Prior to Sept 15, 2011.

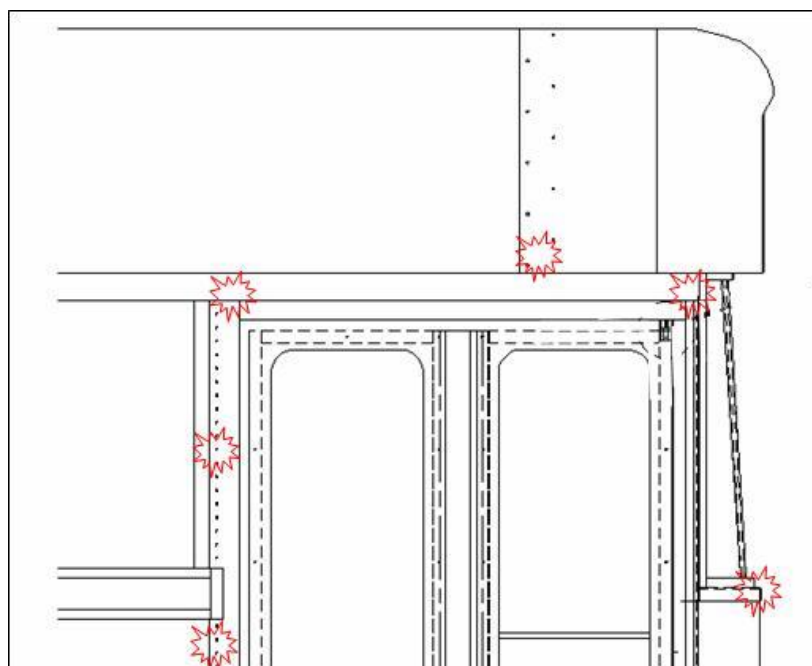
Entrance door area cracks, loose rivets, windshield frame cracks and windshield movement within the frame area, require the inspection of the following areas; cowl leg and cowl fasteners, entrance door header, entrance door forward post, zero bow, passenger side bows aft zero bow to first bow with no damage, frame to body outriggers, and possibly the bow area above Driver's window. Repairs should not be performed without verifying the condition of these areas to ensure root cause is determined.

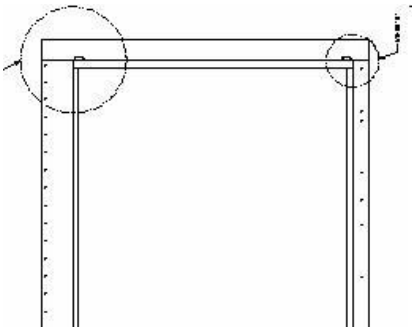
## SYMPTOM #1

- Cracks in the door casing, upper forward and aft corner

## PARTS INFORMATION

| Part # | Description | Qty. |
| 2209681C91 | Exterior, Cosmetic Crack Repair | 1 |
