Service Campaign 63-07 Second Notice

AFFECTED: Certain 2013 Winnebago and Itasca coaches built with Schwintek In Wall Slideout Systems.

SUBJECT: Slideout control module and stop upgrade.

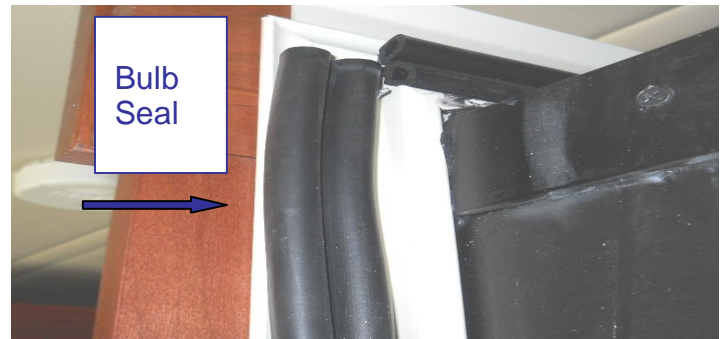
Procedure consists of removal of inside face trim (Bulb seal) and installation of aluminum tube to act as hard stop.

1. Slideout should be in retracted position. Remove inside vertical and top horizontal face trim bulb seals and discard. Clean trim face of tape residue.
2. Measure tubes to be installed on vertical face trim. Cut to length and dry fit tubes. Apply 1/4" bead of adhesive to aluminum tube that will be installed on inside face trim.
3. Install tube on front and rear vertical face trim making sure it is flush with outer edge of trim. Clamp into place until adhesive sets up. May need to remove excess adhesive.
4. Measure tubes to be installed on top face horizontal trim. Cut to length and dry fit tubes. Apply 1/4" bead of adhesive to aluminum tube. Install tube on top face trim and clamp in place, until adhesive sets up, making sure it is flush with edge of face trim.

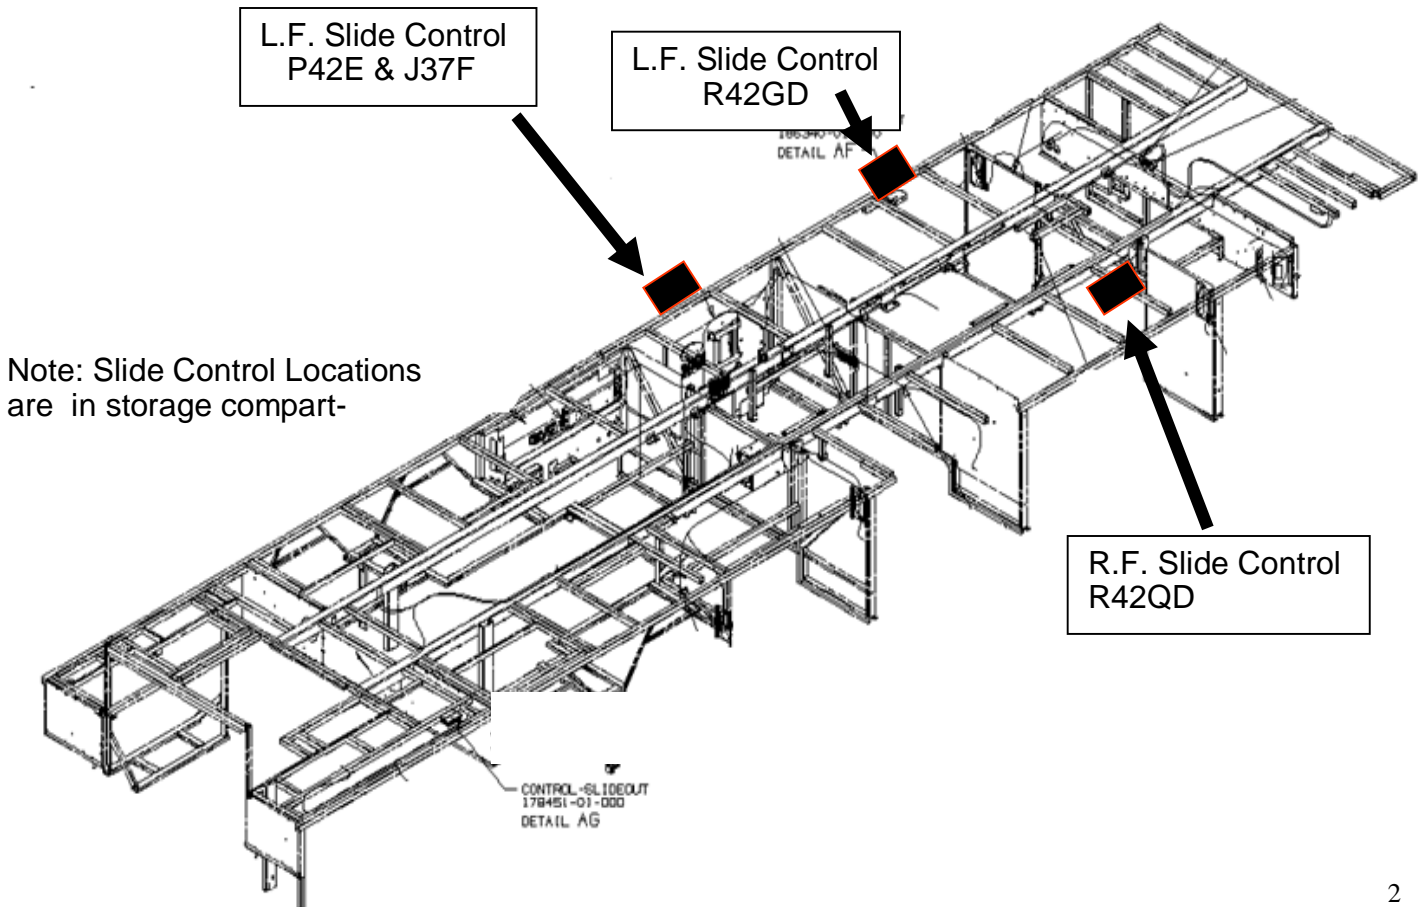
1. Locate & replace slideout control with updated 8 amp control from campaign kit. (LCI # 326876).

1. Extend slideout. When one end of slideout contacts wall there will be delay and then the side that needs to catch up will extend until it contacts wall.
2. Push "In" button, then "Extend" button to make sure slideout is fully extended.
3. Push "In" button one second, then "Extend" button and hold until no noise is heard. This should complete resynchronization.
