## Service Campaign 63-07

**SUBJECT:** Slideout control module and stop upgrade.

# Service Campaign: 63-07, Tube Stops and Module Replacement

## Service Campaign: 63-07, Slideout Control Module Update

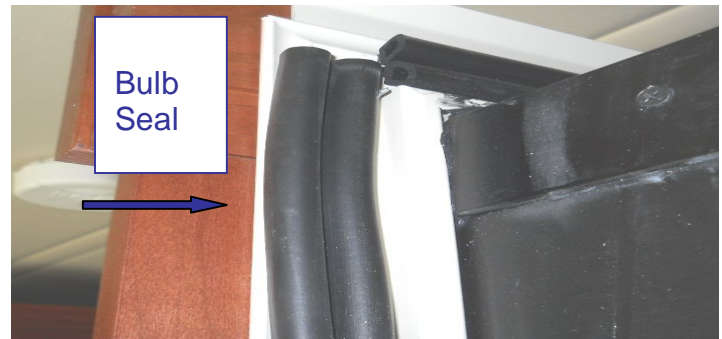
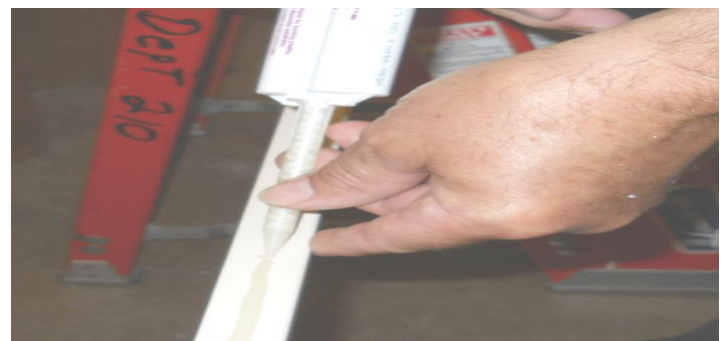
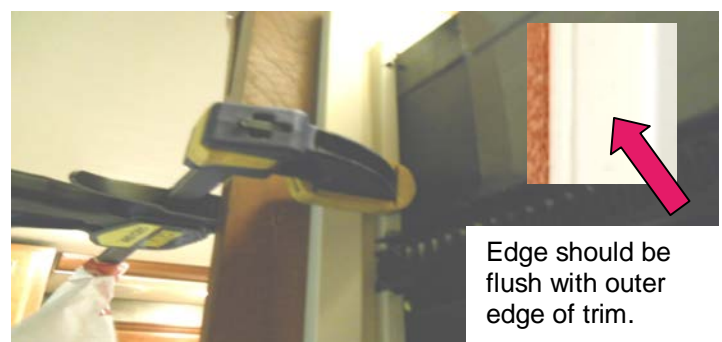
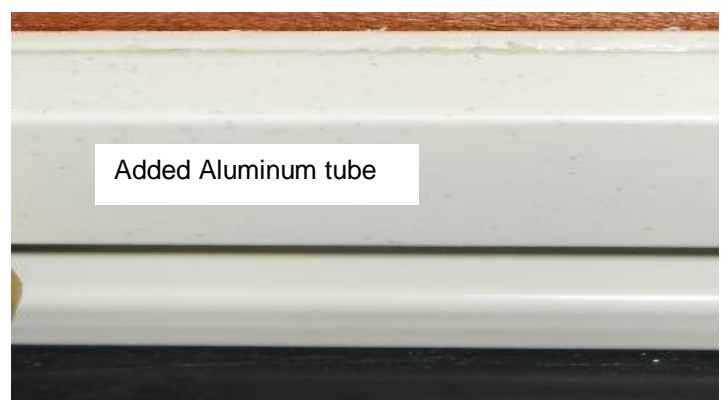
Procedure consists of removal of inside face trim (Bulb seal) and installation of aluminum tube to act as hard stop.

1. Slideout should be in retracted position. Remove inside vertical and top horizontal face trim bulb seals and discard. Clean trim face of tape residue.
2. Measure tubes to be installed on vertical face trim. Cut to length and dry fit tubes. Apply 1/4" bead of adhesive to aluminum tube that will be installed on inside face trim.
3. Install tube on front and rear vertical face trim making sure it is flush with outer edge of trim. Clamp into place until adhesive sets up. May need to remove excess adhesive.
4. Measure tubes to be installed on top face horizontal trim. Cut to length and dry fit tubes. Apply 1/4" bead of adhesive to aluminum tube. Install tube on top face trim and clamp in place, until adhesive sets up, making sure it is flush with edge of face trim.

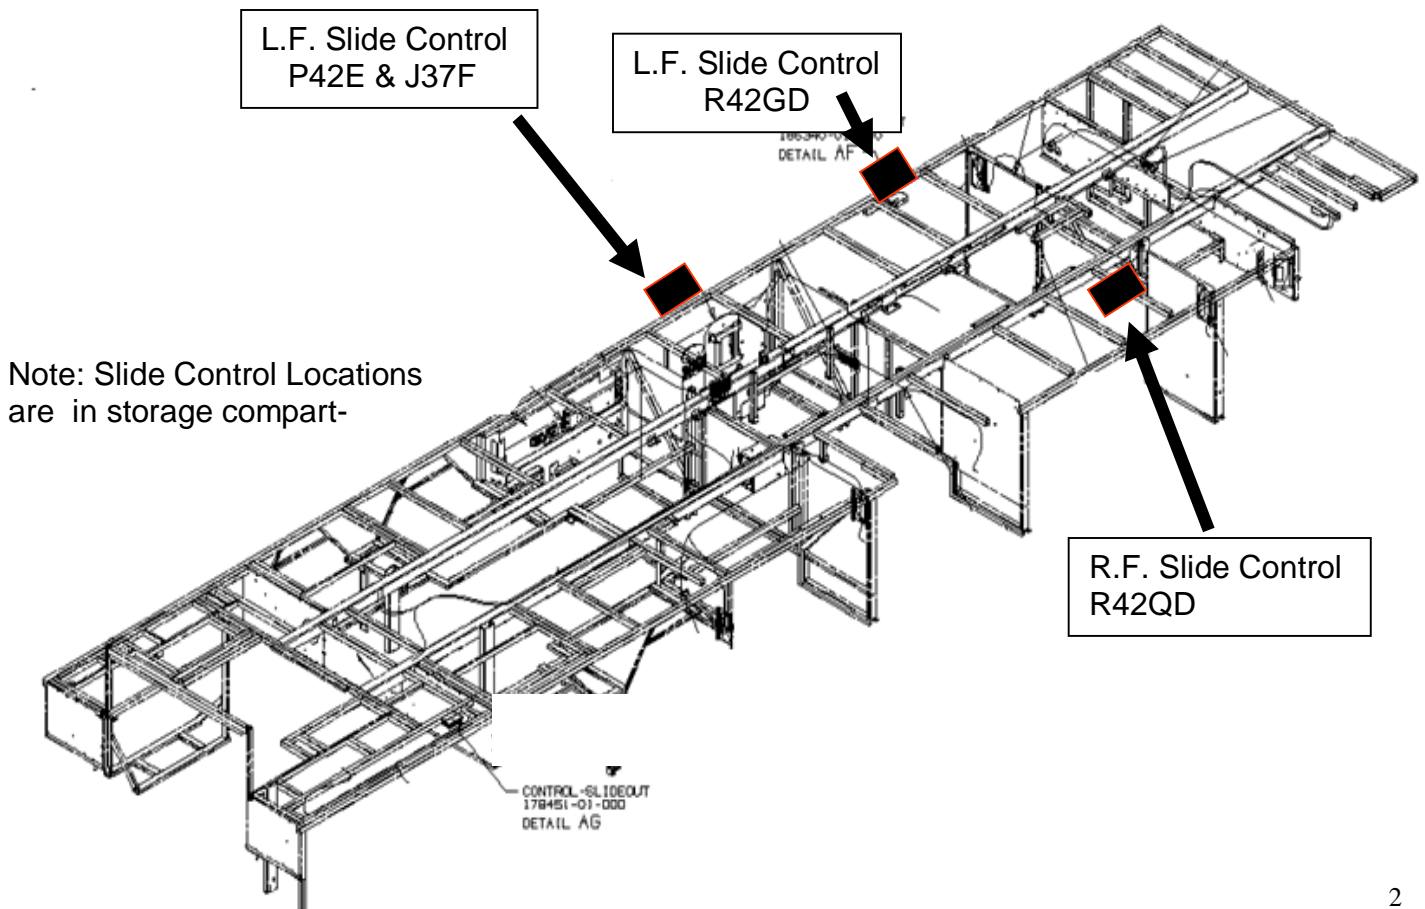
1. Locate & replace slideout control with updated 8 amp control from campaign kit. (LCI # 326876).
