April 2013

## **Customer Satisfaction Notification N06**

### **Instrument and Door Panel Applique Delamination**

2012 (WK) Jeep® Grand Cherokee SRT8

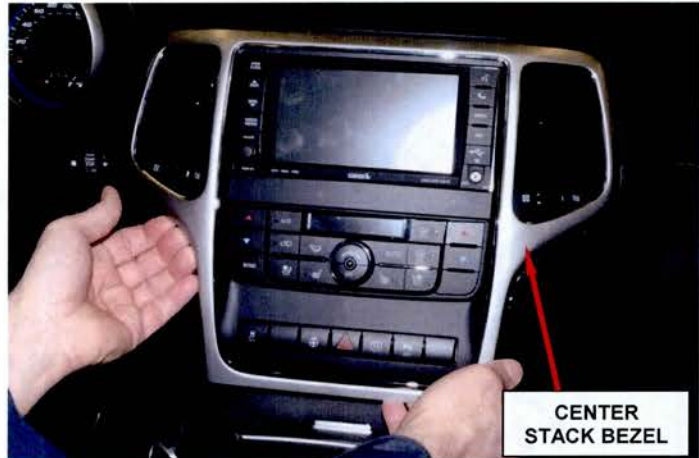
**Figure 1 – Unsnap Center Stack Bezel**

2. Remove and save the center stack bezel (Figure 1).

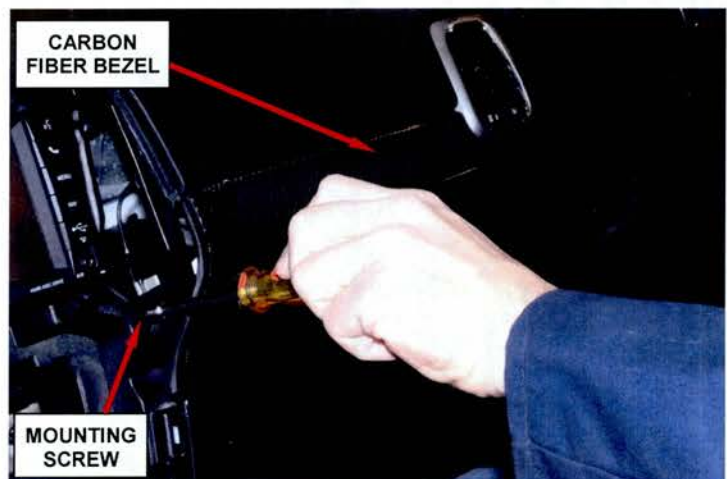
3. Remove and save the right side carbon fiber bezel mounting screw (Figure 2).

**Figure 2 – Bezel Mounting Screw**

8. Install the right side carbon fiber bezel mounting screw and tighten securely.

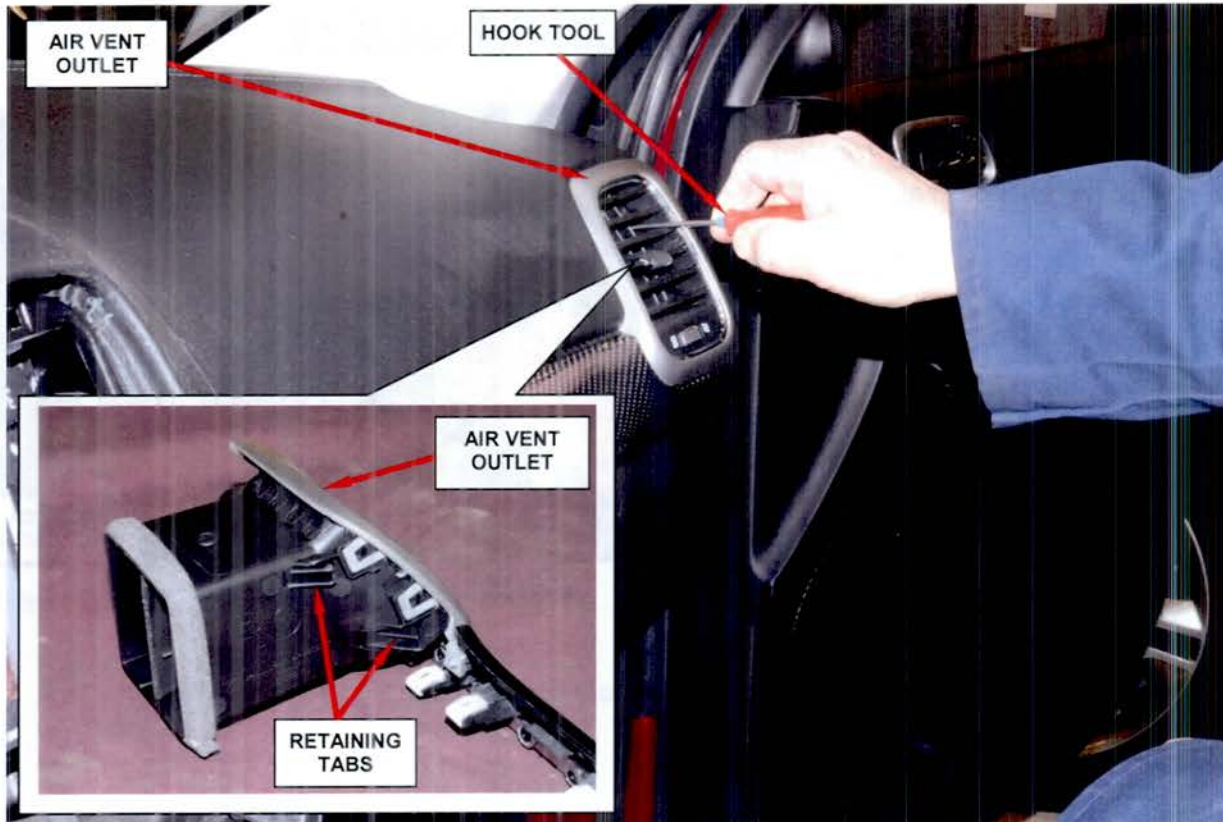
**Figure 3 – Disengage the Air Vent Outlet Retaining Tabs (two per side)**

4. Using a small hook tool, carefully disengage the four (4) right air vent outlet retaining tabs and remove the air vent outlet and carbon fiber bezel as an assembly (Figure 3).

**CAUTION:** The four air vent outlet retaining tabs are difficult to see and even more difficult to disengage. Extreme patience and perseverance is required to disengage the four air vent outlet retaining tabs.

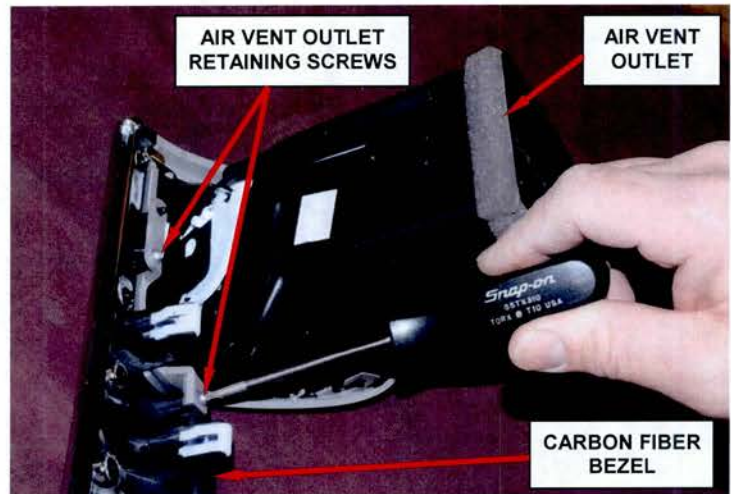
5. Remove and save the two air vent outlet retaining screws and then separate the air vent outlet from the original carbon fiber bezel (Figure 4). Discard the original carbon fiber bezel.

Figure 4 – Air Vent Outlet Retaining Screws

6. Place the air vent outlet onto the new carbon fiber bezel. Install and tighten the two air vent outlet retaining screws.

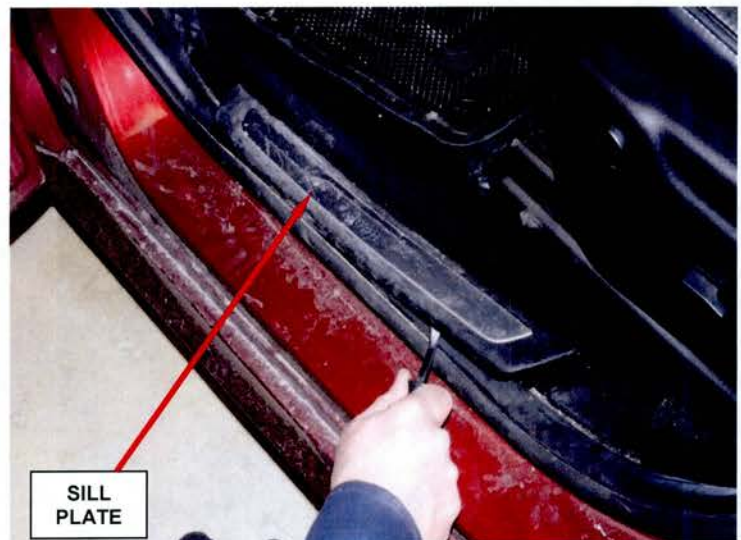
9. Remove and save the left front sill plate (Figure 5).

Figure 5 – Left Front Sill Plate

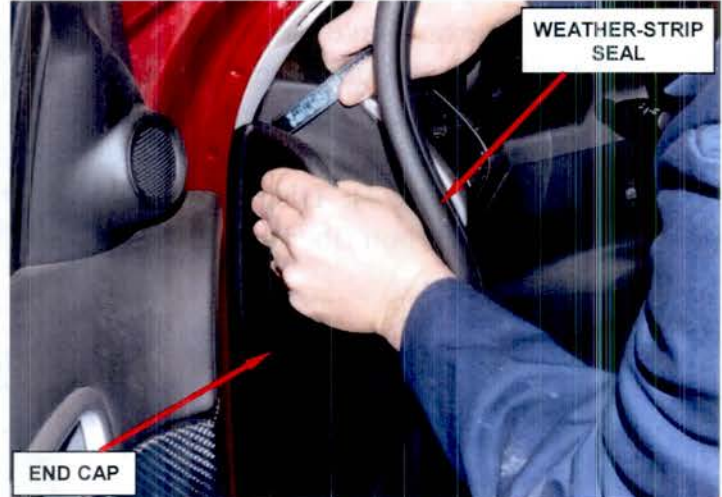
10. Partially remove the body opening weather-strip seal (Figure 6).

Figure 6 – Left Instrument Panel End Cap

11. Remove and save the left instrument panel end cap (Figure 6).

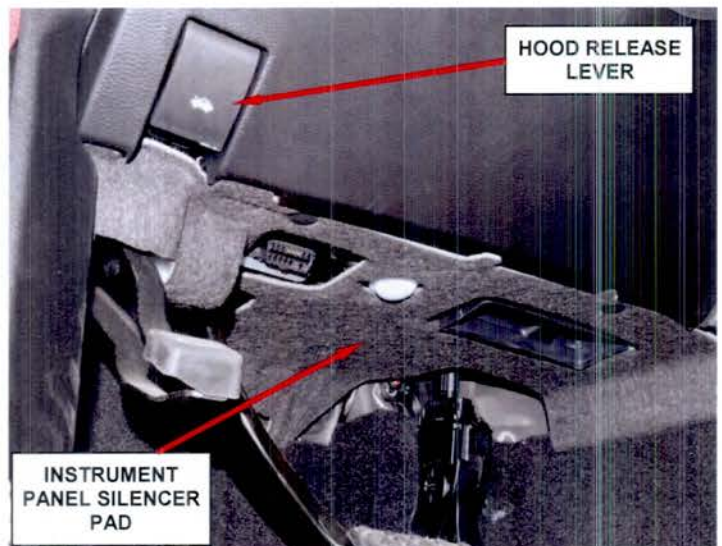
12. Remove and save the instrument panel silencer pad (Figure 7).

Figure 7 – Instrument Panel Silencer Pad

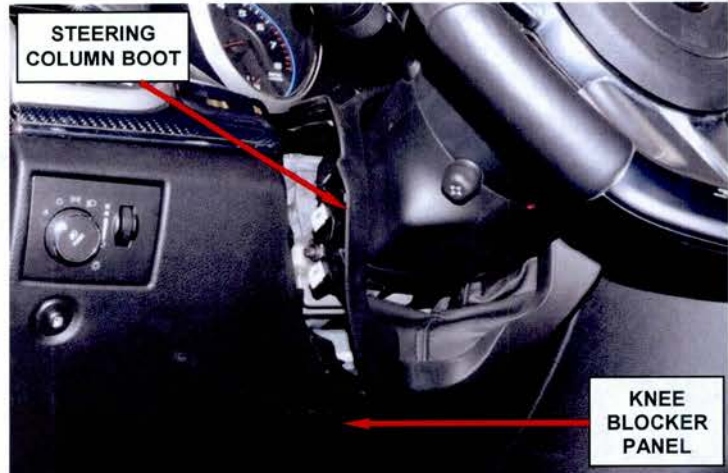
14. Disengage the steering column boot (Figure 8).
15. Remove and save the lower knee blocker panel (Figure 8).
16. **If equipped**, remove and save the “Start” button.

Figure 8 – Steering Column Boot

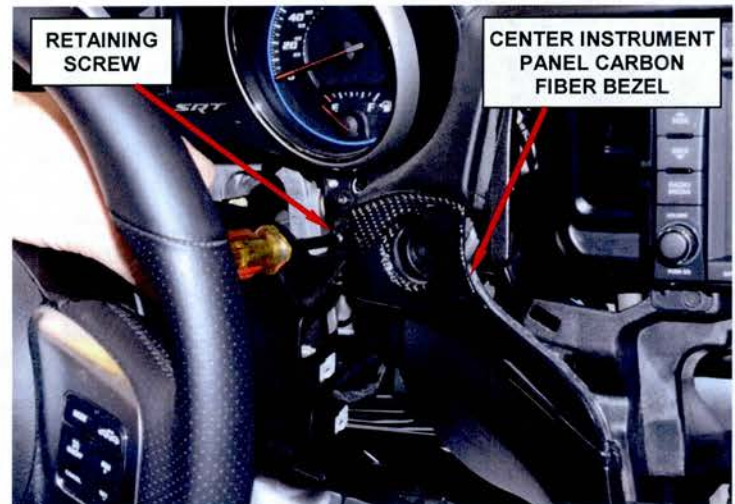
17. Remove and save the center instrument panel carbon fiber bezel retaining screw (Figure 9).
18. Remove and discard the original center instrument panel carbon fiber bezel.
19. Install the new center instrument panel carbon fiber bezel into position on the instrument panel and install the retaining screw. Tighten the screw securely.

Figure 9 – Center Bezel Retaining Screw

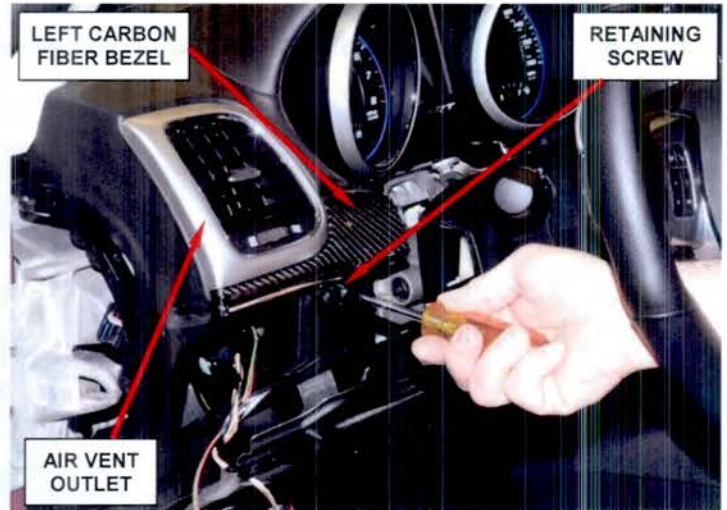
21. Remove and save the left instrument panel carbon fiber bezel retaining screw (Figure 10).
22. Using a small hook tool, disengage the four (4) left air vent outlet retaining tabs and remove the air vent outlet and left instrument panel carbon fiber bezel as an assembly (Figure 11).

Figure 10 – Left Bezel Retaining Screw

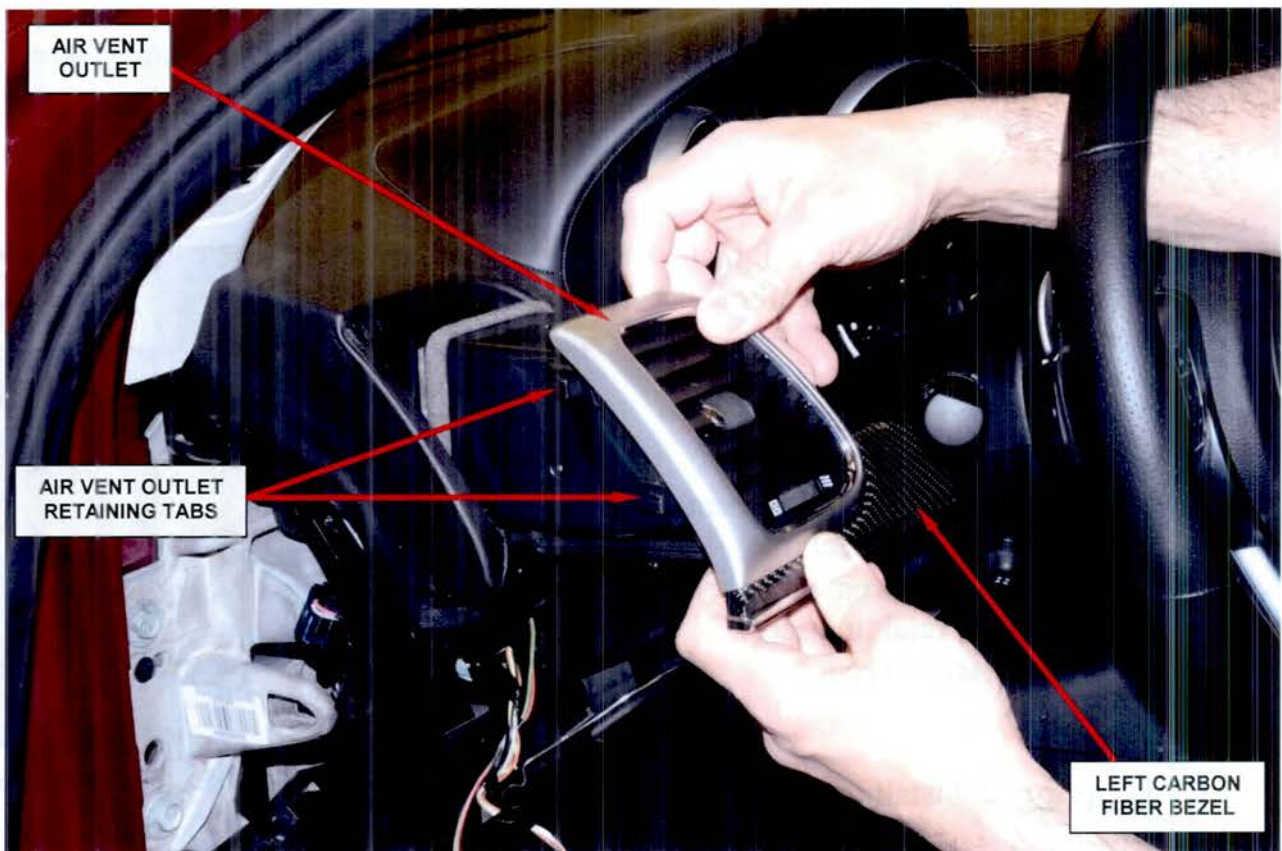
**CAUTION:** The four air vent outlet retaining tabs are difficult to see and even more difficult to disengage. Extreme patience and perseverance is required to disengage the four vent outlet retaining tabs.

Figure 11 – Air Vent Outlet and Left Bezel Assembly

26. Install the left air vent outlet and carbon fiber bezel assembly into position on the instrument panel (Figure 11).
27. Install the left instrument panel carbon fiber bezel retaining screw (Figure 10).
28. Install the lower knee blocker panel.
29. Install the steering column boot (Figure 8).
30. Install the left side kick panel.
31. Install the instrument panel silencer pad (Figure 7).
32. Install the left instrument panel end cap (Figure 6).
33. Install the body opening weather-strip seal.
34. Install the left sill plate (Figure 5).
35. Install the center stack bezel (Figure 1).
36. Continue to **Section B. Inspect Carbon Fiber Door Bezels.**

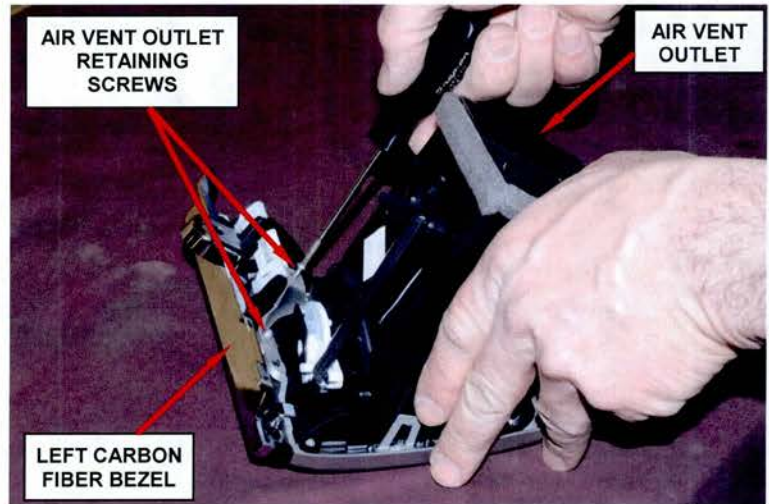
23. Remove and save the two air vent outlet retaining screws (Figure 10).
24. Separate the air vent outlet from the original left carbon fiber bezel. Discard the original carbon fiber bezel.
25. Place the air vent outlet onto the new left carbon fiber bezel and install the two retaining screws. Tighten the screws securely (Figure 12).

**Figure 12 – Air Vent Outlet Retaining Screws**

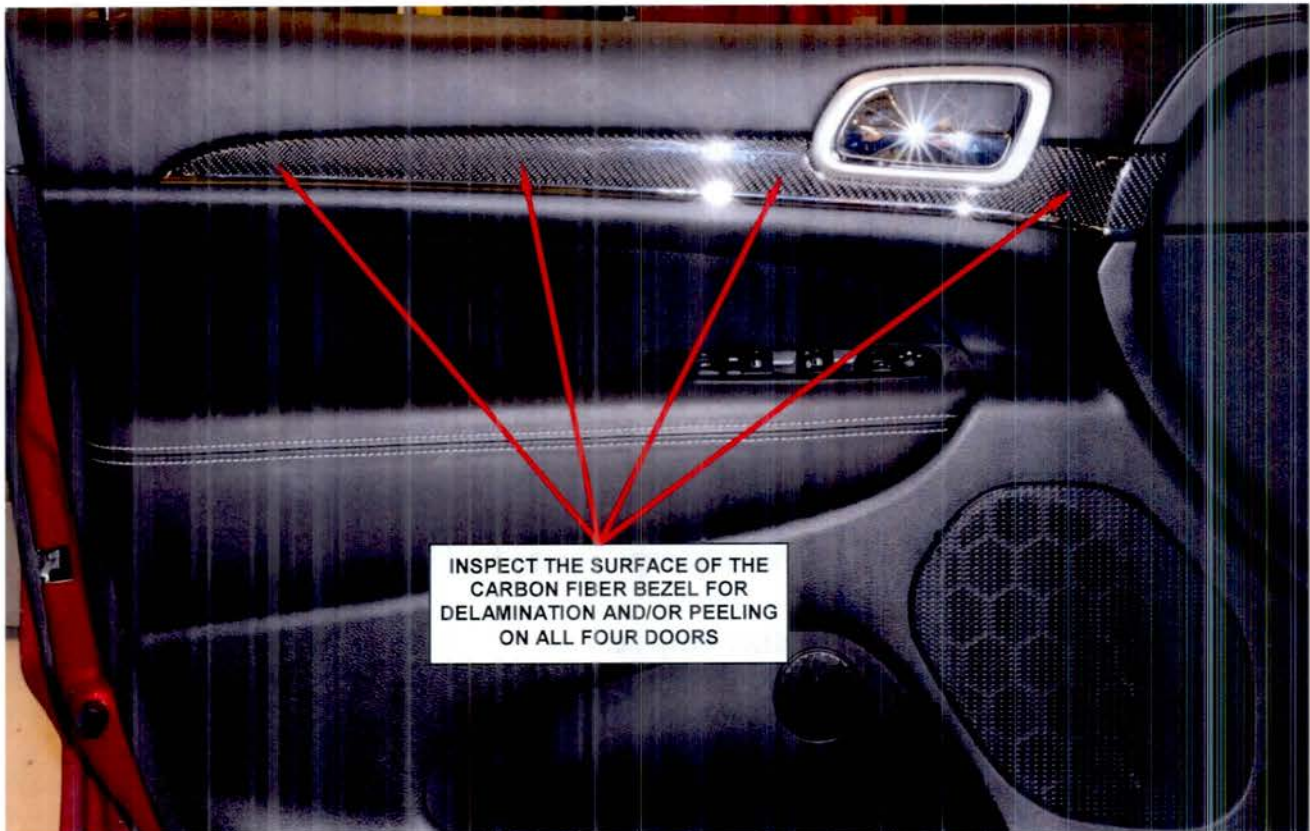
Inspect the carbon fiber bezels on all four doors (Figure 13):

- If **none** of the carbon fiber bezels on the door panels are delaminated or peeling, connect the negative battery cable to the battery and return the vehicle to the customer.
- If there is any delamination or peeling of the carbon fiber on **only the front door bezel(s)**, continue with **Section C. Replace Front Door Carbon Fiber Bezel(s)**.
- If there is any delamination or peeling of the carbon fiber on **only the rear door bezel(s)**, continue with **Section D. Replace Rear Door Carbon Fiber Bezel(s)**.
- If there is any delamination or peeling of the carbon fiber on the **front and rear door bezel(s)**, continue with **Section C. Replace Front Door Carbon Fiber Bezel(s)**.

Figure 13 – Inspect All Door Trim Panel Carbon Fiber Bezels (left front door shown)

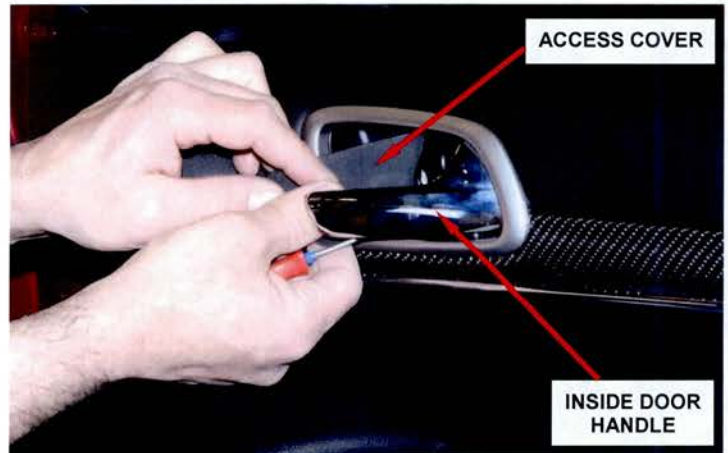
1. Remove and save the inside door handle screw access cover (Figure 14).

Figure 14 – Inside Door Handle Access Cover

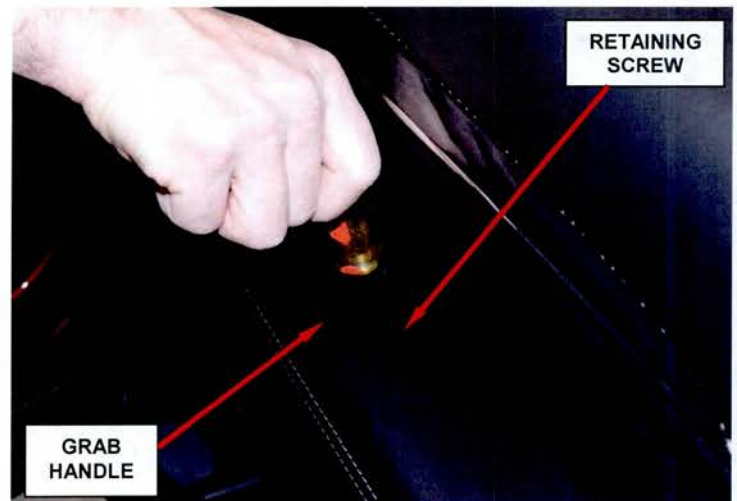
Figure 15 – Grab Handle Retaining Screw

3. Open the grab handle screw access cover. Remove and save the grab handle retaining screw (Figure 15).

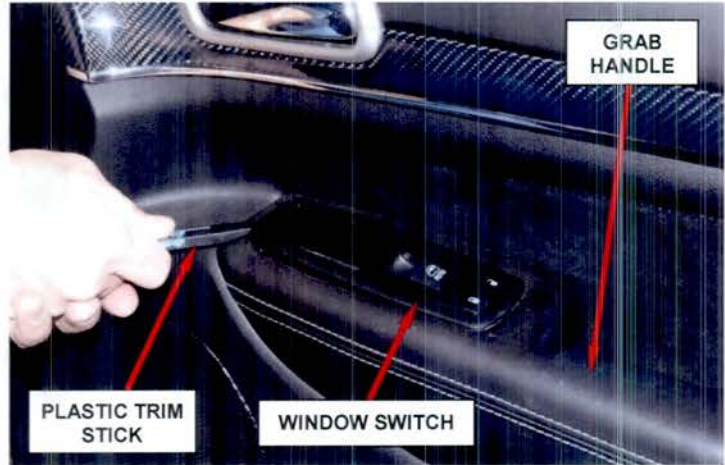
4. Remove and save the window switch assembly (Figure 16).
5. Carefully disengage the door panel retaining clips and remove the door panel from the door (Figure 17).
6. Working from the back side of the door panel, carefully remove and save the seven (7) carbon fiber door panel bezel retaining screws.

Figure 16 – Window Switch

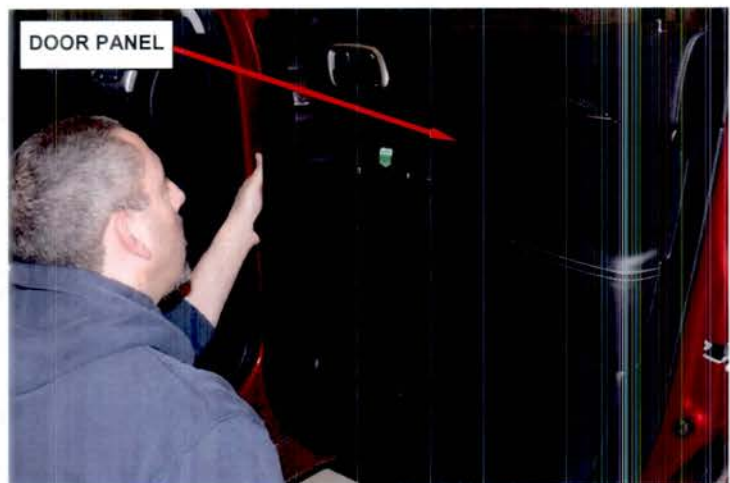
7. Remove and discard the original carbon fiber door panel bezel.
8. Place the new carbon fiber door panel bezel into position on the door panel.
9. Install the seven (7) carbon fiber door panel bezel retaining screws. Tighten the screws securely.
10. Carefully install the door panel onto the door (Figure 17).

**CAUTION: Be sure that all door panel retaining clips are properly engaged.**

Figure 17 – Remove/Install Door Panel

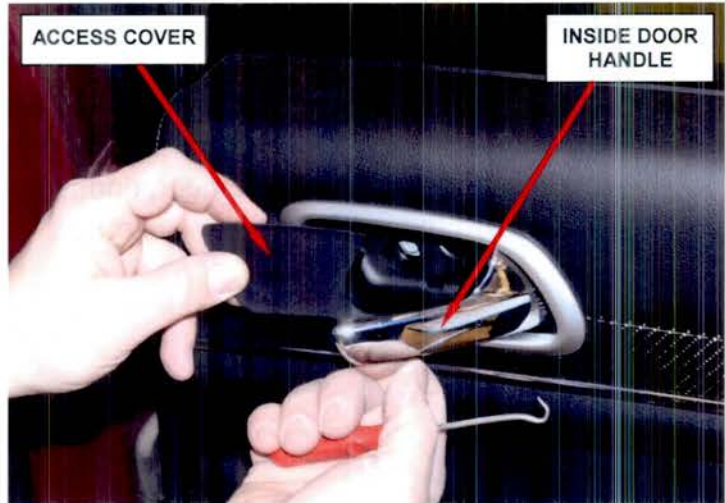
1. Remove and save the inside door handle screw access cover (Figure 18).

Figure 18 – Inside Door Handle Access Cover

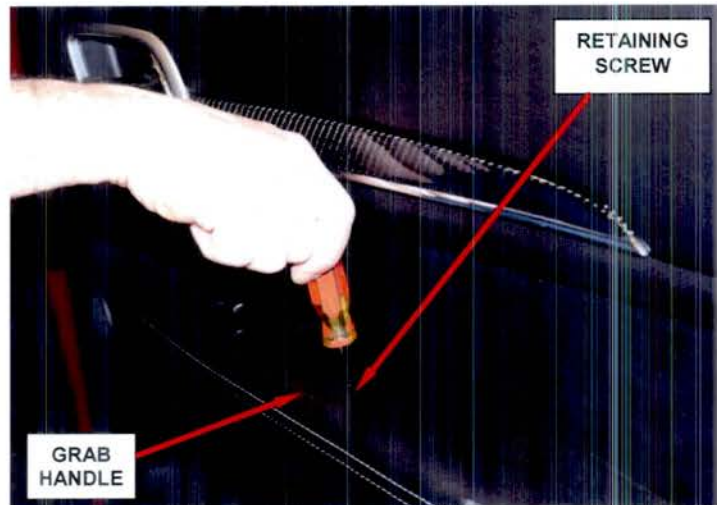
Figure 19 – Grab Handle Retaining Screw

3. Open the grab handle screw access cover. Remove and save the grab handle retaining screw (Figure 19).

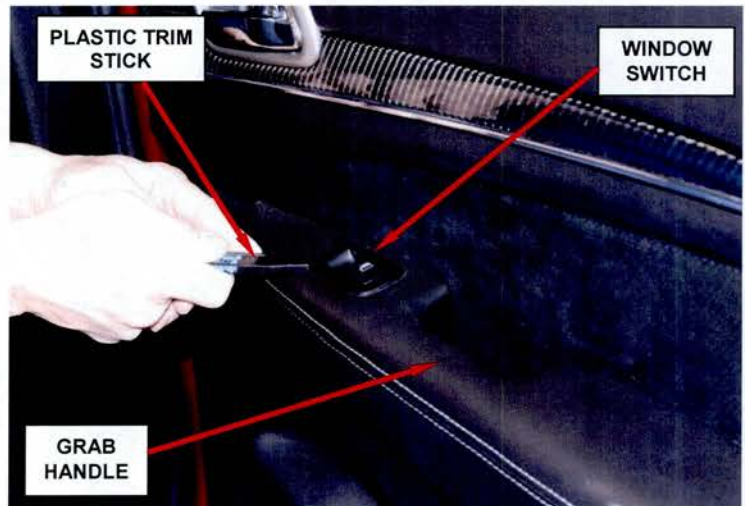
4. Remove and save the window switch assembly (Figure 20).
  5. Carefully disengage the door panel retaining clips and remove the door panel from the door.

Figure 20 – Window Switch
