SERVICE BULLETIN

AT13-004

2013 PATHFINDER; CVT FLUID LEAK AT COOLER HOSE

APPLIED VEHICLE: 2013 Pathfinder (R52)

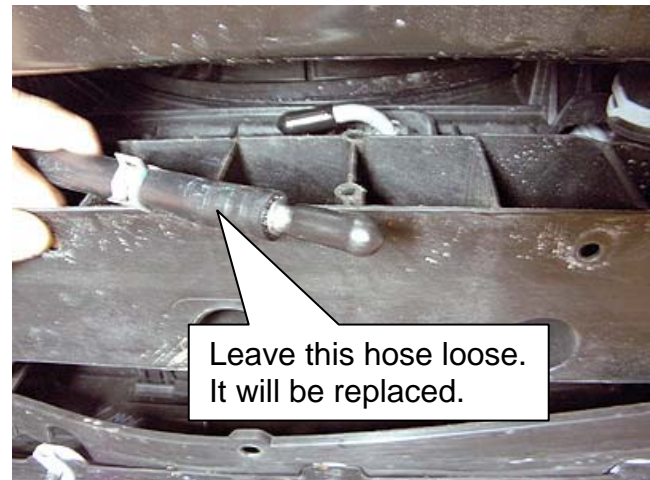
Figure 1

3. Re-attach the engine coolant hoses to the new radiator, and **only** the "auxiliary cooler to radiator hose" (CVT Fluid Cooler Hose C).

- Leave the "transmission to radiator cooler hose" loose at this time (CVT Fluid Cooler Hose A/B Assembly, Figure 1).

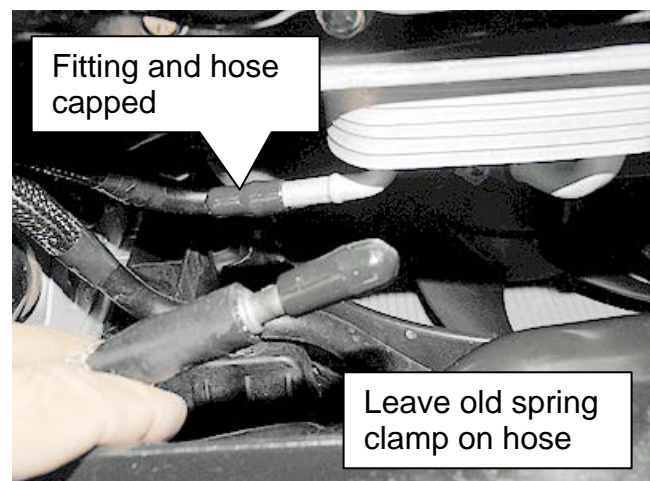
Figure 2

4. On the CVT, slide the "transmission to radiator cooler hose" spring clamp back onto the hose, away from the fitting, and then remove the hose from the fitting (Figure 2).

- Disconnect the two hose support clips to radiator fan shroud.
- Discard this hose and related clamps. They will be replaced with the parts from the **PARTS INFORMATION** table.
