Service Bulletin

Bulletin No.: PI0044D

Subject: Water Leak at Driver/Front Passenger Floor Area and/or Front Carpet Wet**Models:** 2010-2013 Cadillac SRX

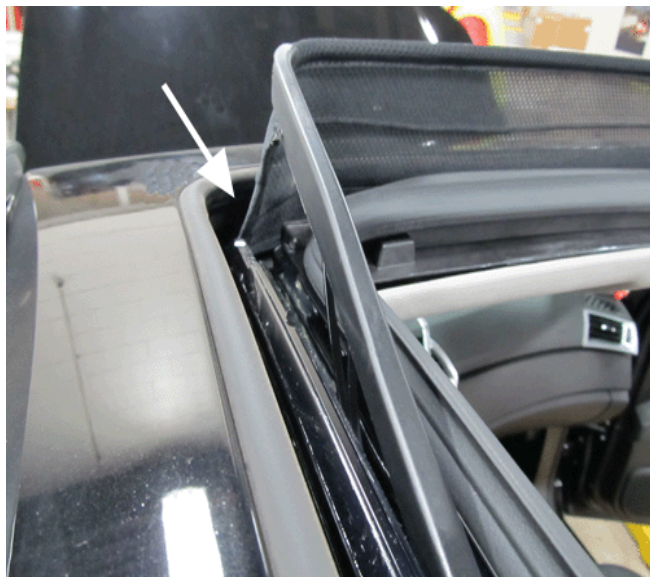
4. Pour water into the outboard front corner of the sunroof frame on one side of the vehicle, and immediately inspect the area rearward of the front tire for water flowing out onto the floor surface.
5. Repeat steps 3 and 4 on the opposite side.
 - If water is properly flowing out the front drain hoses, jump ahead to the “Seal Cowl Seam Repair Procedure” section below and complete the repair steps listed.
 - If water is NOT properly flowing out the front drain hoses, first replace BOTH sunroof front drain hoses following the repair steps below, then continue ahead and complete the “Seal Cowl Seam Repair Procedure” repair steps.

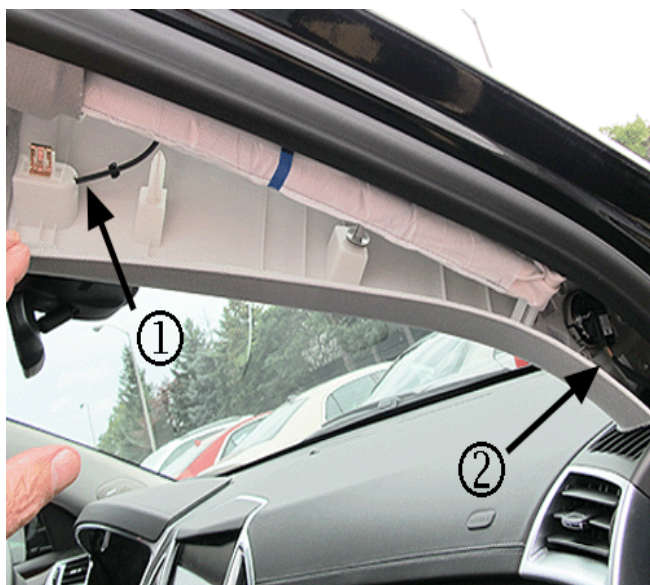
3610902

1. Starting on the left or right side, remove the windshield garnish molding from the A-pillar by pulling gently from the top to disengage the attachment clip. Detach the rubber stop (1) on the tether clip from the molding and disconnect the speaker wiring harness (2).

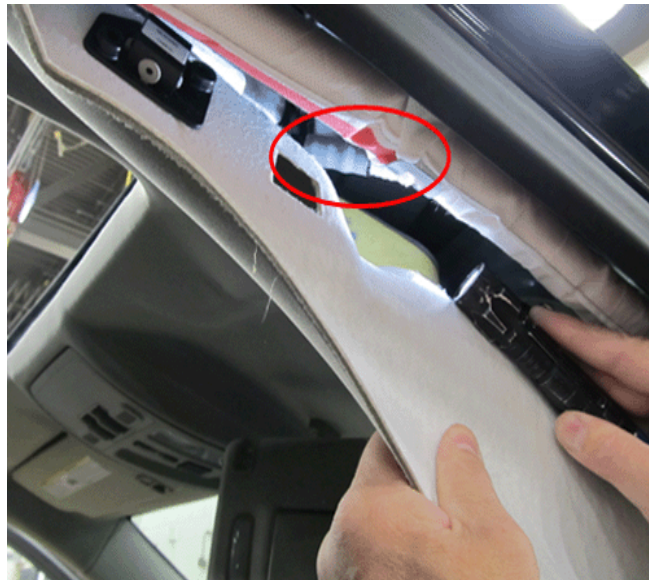
3610910

4. Pull the front corner of the headliner downward to access the drain hose and sunroof drain spigot connection, circled above.
