AT13-006

## 2013 JX; CVT FLUID LEAK AT COOLER HOSE

**APPLIED VEHICLE:** 2013 JX (L50)

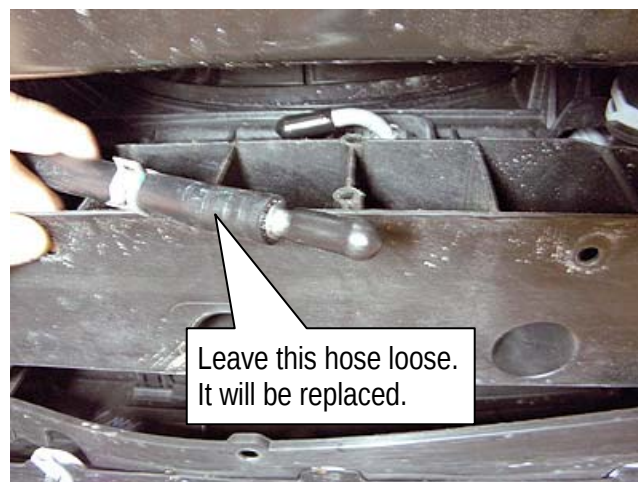
Figure 1

3. Re-attach the engine coolant hoses to the new radiator, and **only** the "auxiliary cooler to radiator hose" (CVT Fluid Cooler Hose C).

- Leave the "transmission to radiator cooler hose" loose at this time (CVT Fluid Cooler Hose A/B Assembly, Figure 1).
