SERVICE BULLETIN

UTILITY TRAILER MANUFACTURING CO.

SB-07-011

PINTLE HOOK LOOP for the Secondary (Safety) Chain – INSPECTION

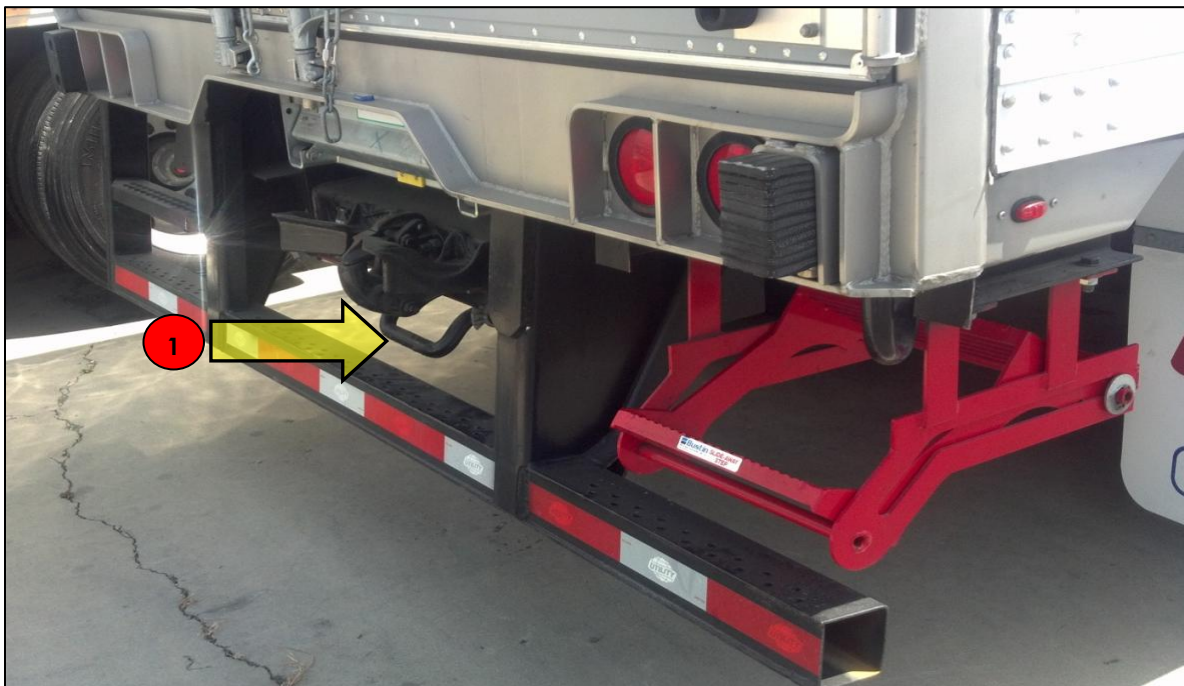
Field Test Procedure (1):

- Stand at the rear of the trailer perpendicular to the pintle hook loop.
- Swing the 10 lbs. sledge and strike the safety loop's rearward surface, striking towards the front of the trailer.
- The impact should leave a mark but not crack the loop in any location.
- Inspect for cracks at the welds to the box beam and any cracks to the loop.

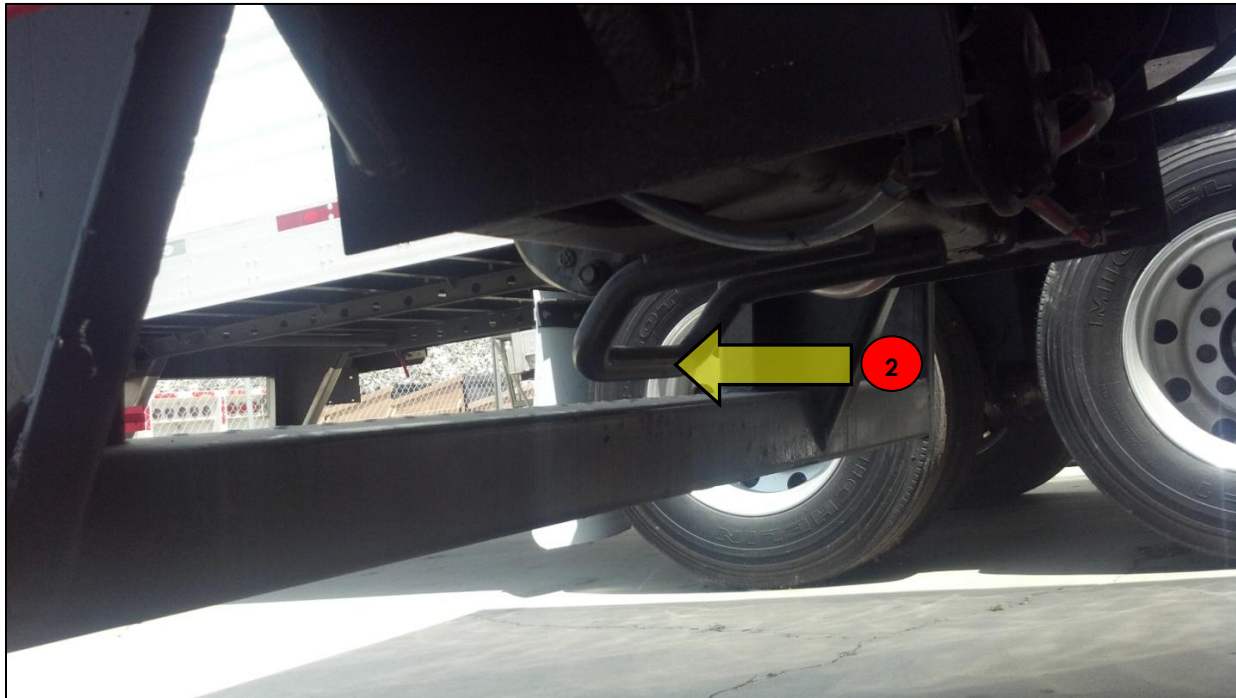
Field Test Procedure (2):

- Repeat sledge hammer strike procedure on the rearward surface of the loop, striking towards the rear of the trailer.
- The impact should leave a mark but not crack the loop in any location.
- Inspect for cracks at the welds to the box beam and any cracks to the loop.

- If you observe any cracks on the pintle hook loop, remove and replace the loop, as follows:
 - Vans and reefers with 1-1/4" diameter loop: [PN 03-5300-027](#)

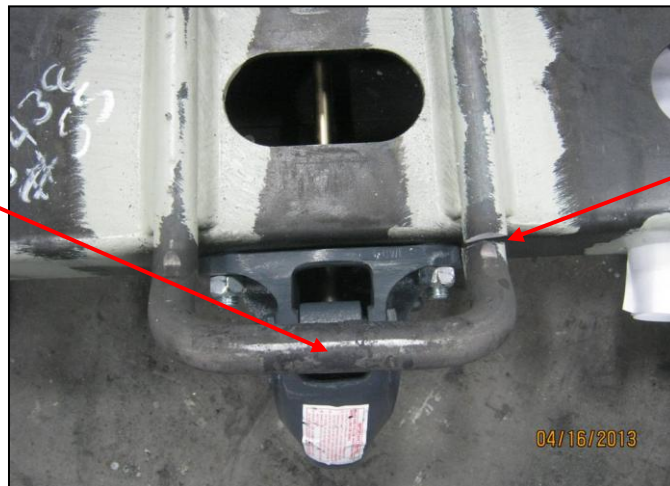
Example of flat mark from sledge hammer impact.

Example of loop not passing inspection – for brittle material

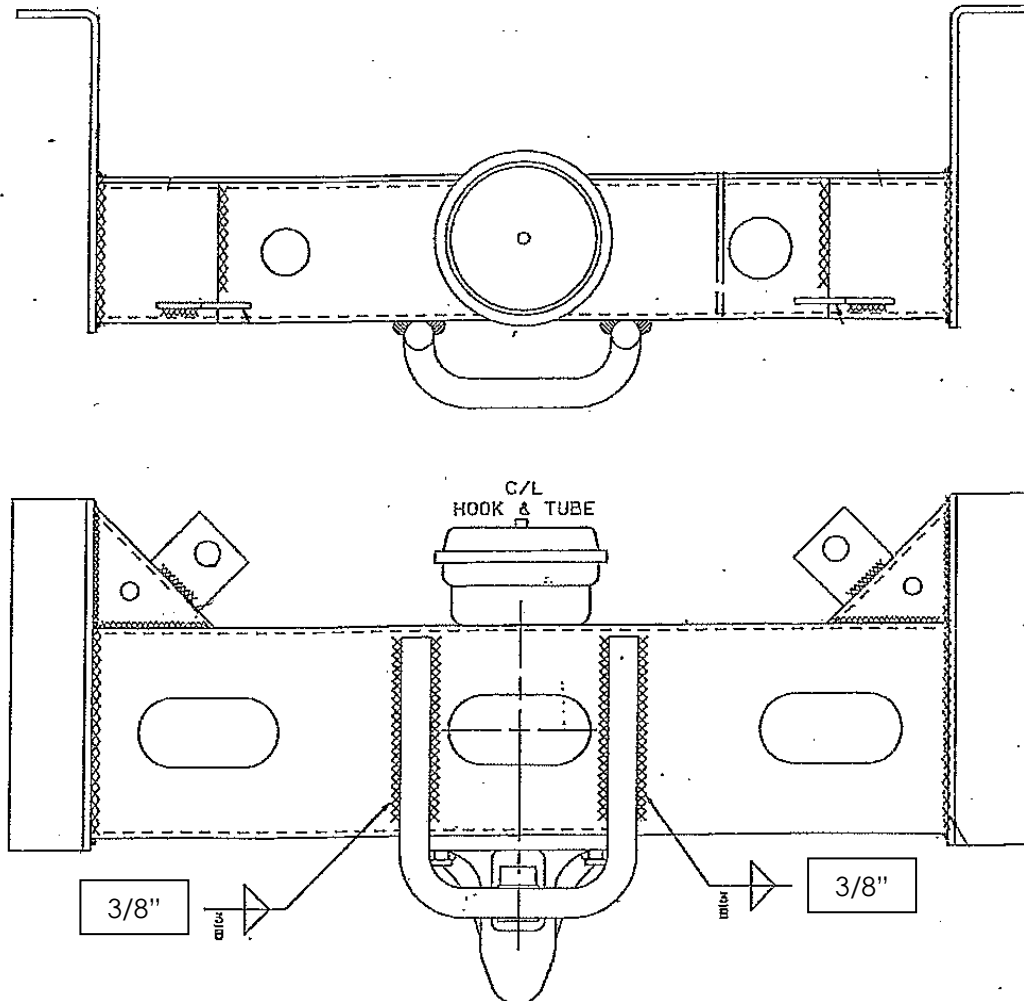
- Weld detail as follows:
