Reach Seat Bellow Support Brackets Service Bulletin

Situation: Driver's seat does not move into the full-forward position.

Corrective Action Summary: Install seat bellow support brackets.

Range of Units Affected: 2012 model year Reach walk-in vans. Contact Utilimaster Warranty Department to verify chassis VIN.

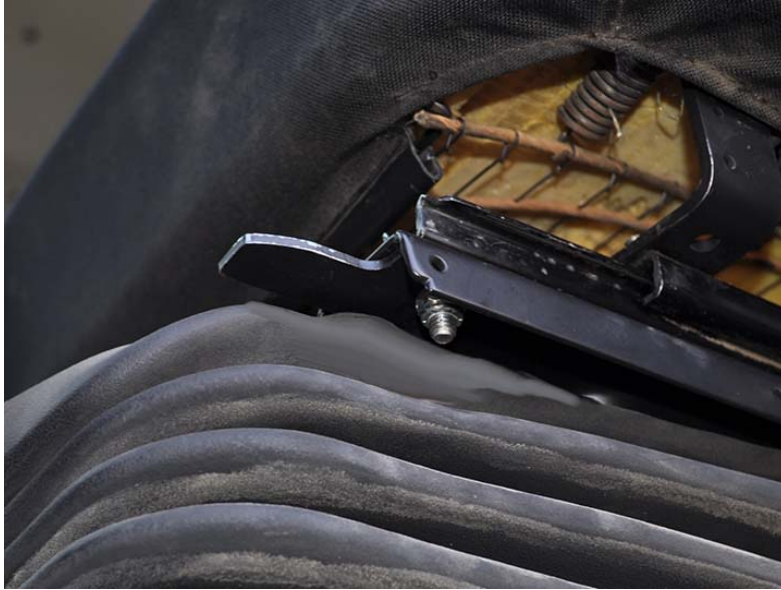
Support bracket orientation

1. Raise the driver's seat into the full UP position.
2. Remove the forward-most seat nuts and pull the seat bellow off the studs.
3. Place a bellow support bracket on BOTH the right-hand and left-hand studs under the slider and put the bellow back on the studs. Secure with the original lock nuts.

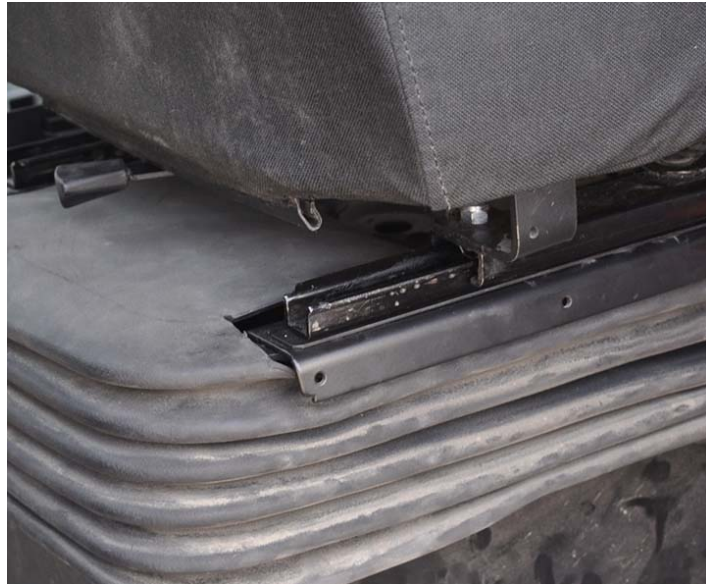
Brackets tucked inside bellows

4. Lower the seat to reduce the tension on the bellows.
5. Pull the corners of the bellows over the brackets.

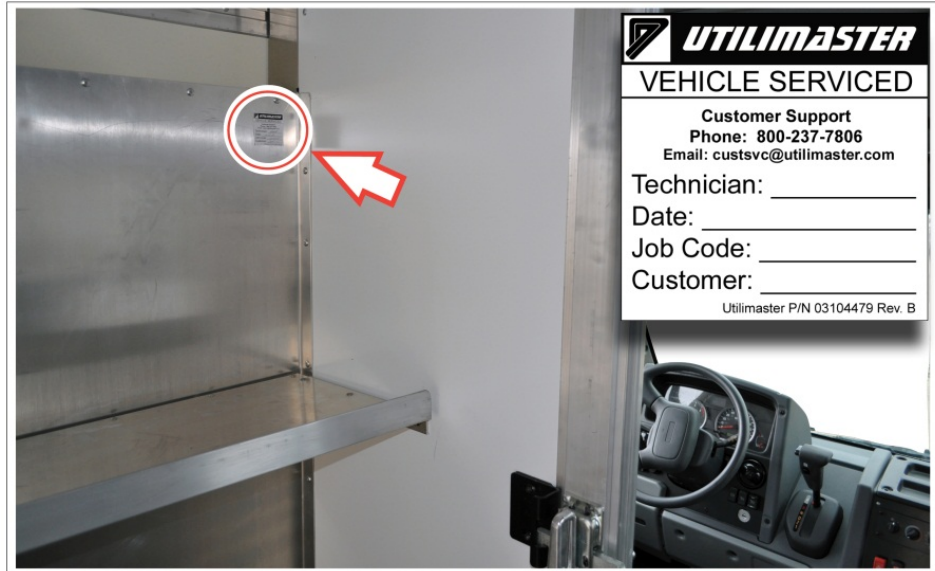
SERVICED decal on driver's door pocket (cargo side)

6. Use Job Code 13-H3-08-Z6 from this document to complete the SERVICED decal.
7. Adhere the decal to the upper right-hand corner of the driver's door pocket panel next to the bulkhead wall. Do NOT cover any previously applied decals.
