**NUMBER:** 08-060-13

**GROUP:** Electrical

Backup Camera Display Screen Is Blank

This bulletin involves installing a jumper harness.

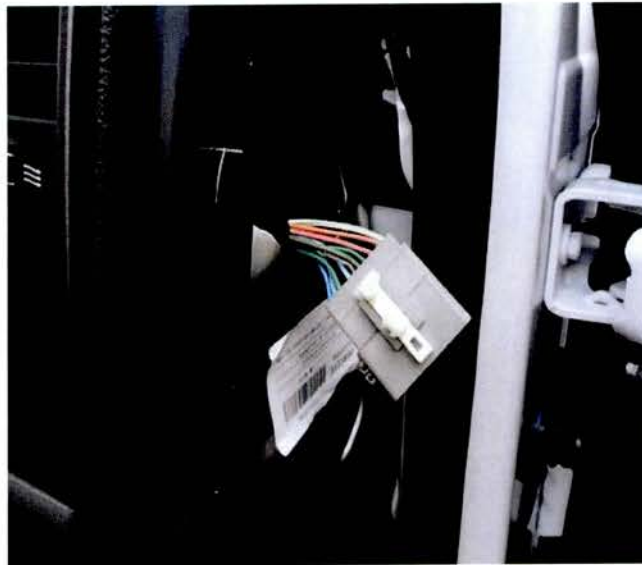
**Fig. 1 Location of connector I 340**

1 - Disconnect connector and pull out for easy access.

1. Is the vehicle equipped With an RA1 radio?
  - a. No >>> Proceed to [Step #20](#)
  - b. Yes >>> Proceed to [Step #2](#)
2. To gain access to the connectors and wire harness the knee bolster, cluster, radio, glove box and right side Instrument panel end cap needs to be removed.
3. Remove knee bolster per TechConnect, 23 - Body / Instrument Panel / COVER, Steering Column Opening/Removal.
4. Remove the cluster per TechConnect, 08 - Electrical/8J - Instrument Cluster/Removal.
5. Remove the radio per TechConnect, 08 - Electrical/8A - Audio/Video/Entertainment/Connectivity/RADIO/Removal.
6. Remove the glove box per TechConnect, 23 - Body/Instrument Panel/GLOVE BOX, Instrument Panel/Removal.
7. Use a trim stick to remove the IP end cap.
8. Locate gray connector I 340, through the opening of the right side of dash, see ([Fig. 1](#)).
