Number: **FS-2013-03**Date: **July 2, 2013**Model: **All Buses Subject To FS-2012-03, 04 & 05**

Robert L. Birdwell, Executive Director  
Quality Control & Field Service**Subject: Exhaust System Flex Pipe Change**

# FIELD SERVICE BULLETIN

### **For the installation of the Tru-Flex all metal, braid reinforced NTSD exhaust bellows on 2007-2013 year engine equipped buses.**

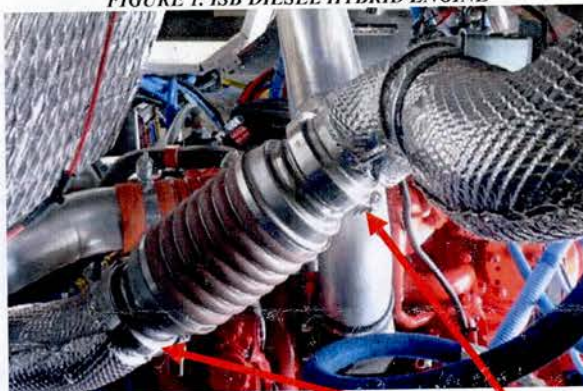
FIGURE 1. ISB DIESEL HYBRID ENGINE

LOOSEN V-BAND CLAMPS  
SHOWN TO REMOVE THE  
EXISTING BELLOWS  
(CLAMP LOCATION "C")

NOTE: LINKEO BELLOWS  
SHOWN, BTLI AND NTSD  
REMOVAL IS SIMILAR.

1. Remove the existing exhaust bellows from the bus by loosening the two V-Band clamps.

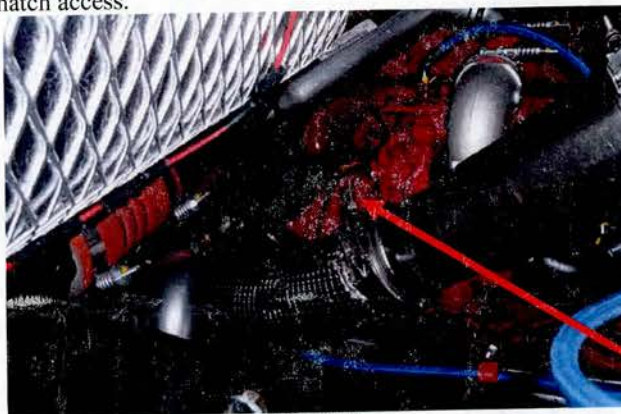
FIGURE 7.

4. To access the turbo outlet pipe V-Band clamps, remove the settee hatch from inside the bus.
5. Loosen both Cummins cast turbo outlet elbow V-Band clamp and exhaust turbo outlet pipe V-Band clamp through the settee hatch access.

LOOSE V-BAND CLAMPS  
THROUGH SETTEE HATCH

VIEW FROM  
SETTEE HATCH

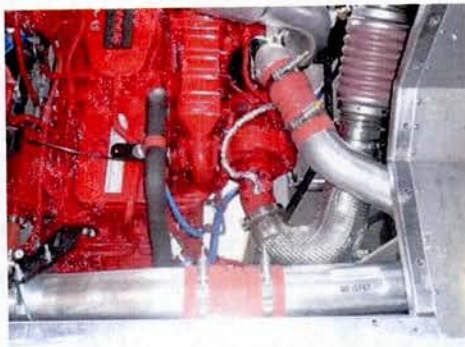
FIGURES 8 & 9. ISB DIESEL HYBRID ENGINE SHOWN

CAST ELBOW AT TURBO  
OUTLET V-BAND CLAMP  
(CLAMP LOCATION "A")

- CAST TURBO OUTLET ELBOW V-BAND CLAMP LOCATION "A", SEE FIGURES:  
8 & 9 FOR ISB on page 4  
10 & 11 FOR ISL on page 4  
12 & 13 FOR ISL-G on page 5
- EXHAUST TURBO OUTLET PIPE V-BAND CLAMP LOCATION "B", SEE FIGURES:  
8 & 9 FOR ISB on page 4  
10 & 11 FOR ISL on page 4  
N/A for ISL-G
- ALIGNMENT TOOL UPPER & LOWER V-BAND CLAMPS LOCATION "C", SEE FIGURE 16 BELOW
- MUFFLER INLET PIPE V-BAND CLAMP LOCATION "D", SEE FIGURES:  
14 FOR ISB on page 5  
14 FOR ISL on page 5  
15 FOR ISL-G on page 5
- MUFFLER INLET PIPE U-CLAMP LOCATION "E", SEE FIGURES:  
14 FOR ISB on page 5  
14 FOR ISL on page 5  
15 FOR ISL-G on page 5

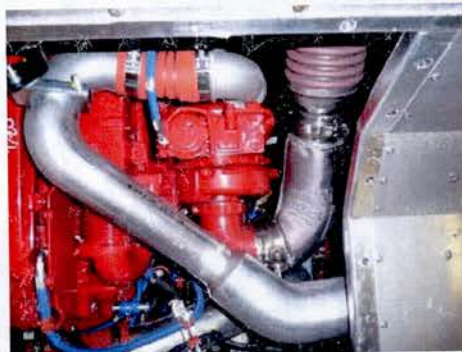
FIGURE 10 & 11. ISL ENGINE SHOWN

TURBO OUTLET  
PIPE INLET  
V-BAND CLAMP  
(CLAMP  
LOCATION "B")

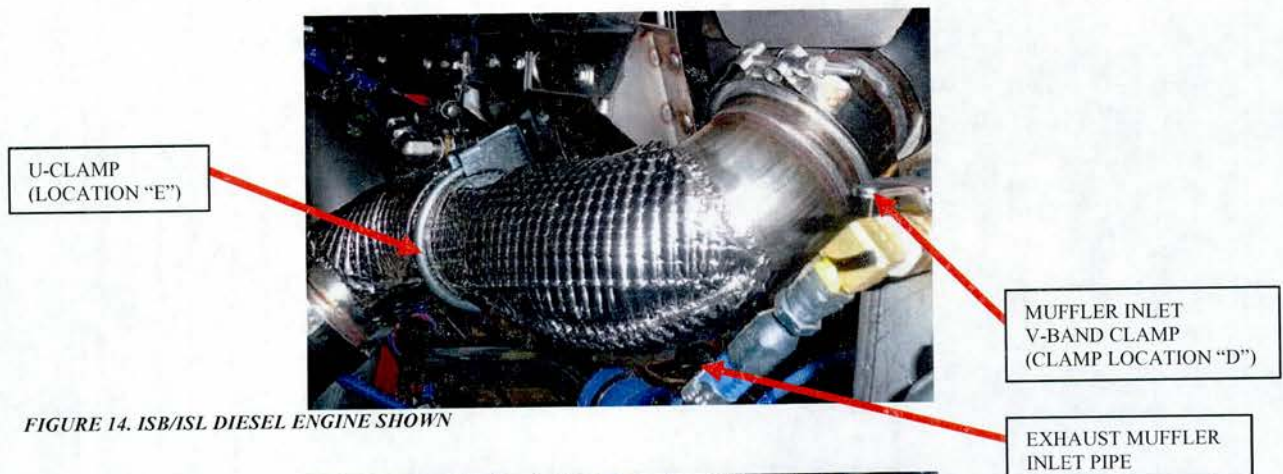
FIGURE 14. ISB/ISL DIESEL ENGINE SHOWN

6. Loosen the V-Band & U clamps on exhaust muffler inlet pipe. Loosening the clamps will allow the pipes to move into alignment.

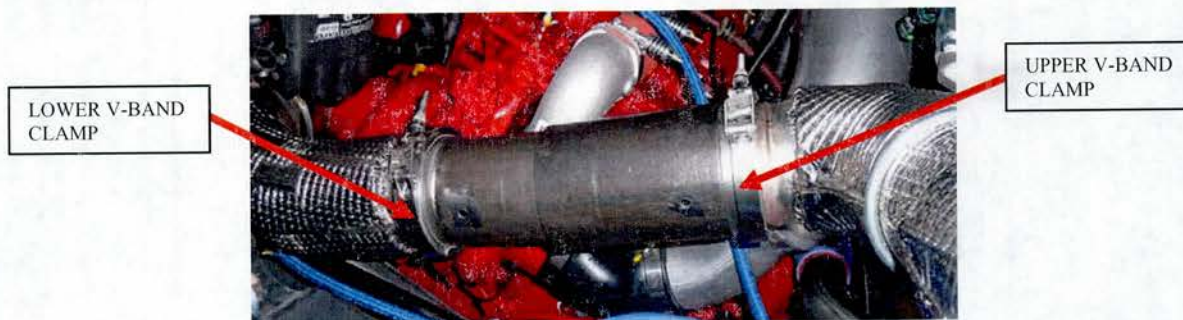
FIGURE 16.

8. After torquing all the clamps to 13+/- 0.5 ft-lb, remove the alignment tool by loosening upper & lower V-Band clamps.
9. Measure the length of the gap between the two exhaust pipe flanges and verify the length is within the allowable range for the specific bellows to be installed. Refer to the table below and Figure 17 for the appropriate dimension.
