SERVICE CAMPAIGN BULLETIN

NTB13-092

VOLUNTARY SERVICE CAMPAIGN 2013 FRONTIER HVAC FRONT AIR CONTROL ASSEMBLY

APPLIED VEHICLES: 2013 Frontier (D40)

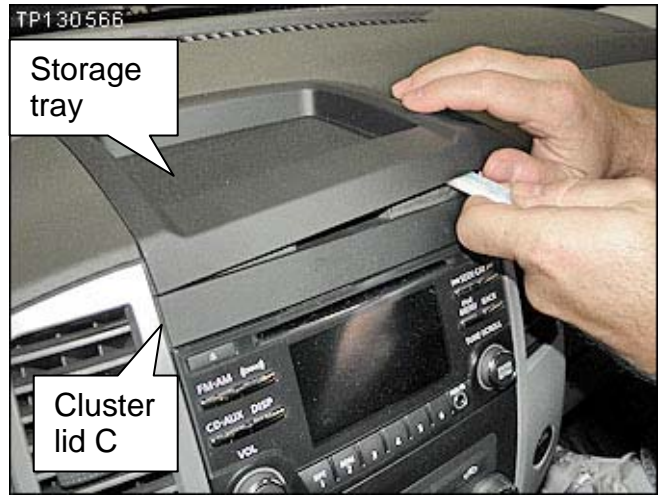
Figure 1

4. Remove the storage tray.
 - The storage tray snaps loose from the top of cluster lid C.
 - Use a plastic trim tool as needed.

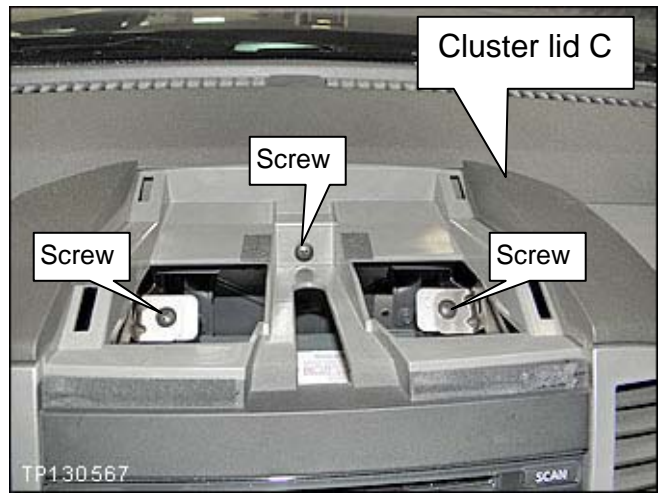
Figure 2

5. Remove three screws from the top of cluster lid C.

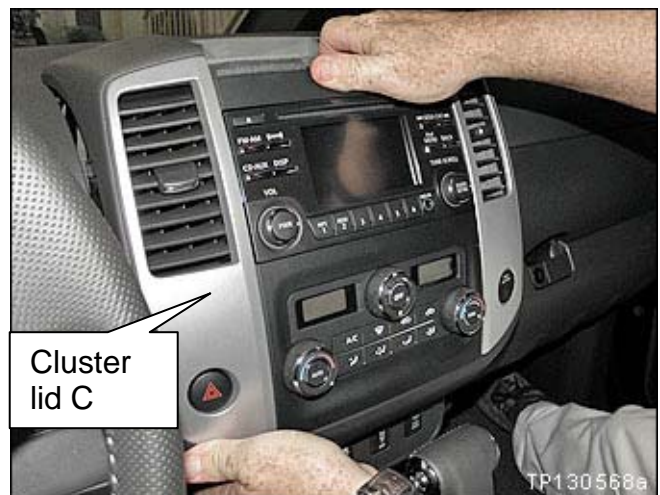
Figure 3

6. Carefully pull cluster lid C rearward to snap it loose from the instrument panel.
7. Disconnect all of the electrical connectors from the back of cluster lid C.

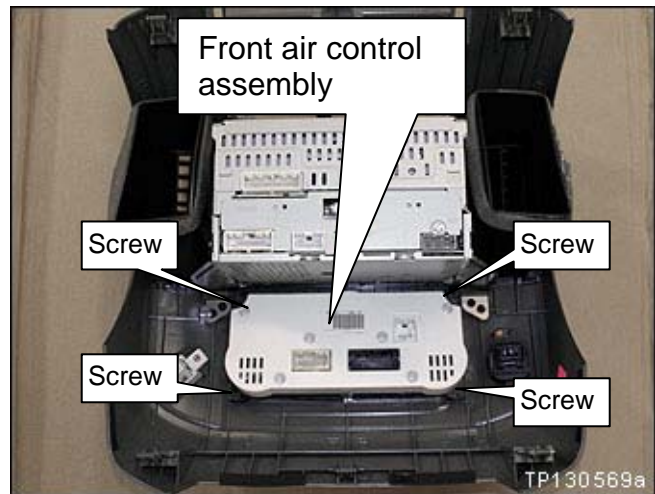
Figure 4

9. Remove the 4 screws from the front air control assembly (one at each corner).

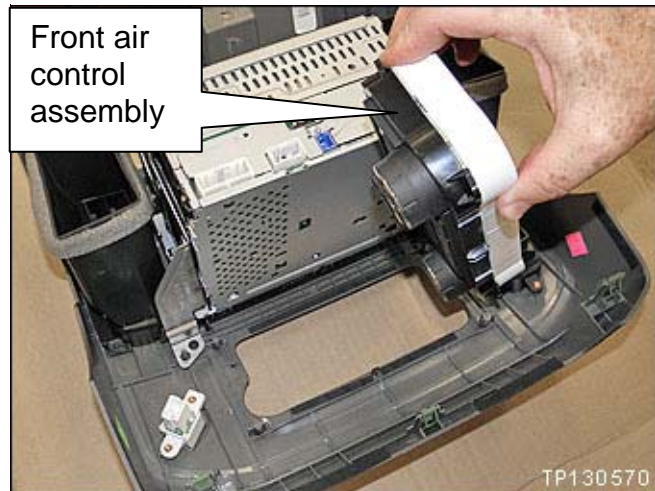
Figure 5

10. Remove the old front air control assembly and install the new one.
