HYUNDAI NEW THINKING. NEW POSSIBILITIES. Technical Service Bulletin	GROUP CAMPAIGN	NUMBER 13-01-025
	DATE JULY 2013	MODEL(S) YF SONATA, YF HEV SONATA HYBRID, HG AZERA
SUBJECT: REAR LOWER CONTROL ARMS REPLACEMENT (SERVICE CAMPAIGN TP3)

Description: This bulletin describes the procedure to replace the rear lower control arms on some Sonata (YF), Sonata Hybrid (YF HEV), and Azera (HG) vehicles.

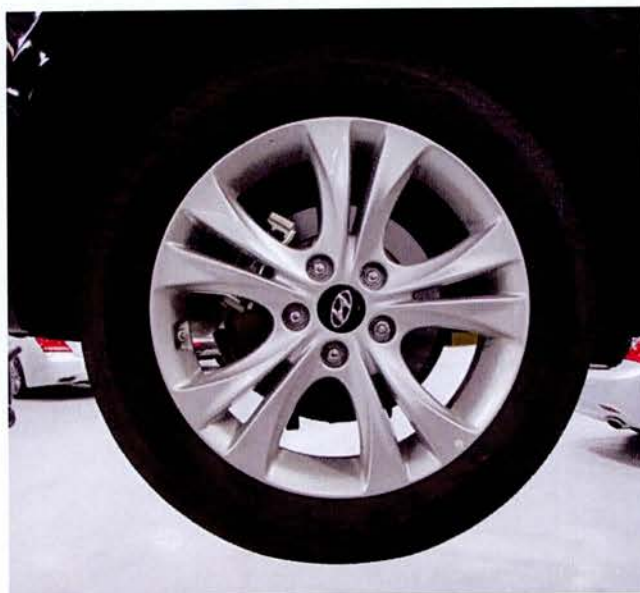
1. Lift the vehicle using a hoist.
Remove the rear wheel/tire assemblies.

Tightening torque:
88.3~107.9 Nm (9.0~11.0 kgfm,
65.1~79.6 lb-ft)

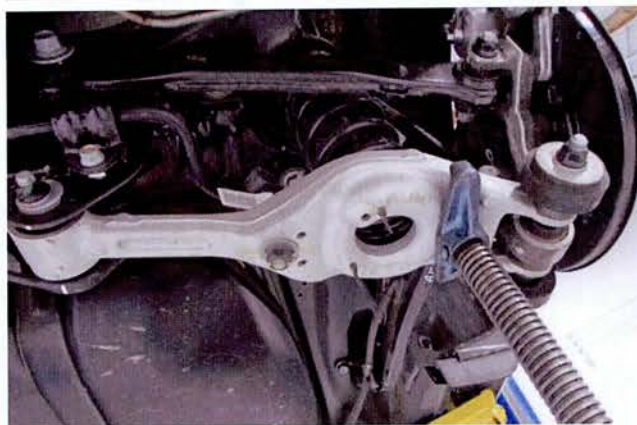
2. Position a transmission jack under the right rear control arm by the spring seat.

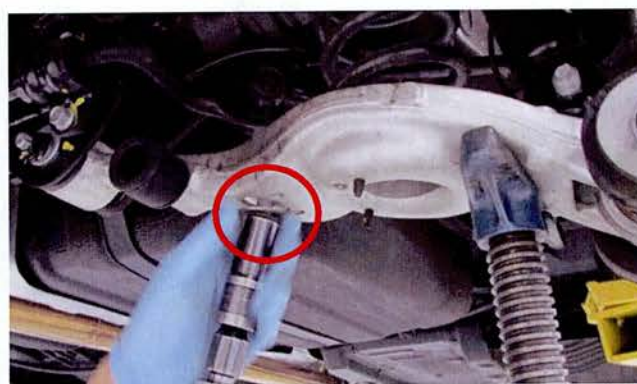
3. Remove the right side stabilizer bar end link nut that mounts the link to the control arm. This link will be re-used.

Tightening torque:
98.1~117.7 Nm (10.0~12.0
kgfm, 72.3~86.8 lb-ft)

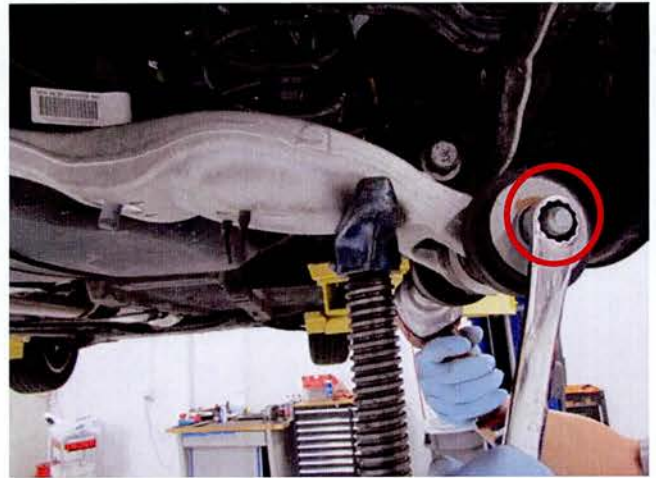
4. Remove the lower control arm bolt at the wheel side.

Tightening torque:
137.3~156.9 Nm (14.0~16.0
kgfm, 101.3~115.7 lb-ft)

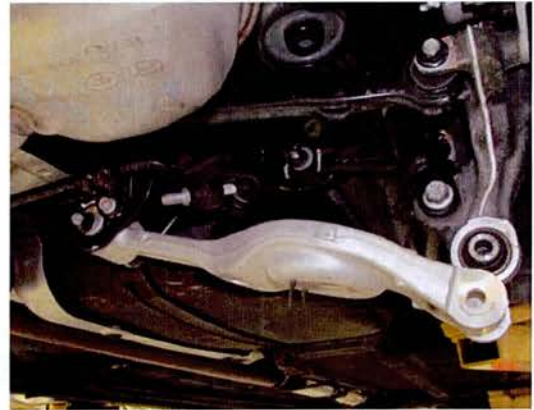
5. Carefully lower the transmission jack until the control arm swings down and releases the coil spring. Remove the coil spring.

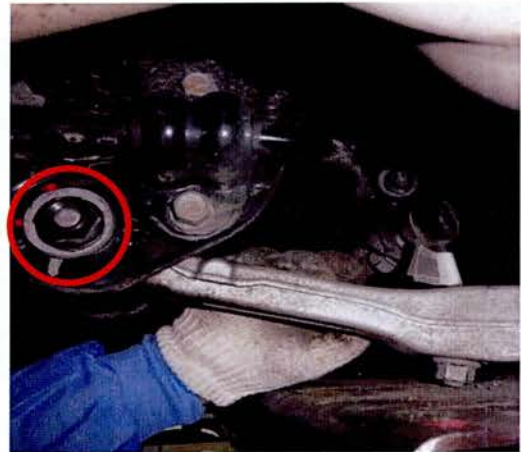
6. Mark the location of the alignment washer, then loosen the control arm bolt on the subframe side.

Tightening torque:
107.9~117.7 Nm (11.0~12.0
kgfm, 79.6~86.8 lb-ft)

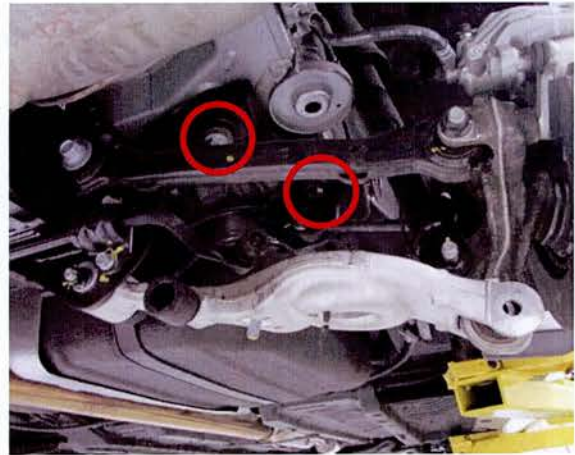
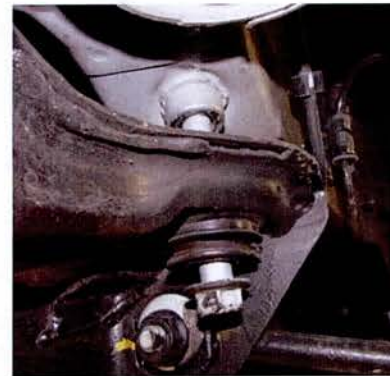
7. Locate the rear subframe. Loosen the two right side mounting bolts to allow clearance to remove the control arm bolt.

Tightening torque:
156.9~176.5 Nm (16.0~18.0
kgfm, 115.7~130.2 lb-ft)

All models of Sonata, Sonata HEV, and Azera require that the RIGHT side of the rear subframe be loosened to allow clearance for the bolt to be removed.

Only Sonata HEV requires an additional step to remove a fastener on the LEFT side to allow clearance for the bolt to be removed. See step 9.

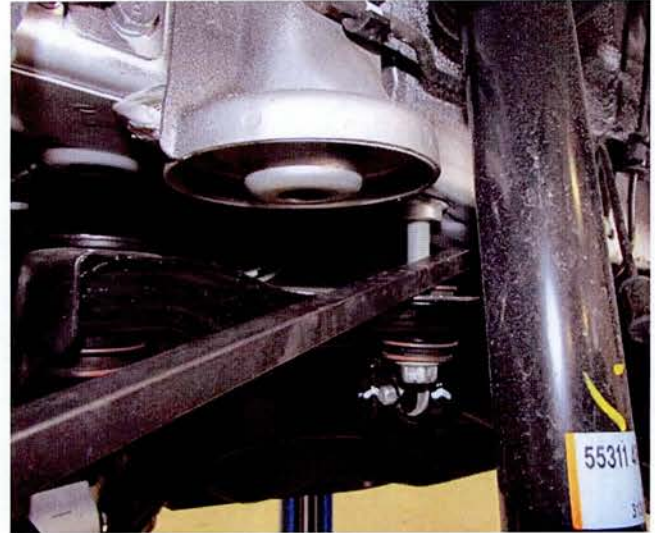
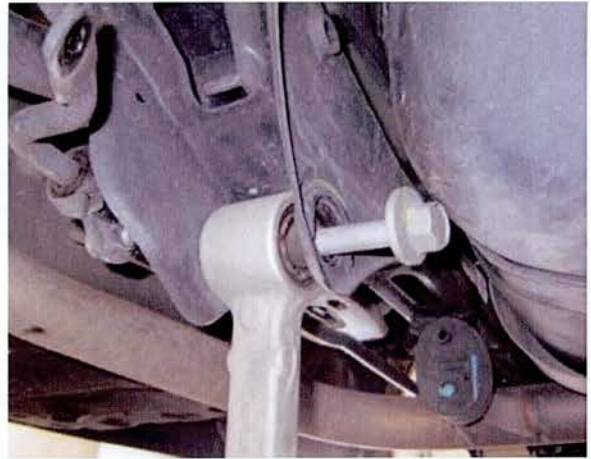
8. Use a pry bar to pull the subframe downwards slightly to create enough clearance between the control arm bolt and the fuel tank. Remove the bolt, and the right side rear lower control arm.

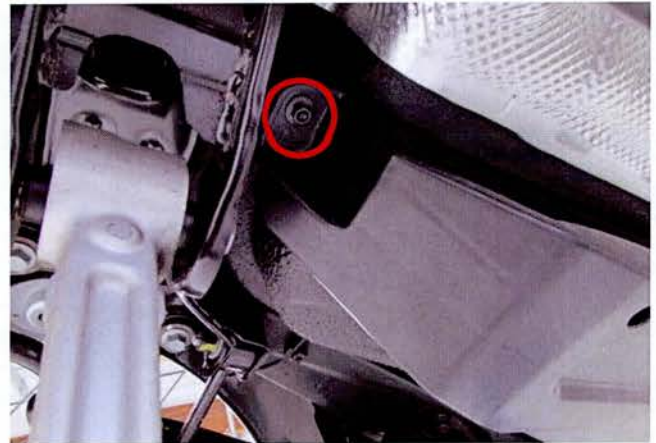
This step applies to Sonata HEV only. Skip this step for other models.

On the LEFT side, remove the fastener for the plastic underbody tray closest to the rear control arm.

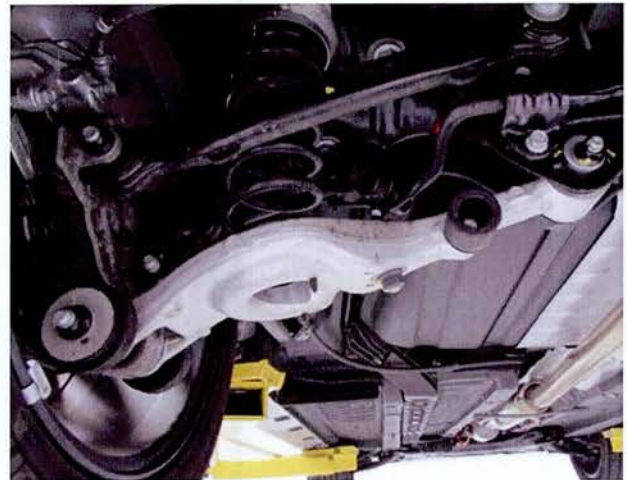
Repeat steps 2-6 on the left side of the vehicle and then remove the left rear lower control arm.

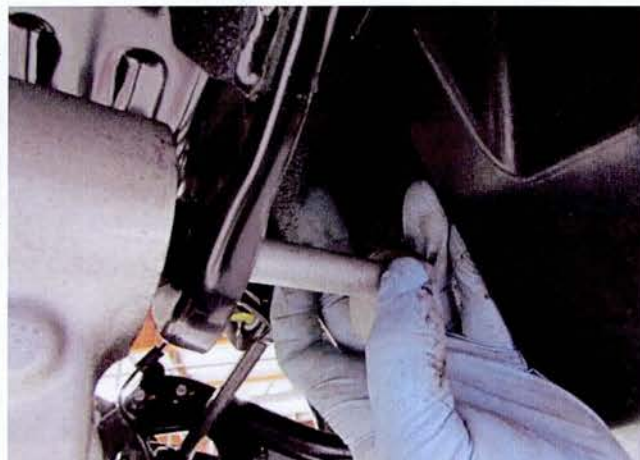
For Sonata HEV vehicles, push the loosened plastic underbody tray away to create enough clearance for the lower control arm bolt to be removed.
