GROUP Engine	MODEL 2011-2013MY Sorento (XMa)
	NUMBER 139	DATE September 2013
TECHNICAL SERVICE BULLETIN		
SUBJECT: VCMA DIAGNOSIS - MIL ON WITH DTC P200A

SUBJECT: VCMA DIAGNOSIS - MIL ON WITH DTC P200A

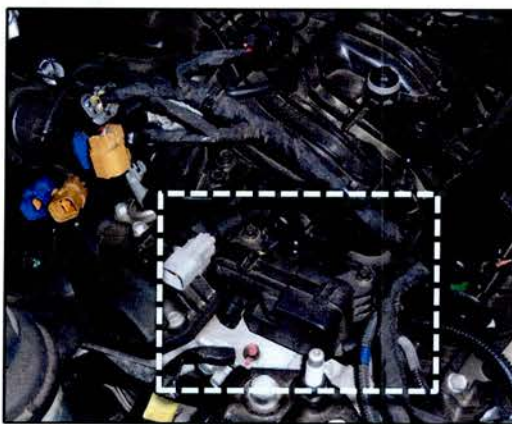
This bulletin provides information for some 2011-2013MY Sorento (XMa) vehicles, equipped with a 3.5L MPI engine, which may exhibit a Malfunction Indicator Lamp (MIL) with DTC P200A, after engine startup. DTC P200A may be caused by an inoperative VCM actuator, or by an inoperative valve linkage inside the intake manifold assembly. If the VCMA or the valve linkage is inoperative, the ECM may not be able to correctly control the intake path of air into the engine. Follow the procedures outlined in this bulletin to diagnose and correct the concern.

DTC P200A Intake Manifold Runner Performance

Variable Charge Motion Actuator (VCMA)

13. If the VCMA does not activate, replace it by referring to the applicable Service Manual on KGIS. Proceed to step 14 for additional testing of the valve linkage.

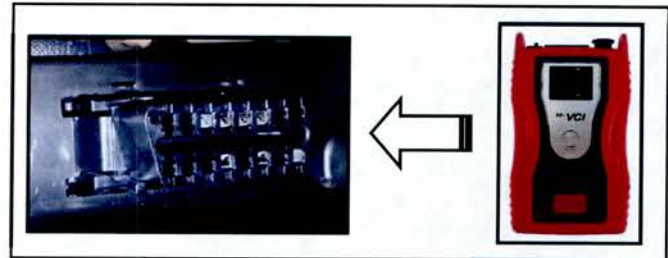
6. Connect the Main 16-pin DLC cable (GHDM – 241000) to the OBD-II connector, located under the driver's side of the instrument panel.

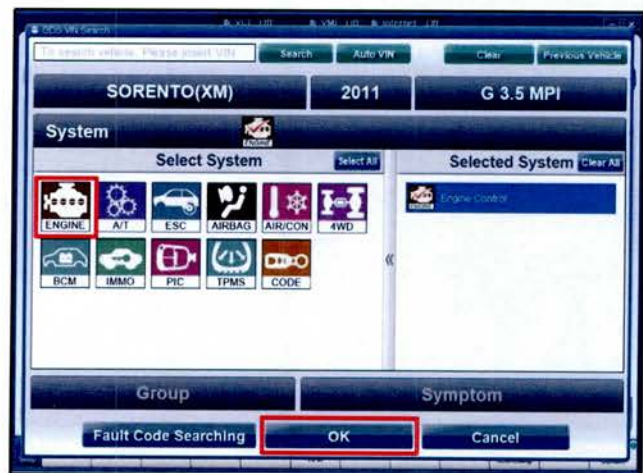
7. With the ignition key ON, turn "ON" the VCI and GDS tool. Access the GDS vehicle identification number (VIN) screen and configure the vehicle using the **VIN AUTO DETECT** Function.
8. Select **ENGINE** system and click **OK**.

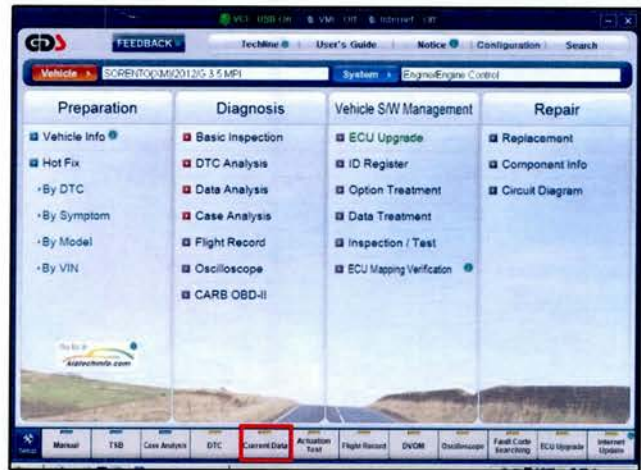
9. Click on **Current Data**.

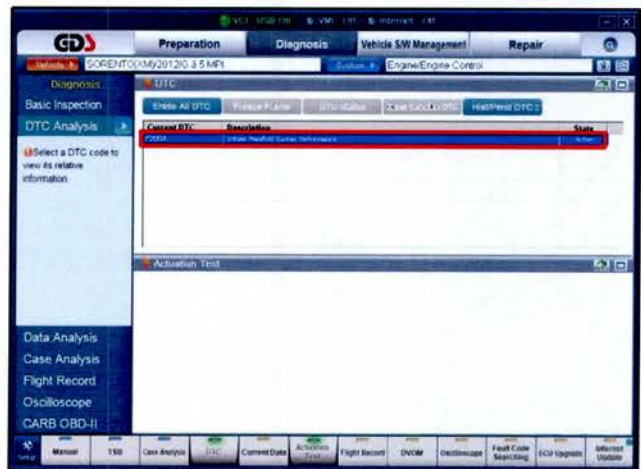
10. Click on **DTC Analysis** and check for the presence of DTC P200A.

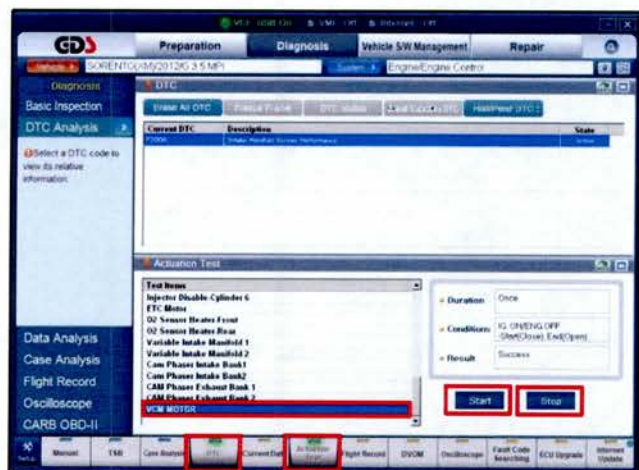
11. Select **Current Data > Actuation Test > VCM Motor**.

- Use the **START** and **STOP** buttons to activate the VCMA.
- Visually check VCMA activation under the hood.

12. If the VCMA activates, no further action on the VCMA is required. Proceed to step 14.

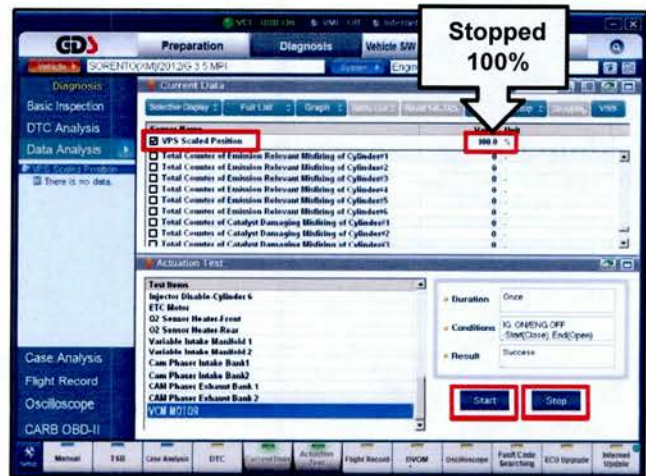
- After successfully testing the actuation of the VCMA, or replacing the VCMA, select **Data Analysis > Current Data > Actuation Test** to actuate the valve linkage.
- Check the box for **VPS Scaled Position** and click on the **Start** and **Stop** buttons.

*** NOTICE**
 Displayed values for the valve linkage test will vary from vehicle to vehicle.

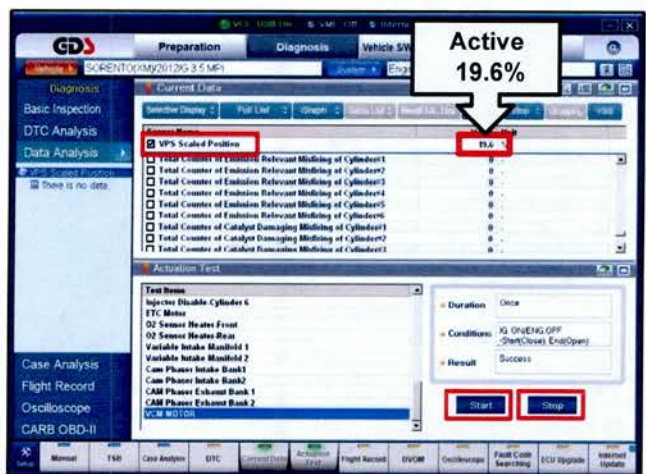
- Perform the valve linkage actuation test a total of three (3) times. Record and compare the actual values displayed to the specification values shown in the table below.

Specification Values	
Stopped	Active
90% (±10%)	25% (±10%)

- If the values are within specification, no further action is required. If there is no change in the values, replace the lower intake manifold assembly by referring to the applicable Service Manual on KGIS.
- Reinstall all other removed components.

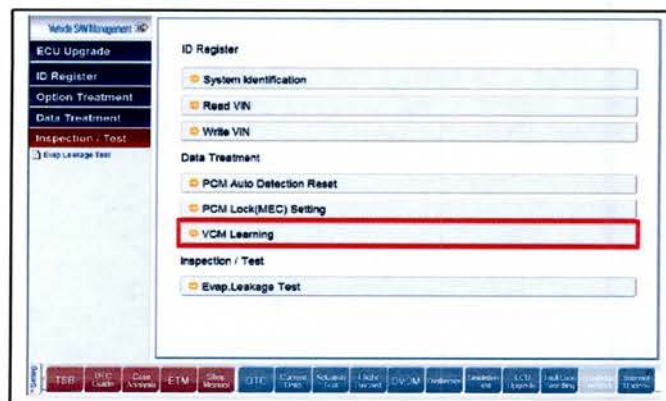
19. Perform a VCMA relearn procedure as outlined below, otherwise, DTC P200A may recur.
- Turn OFF the ignition switch
 - Connect GDS to the Data Link Connector (DLC)
 - Turn the ignition switch ON
 - Select the "Vehicle", "Model year", "Engine" and "System"
 - Select the "Vehicle S/W Management"
 - Select "Inspection/Test"
 - Select "Inspection/Test"

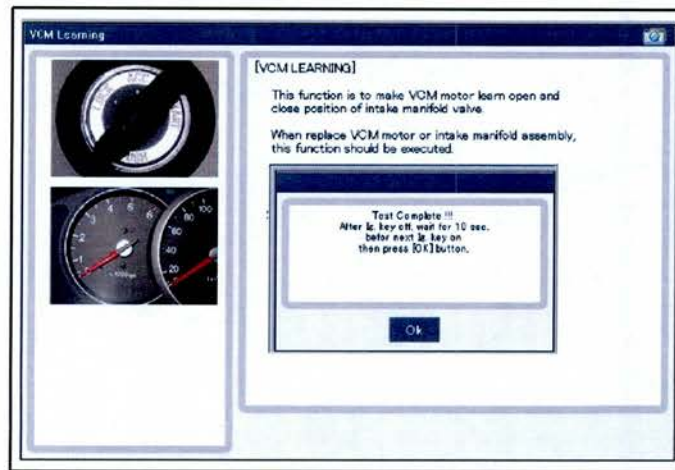
- Follow the on-screen instructions to finalize the test.
