GROUP Brake System	MODEL 2011MY Sorento (XM)
	NUMBER PS252	DATE May 2013

<p>SUBJECT: 2011MY SORENTO STOP LAMP SWITCH INOPERATIVE AFTER PERFORMING CAMPAIGN SC098</p>

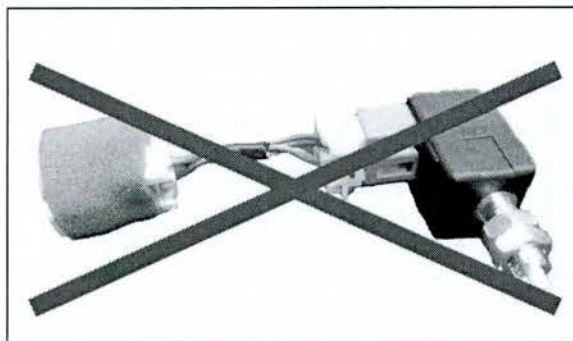
This article provides information regarding a small number of nonfunctioning stop lamp switches in Sorento (XM) vehicles, after performing Voluntary Safety Recall Campaign SC098. It is possible that in some cases, as a result of a previous improper repair, an incorrect stop lamp switch, originally supplied only for 2006-07MY Sorento (BL) vehicles, was installed in 2011MY Sorento vehicles. The stop lamp switch in question has a pigtail (see image) and installation of this pigtail into the new solid state switch results in a reversal of polarity at the switch. Polarity is critical for the correct operation of the new switch and, therefore, it will not function as intended if the pigtail is used.

P/N 93810 3K300QK
Only applies to 2006-07 Sorento (BL)
Do not use in any other application

If you encounter a situation as described above, remove the switch and pigtail from the vehicle's wiring harness and discard them. Plug the vehicle's wiring harness directly into the new stop lamp switch as described in Voluntary Safety Recall Campaign SC098. Once installation is complete, verify proper operation of the stop lamps.
