Fuel hose under engine cover leaky

Topic number	LI47.25-N-057148
Version	1
Design group	47.25 Lines, hoses
Date	09-16-2013
Validity	MODEL 906 with OM651
Reason for change	Distribution extended
Reason for block

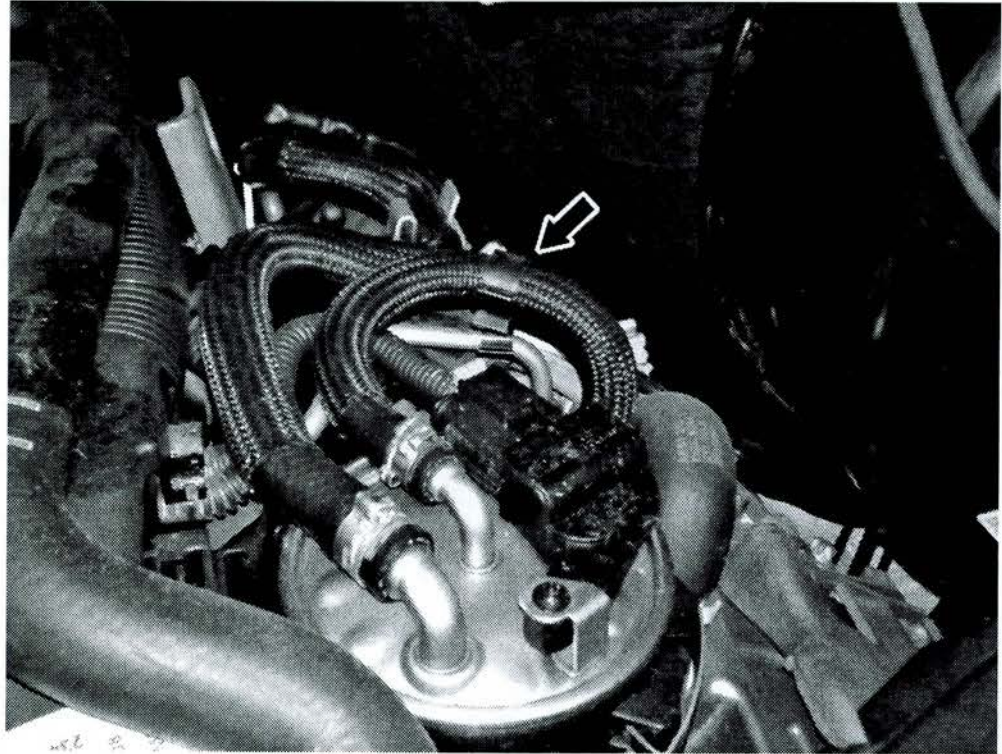
1.jpg:

Fuel hose chafes on engine cover.

Attachments	
File	Designation
1.jpg	Hose bracket on fuel hose.

Replace fuel hose and connect to other line with hose bracket (see attachment).
