Bulletin No.: PI1088

# Service Bulletin

**Subject: Information on Proper Auxiliary Power Connections**

**Models:** 2011-2014 Chevrolet Caprice PPV  
Equipped with Auxiliary Battery RPO K4S or K5S

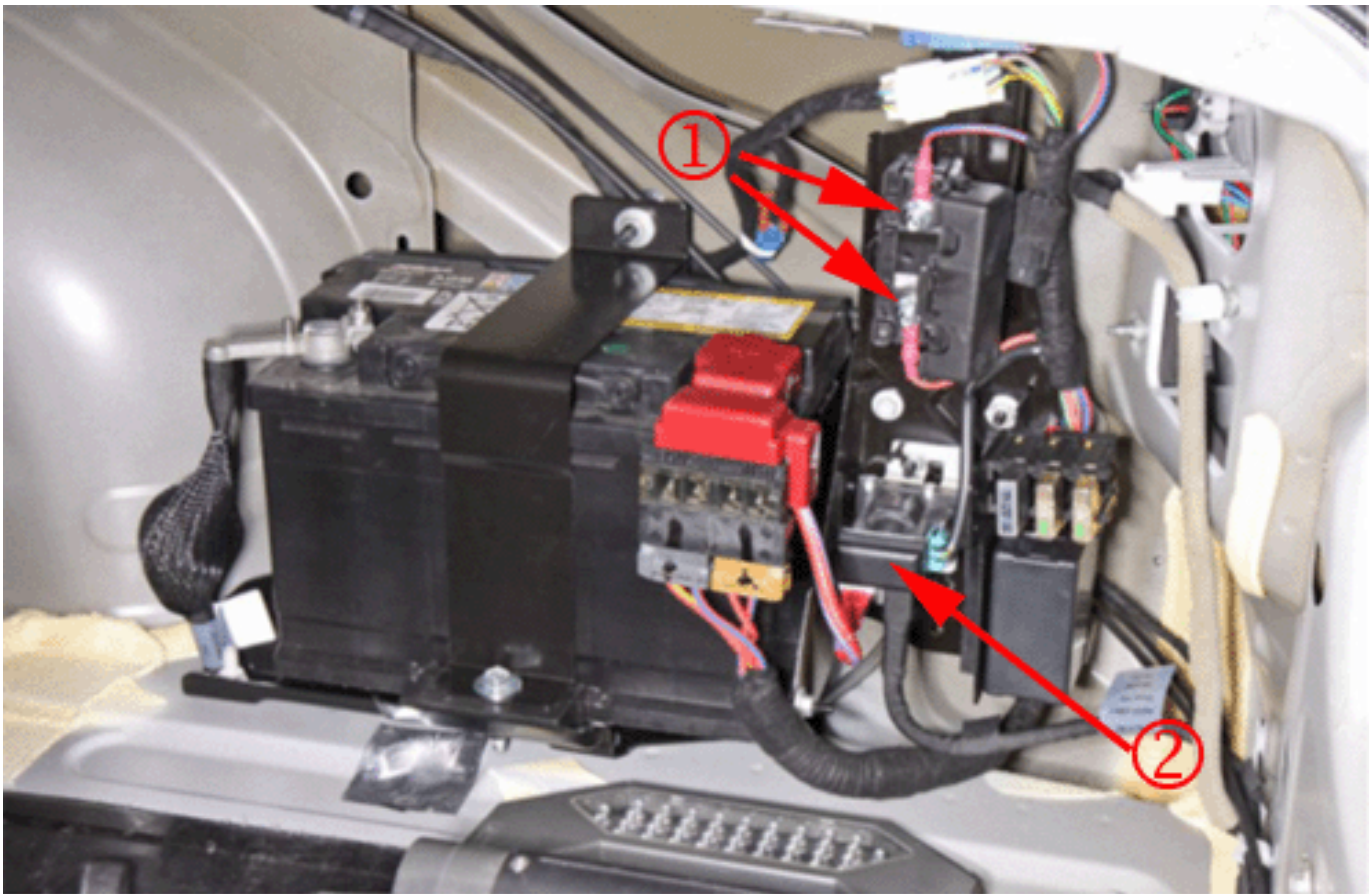
3634969

Improper electrical connections using the power studs on the isolation relay rather than the provided power studs. Any added power circuit in the trunk electrical center should not utilize the studs on the isolation relay.

- (1) Auxiliary Power Taps (shown with cover open)
- (2) Isolation Relay - DO NOT use as power taps

The Caprice PPV equipped with the auxiliary battery utilizes an isolation relay to protect the auxiliary battery from being discharged during engine starting. To eliminate the possibility of improper power tapping, refer to the image below to identify the location of the proper power taps on vehicles equipped with the auxiliary battery, which is located in the trunk of the vehicle directly behind the RH wheel.
