Technical Service Bulletin

94 Headlight cracked / water ingress into headlight lens

94 13 25 2034735/1 July 24, 2013.

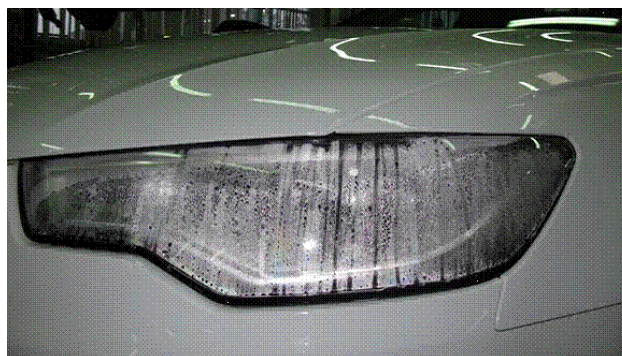
- Heavy condensation present in the headlight (Figure 1).

Figure 1. Headlight with heavy condensation

Replace the affected headlight with the new part number:

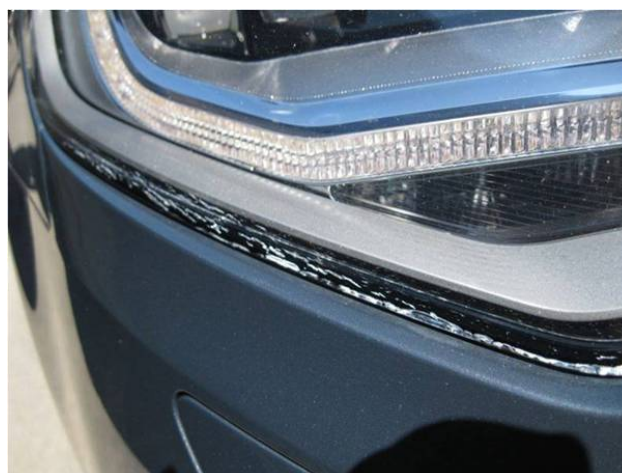
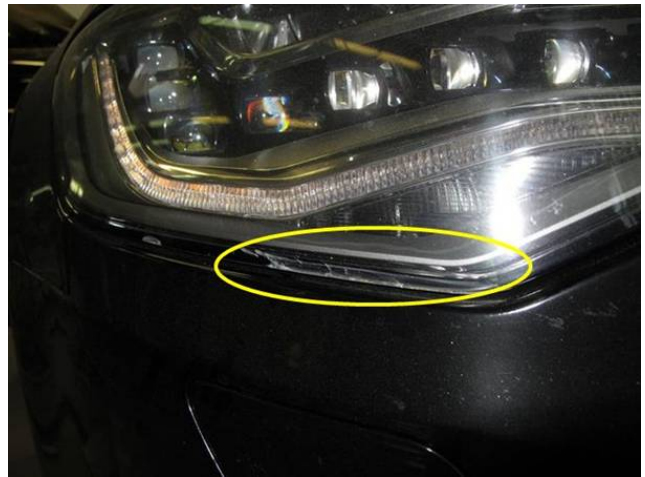
- Lower headlight lens cracking (Figure 2 and Figure 3).

Figure 2. Lower headlight lens cracking.

Figure 3. Lower headlight lens cracking.

The production process causes stress on the headlights from the bumper, as well as torsion force from installation.

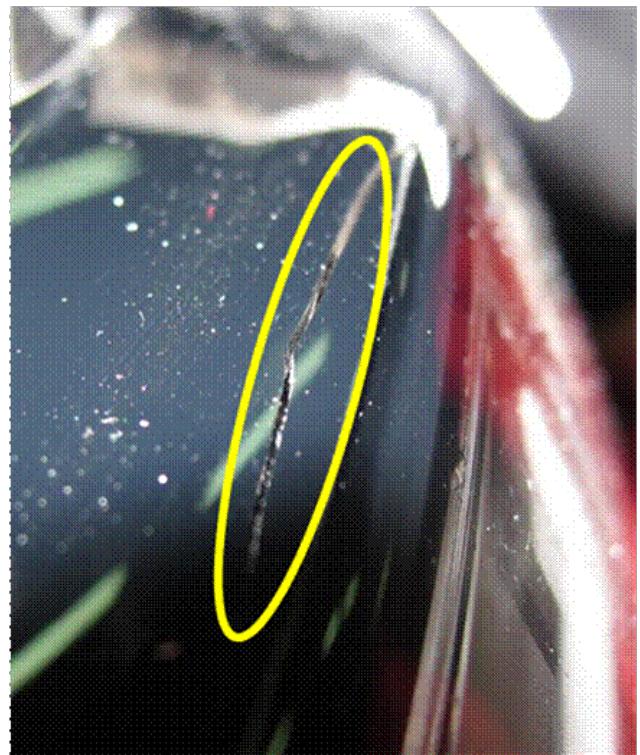
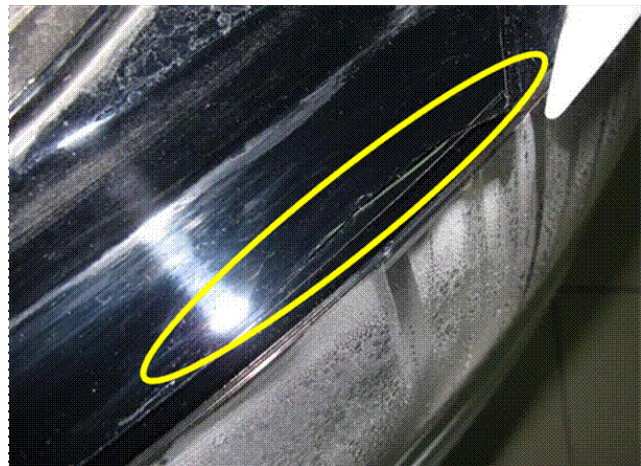
- Upper headlight housing cracking (at transition from lens to black surround) (Figure 4 and Figure 5).

Figure 4. Upper headlight housing cracking.

Figure 5. Upper headlight housing cracking.
