INSTRUCTION TO SERVICE ITS: 4939

| SECTION: 405 Artic Joint | MODEL: <input type="checkbox"/> 30FT <input type="checkbox"/> 35FT <input type="checkbox"/> 40FT <input checked="" type="checkbox"/> 60FT <input checked="" type="checkbox"/> DSL <input type="checkbox"/> CNG <input type="checkbox"/> LNG <input checked="" type="checkbox"/> ELEC | TYPE: <input type="checkbox"/> HIGH FLOOR <input checked="" type="checkbox"/> LOW FLOOR | WRITTEN BY: Jermie Marasigan |

OBJECTIVE/SUBJECT:
 Repair and raise articulated joint bellows.

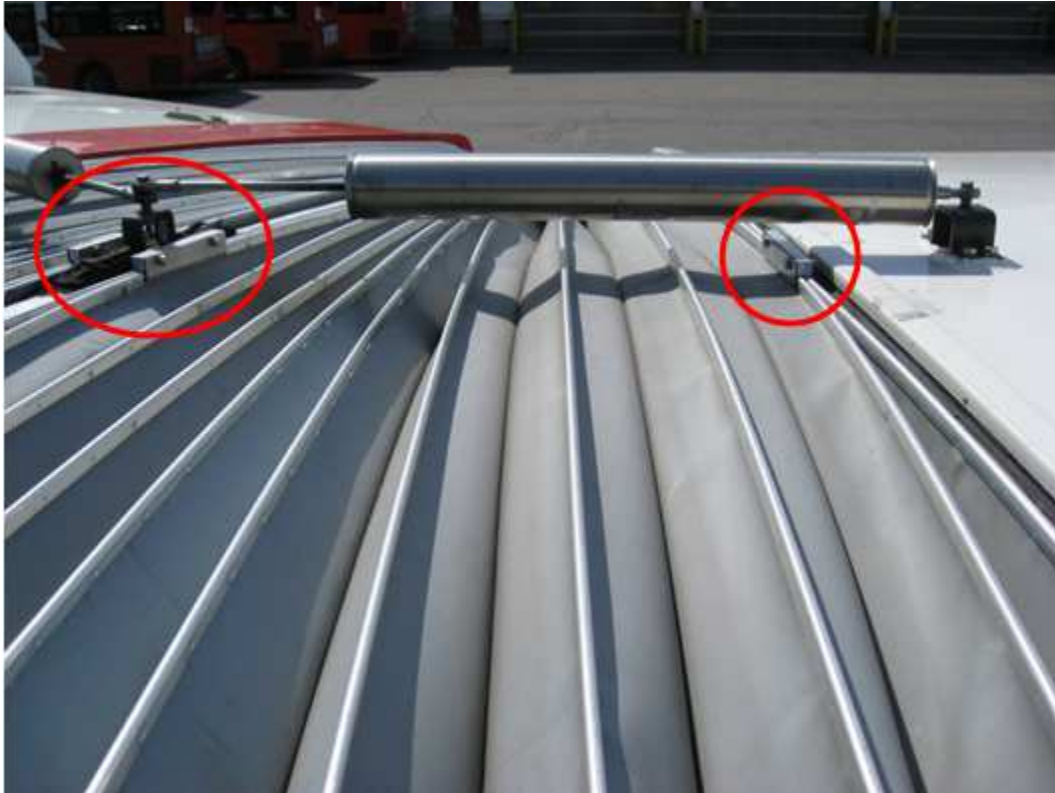
Figure 1: ROOF TOP BELLOW CLIP

- PROCEDURE:**
1. Turn the main battery disconnect switch to the "OFF" position.
 2. From the outer topside of the artic joint locate the adjacent peaks on either side of the center hoop as well as the adjacent peaks at the fore and aft articulation bulkheads.
 3. Apply Polyurethane film tape NF P/N: 6407551 onto the bellows extrusion where the clamps will be installed to act as a dissimilar metal barrier.
 4. Clamp the peaks together using the A&A bellow's clip NF PN 6394515. Refer to Figure 1.

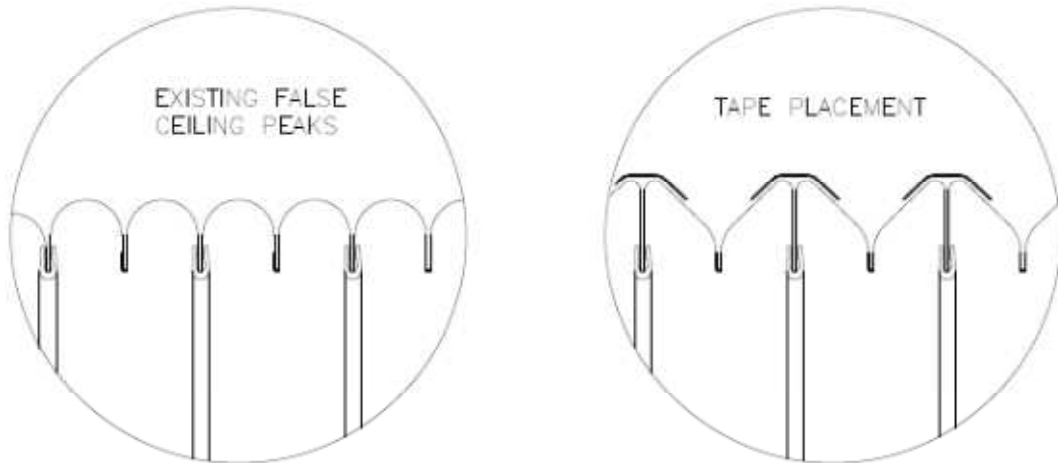
Figure 2: POLYURETHANE TAPE INSTALLATION REFERENCE

5. From the inside of the coach, inspect the false ceiling bellows if drooping or sagging and repair if required.
6. Remove the interior false ceiling bellows.
7. Using a Polyurethane film tape with PSA (NF P/N: 6407551), bond the top peaks of the folds which come together above the aluminum support frame support frame. See Figure 2. The tape is only required (Qty = 20, 10 on each sides) at the outer location of the folding sections. Tape will be located from the stitching end toward the center line of the bellows. See Figure 3 & 4 for reference.
 - a. Clean the outer location of the folding sections where tape will be installed with common household cleaner (409, Fantastic etc.). Dry area then clean with alcohol.
 - b. Affix polyurethane tape 6" W X 7" L to bond the top peaks of the folds.

☞ **NOTE:** If the false ceiling bellows is not sagging, tape installation is not required.

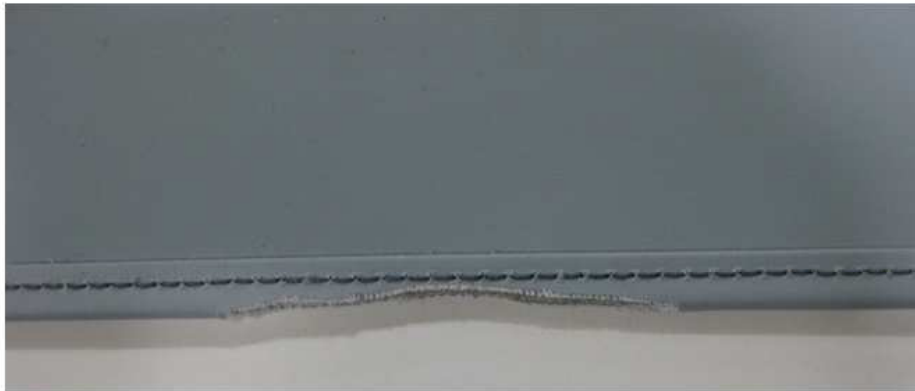
Step 1: Clean inside affected area with common household cleaner (409, Fantastic etc.)
Let area dry prior to proceeding.

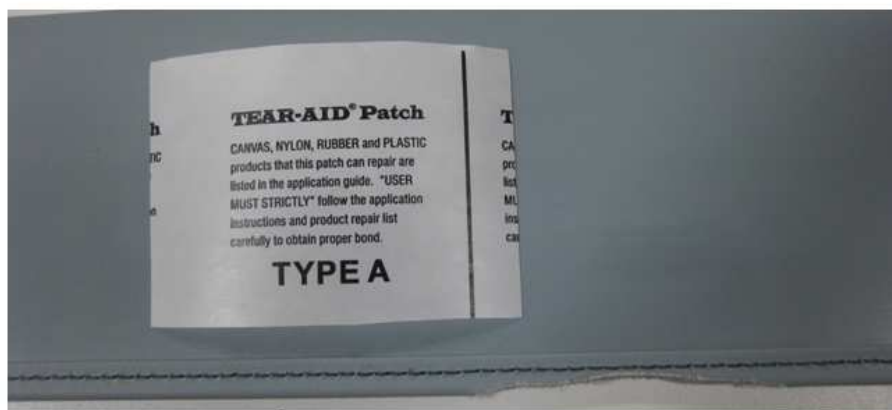
Step 2: Apply a small piece of Tear-Aid tape approximately 0.75" wide x damaged length plus 0.5" overage on each side beyond damaged area. (1.0" longer than the affected abraded area to reduce the possibility of leakage)

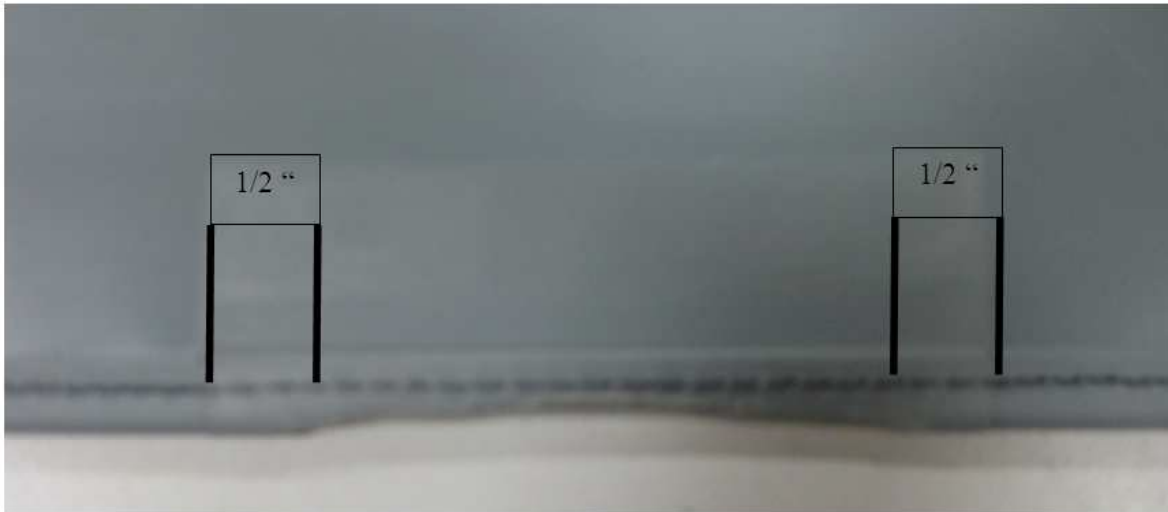
Step 3: Press and rub tape to insure adhesion to material and removal of any air bubbles. Affixing of tape can follow contour of damage or straight across along the seam.

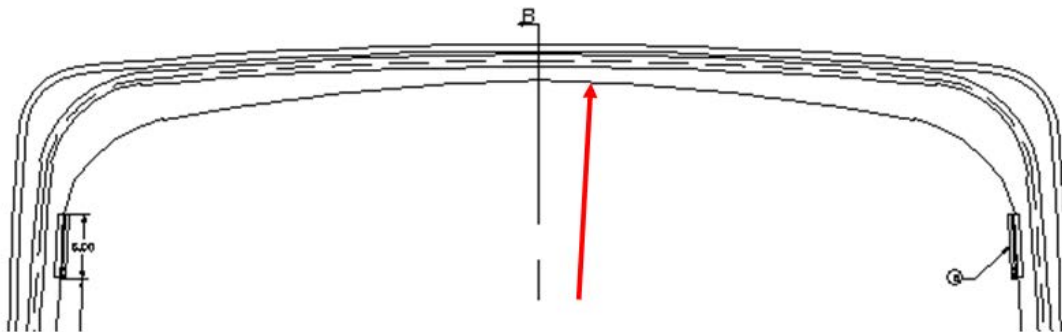
Step 4: Place the aluminum binding strip P/N, K25412-1 over the area and crimp into place every 3.0" on the inside of the Bellow.

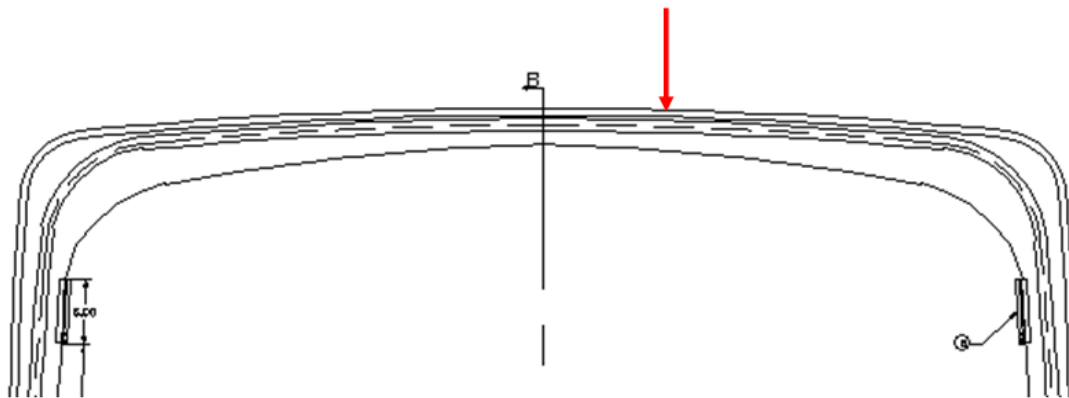
Step 2a: Additional sealing is required on the outside of the Bellows as a preventative measure to avoid leaking. Clean the Bellow at the wear point and apply a small bead of PRO SEAL 34 (A&A P/N 12000043).

Step 3a: Tool the bead into the area by dipping your finger into a water and soap solution and work the sealant into the valley.
