# Tech Tips

TT 50-12-01

**2011-2014 Jetta Sedan – Water Leak into Front Passenger  
Compartment**

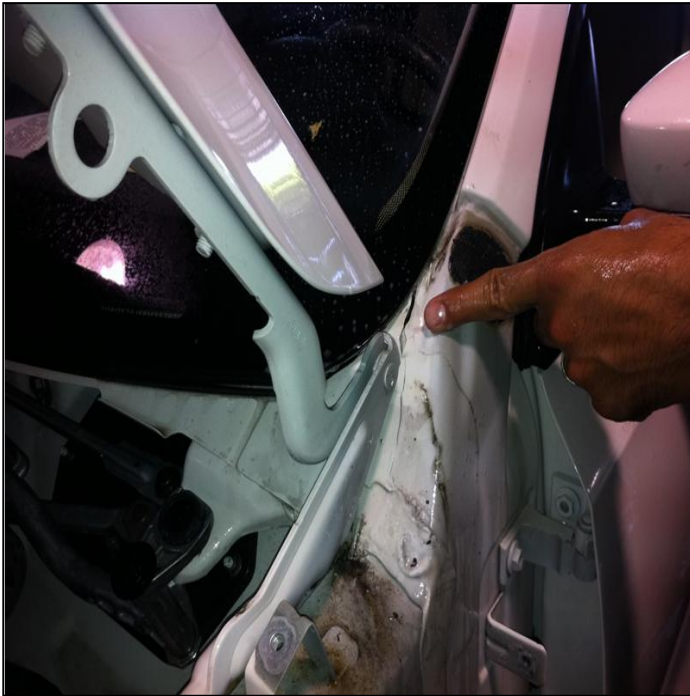
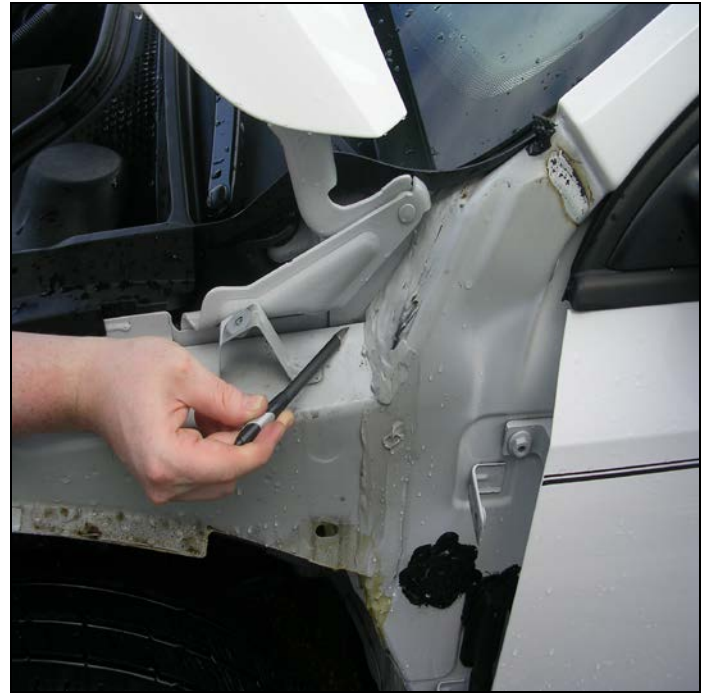
A concern of water leak into the front passenger compartment may be caused by a seam sealer skip or hole in the area around hood hinge or behind front fender.

Isolate leak location by switching HVAC blower on high, with all doors and windows closed, and then spraying soapy water, or a foaming cleaner, over seam sealer. If bubbles are observed at any point during this test, repair leak at location of bubbles using an appropriate seam sealer.
