SB-10054493-5153

A/C DRAIN LINE REWORK

Property and Top Bus Number: DART: 304500

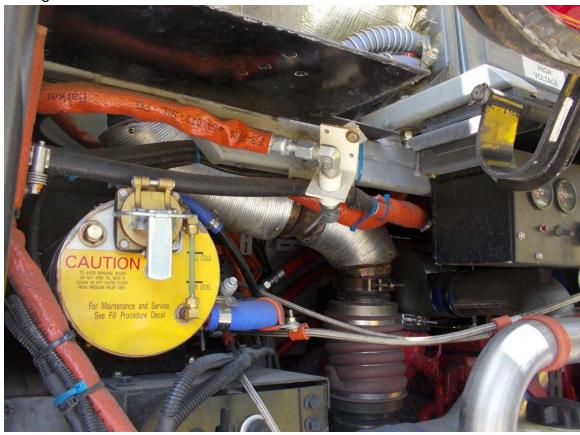
- 1. Park the bus and apply the parking brake.
- 2. Turn off main battery disconnect switch(es).
- 3. Take existing s/s drain lines out of bus.

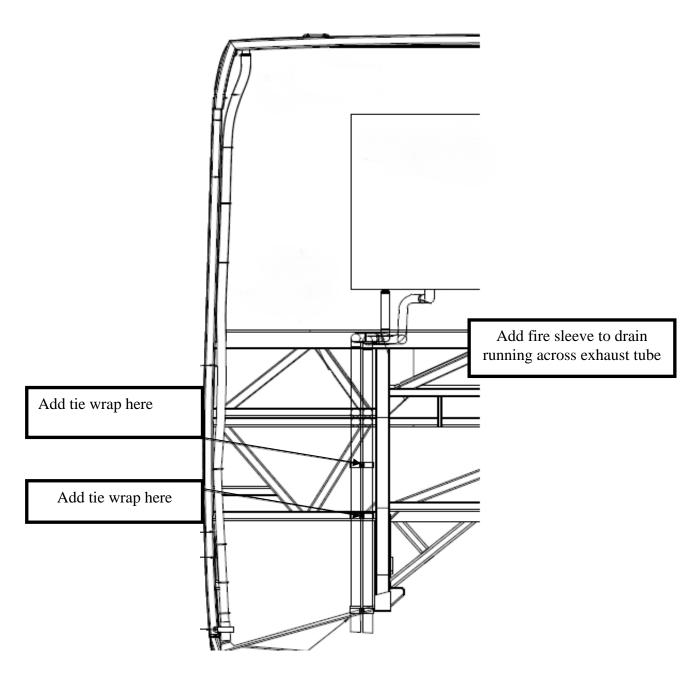
4. At the tee in the line replace with a coupling. Run the ones from the bottom of the a/c unit to the back wall and tie wrap. Add fire sleeve to drain line running across exhaust tube.

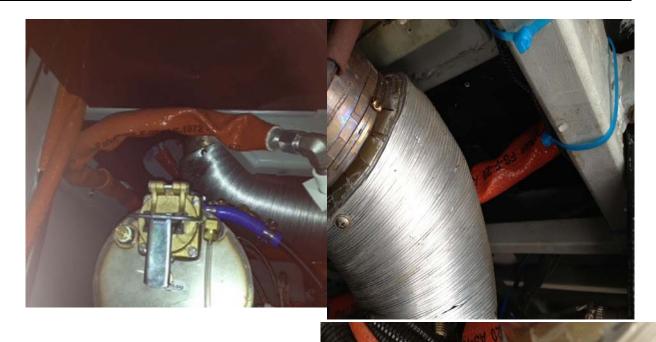
Run drain line behind existing harness and lines as shown

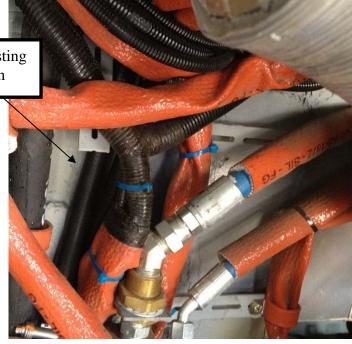
- 5. Secure any loose spots while routing with wire ties
- 6. Check for completeness of work.
- 7. Remove all tools from working area.
- 8. Turn the main battery disconnect switch (es) on.
