Tiffin Motorhomes, Inc.  
105 2<sup>nd</sup> Street NW  
Red Bay, AL 35582  
256-356-8661

**SB-38**  
**Tightening Seat Belt to Mounting Bracket**

## Tightening Seat Belt to Mounting Bracket

**WI-196**

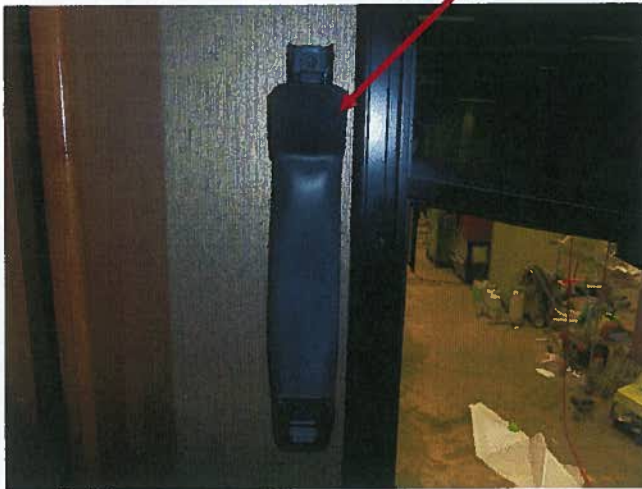
1. Gently pull down top of plastic covering to expose seat belt bracket on Driver/Passenger main wall.

See photo below

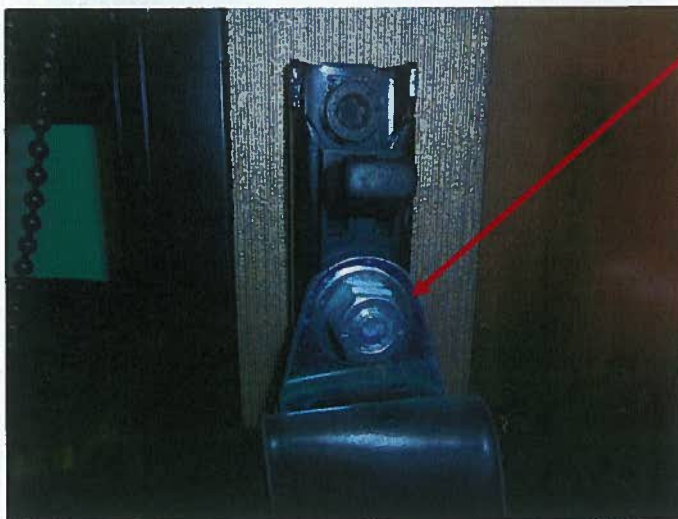
2. Tightening Driver/Passenger seat belt to mounting bracket.

A. Hand Tighten nut with 17 mm wrench. See photo below
