Technical Service Bulletin

GROUP	NUMBER	
ELECTRICAL	13-EE-002	
DATE	MODEL(S)	
JUNE 2013	Santa Fe (CM)

OVERHEAD CONSOLE LAMP REPAIR

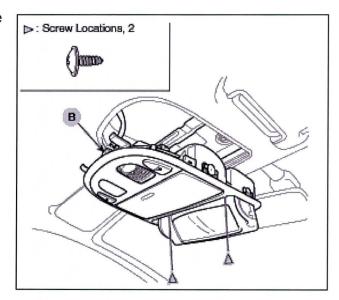
1. Flip open the sunglasses holder and remove the 2 screws. Slide overhead console towards the windshield and disconnect connector (B).

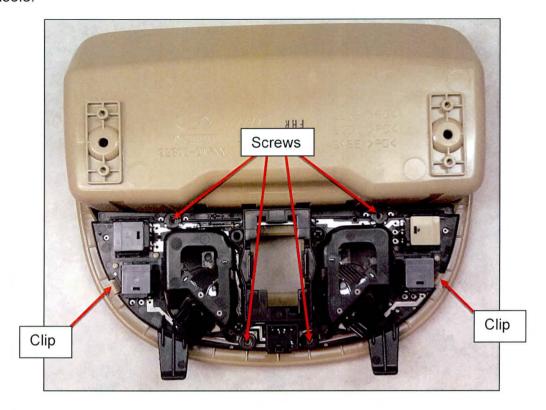
2. Remove the 4 screws holding the circuit board to the overhead console. Unclip 2 plastic retaining clips using a trim removal tool and remove the circuit board from the overhead console.

- 3. Snap new circuit board assembly into the overhead console.
- 4. Tighten 4 screws securing the circuit board to the overhead console.
- 5. Install overhead console into vehicle by following reverse of removal.
- 6. Check for proper operation of sunglass holder, map lamp and sunroof (if equipped).
