# **Technical Service Bulletin**

GROUP	NUMBER
_	BODY	13-BD-001
٥.	DATE	MODEL(S)
	JULY 2013	<b>ELANTRA COUPE</b>
		(IK)

### FRONT SEATBACK RECLINER RESET

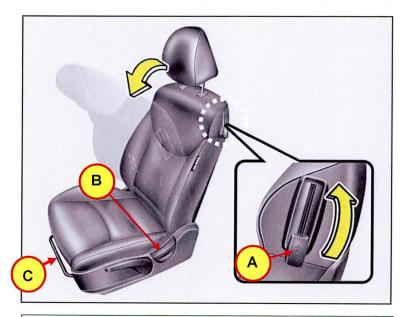
This symptom may occur when pulling the recline lever (**B**) to return the seatback to its upright position after folding the seatback using the walk-in seat lever (**A**).

A: Walk-In Seat Lever

B: Seat Recline Lever

C: Seat Slide Lever

1. Fully slide the front seat forward by using the slide lever (**C**).

Using your hand only, fully recline the seatback until the seatback recliner is locked.

3. Hold the recline lever (**B**) and adjust seatback to the desired position.
